HAZARDOUS MATERIALS SURVEY REPORT

LOS ANGELES COUNTY HALL OF JUSTICE BUILDING
211 WEST TEMPLE STREET
LOS ANGELES, CALIFORNIA

CITADEL Project Number 7139.001

May 9, 2003

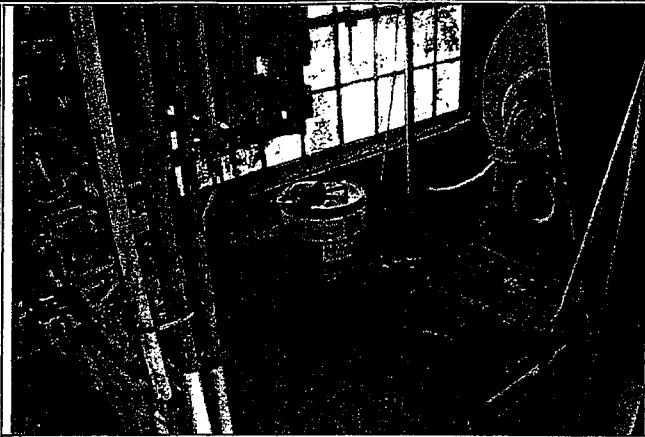
Spent and partially used containers of solvents, paints, thinners, varnishes, lacquers, lubricants, oils, cleaning products, acids, corrosive inhibitors, degreasers, disinfectants, film processing chemicals, and gasoline, etc. were found throughout the structure. The majority of containers were housed on the Basement Level, however, containers can be found on every floor.

Photo 2-Chemical/Solvent Storage-Roof Penthouse

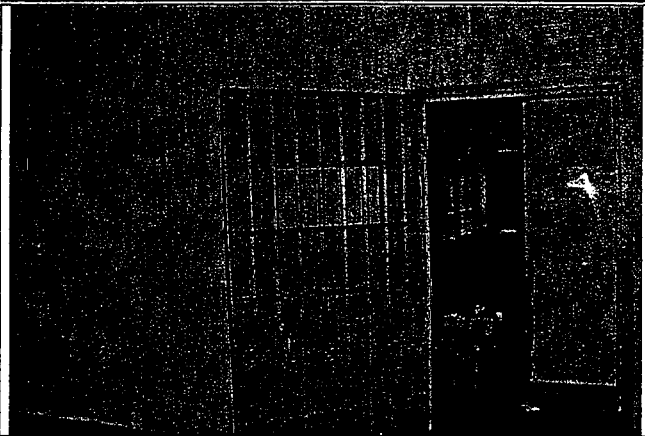
Lead-containing paint, as defined by the CPSC (>600 ppm) and HUD (\geq 5,000 ppm) was detected on several of the building components tested. The paint film on numerous components was observed to be in defective condition (i.e., peeling, blistering, etc.).

Photo 4- Lead-Coated Component- Typical

Given the extent of impacts to occur, the levels of lead present, and the amount of other hazardous materials abatement work to take place, Citadel concurs with HOJA's proposed strategy of having an abatement/demolition contractor perform the majority of demolition work. This contracting approach will minimize the impacts caused by the presence of lead. Citadel recommends that the abatement contractor stabilize all defective paint, remove all painted components to be impacted, and remove as much paint as feasible on components to remain.

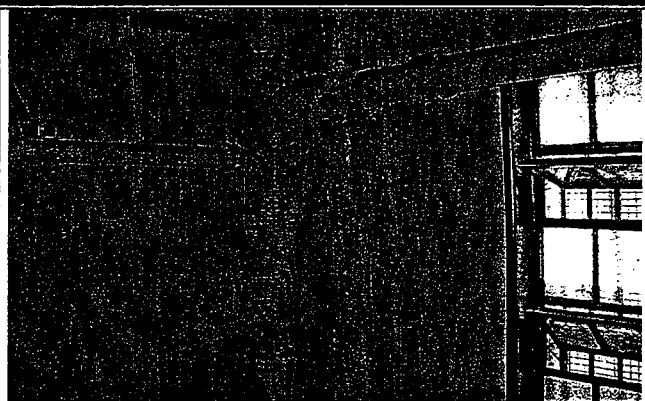
Previous bulk sampling by CTL, and visual observation by Citadel, identified asbestos-containing (5-70% Amosite and 5-40% chrysotile) thermal system pipe, fitting and tank insulations (TSI) on steam lines, condensate lines, domestic hot water lines, and heating hot water risers throughout much of the building. In some instances, the original asbestos TSI has been replaced or overwrapped with non-suspect fiberglass insulation.

At the time of the survey and assessment, the majority of TSI in accessible locations was observed to be in *good condition*. Although the TSI is a friable ACM, it is unlikely to pose a significant exposure hazard in its current condition (unless it is disturbed or damaged) due to its location and intact canvas coverings. While a majority of the TSI was observed to be in *good condition*, there limited areas where Citadel observed visible debris and *damaged* ACMs.

Photo 6- Thermal System Pipe Insulation Riser-Typical

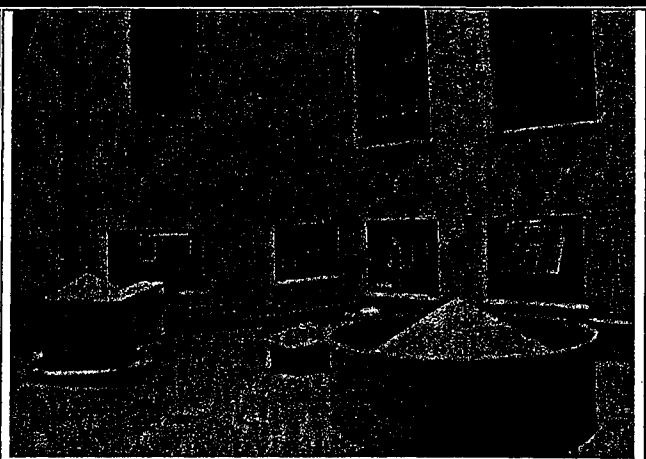
The roof field membranes were observed to be in good, nonfriable condition at the time of the survey. Since the non-friable roofings are relatively inaccessible, they are unlikely to pose significant exposure hazards in their current conditions.

Photo 8- Built-Up Roofing (Flat)-RBC2 and RBC4
