**REPORT OF
SURVEY FOR HAZARDOUS MATERIALS**

**HALL OF JUSTICE
LOS ANGELES, CALIFORNIA**

April 20, 2005

MACTEC Project 4952-04-2862

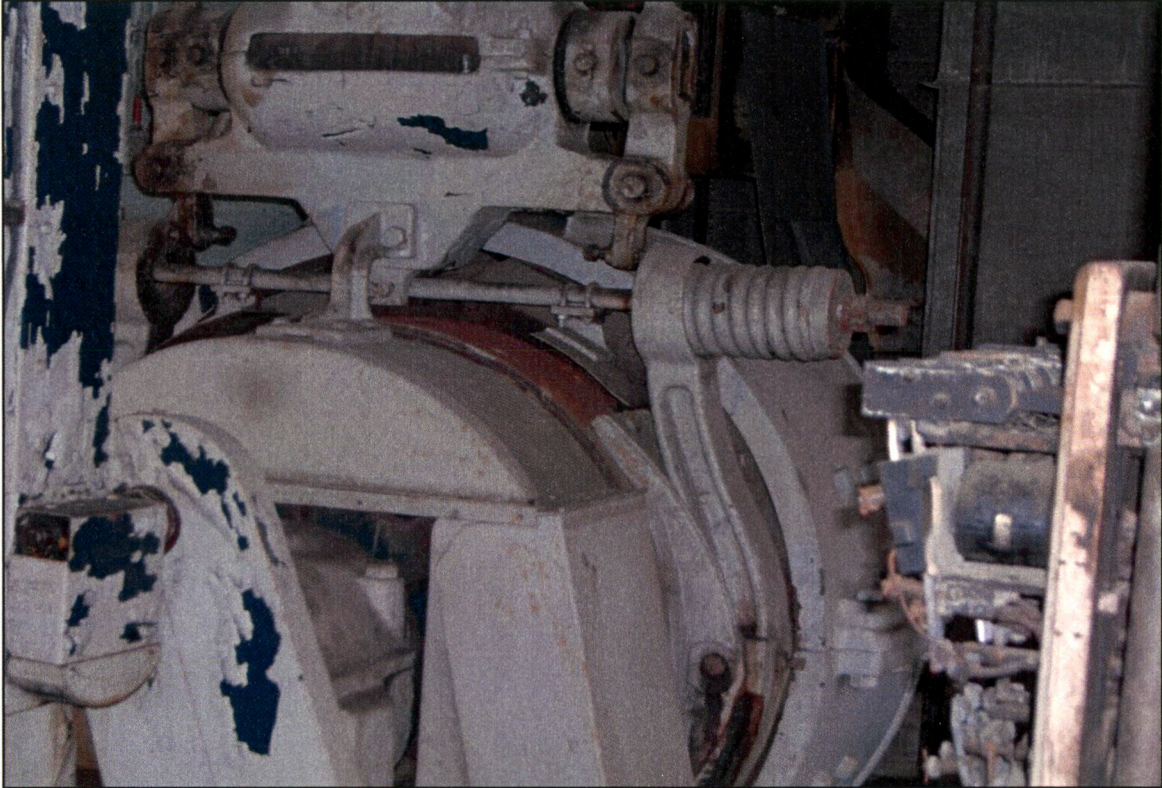
Photograph 1: Elevator equipment with asbestos brake pads

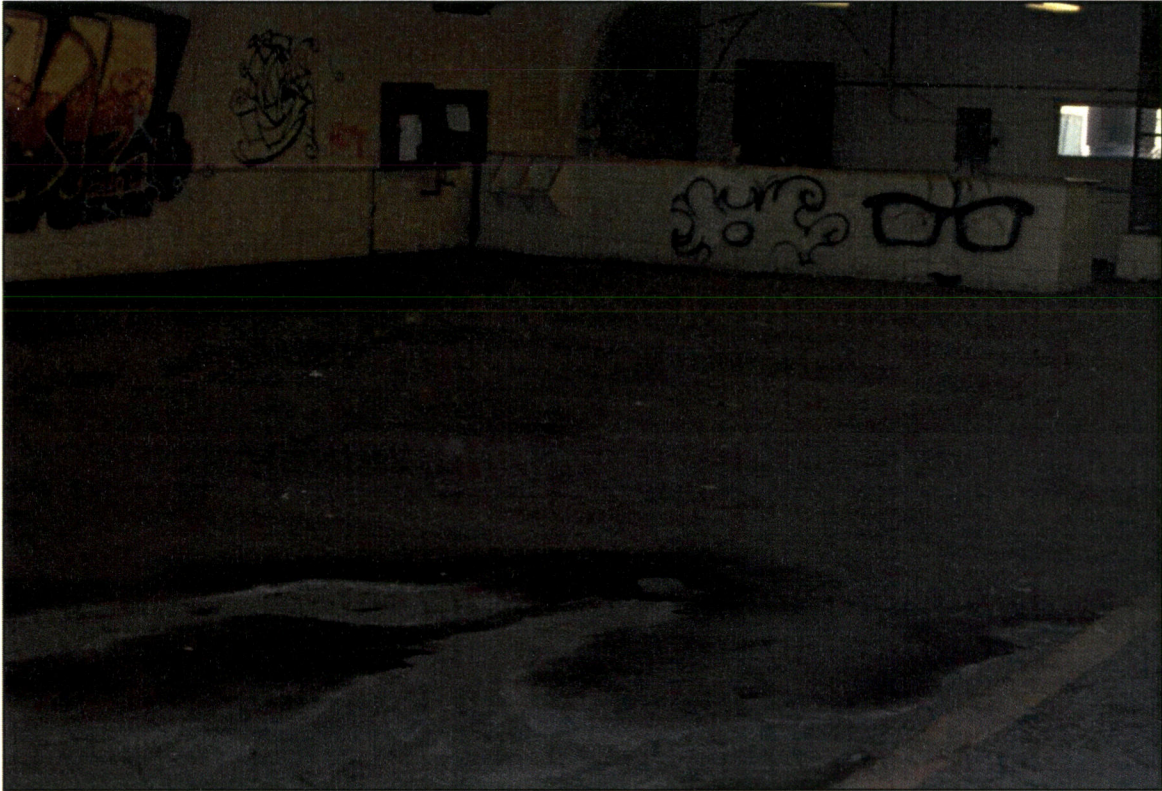
MACTEC's subcontractor/consultant, LVI/TEG, indicated that a red flooring material observed in the penthouse may contain mercury (Sample No. SC 12-13-8). MACTEC sampled the material and submitted it for analysis.

Photograph 2: Flooring material in penthouse containing mercury

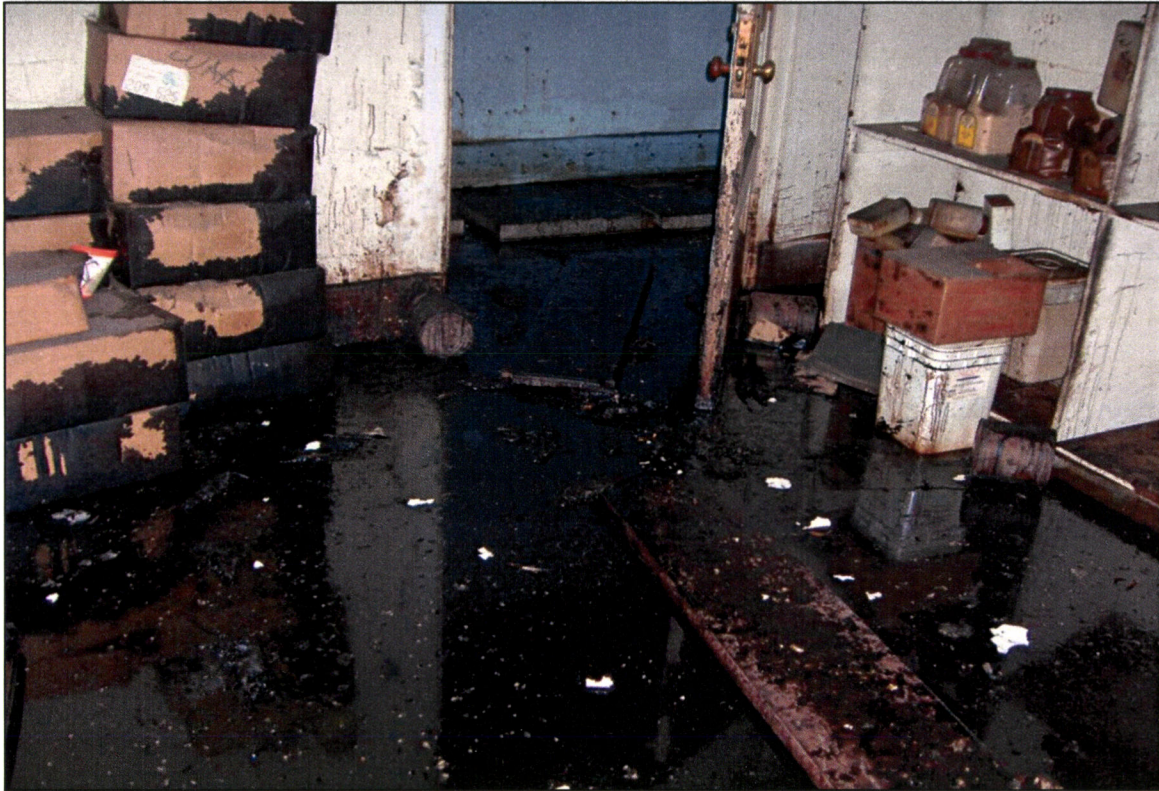
Photograph 3: Area of prison on 14th floor with foodstuffs and dead rats

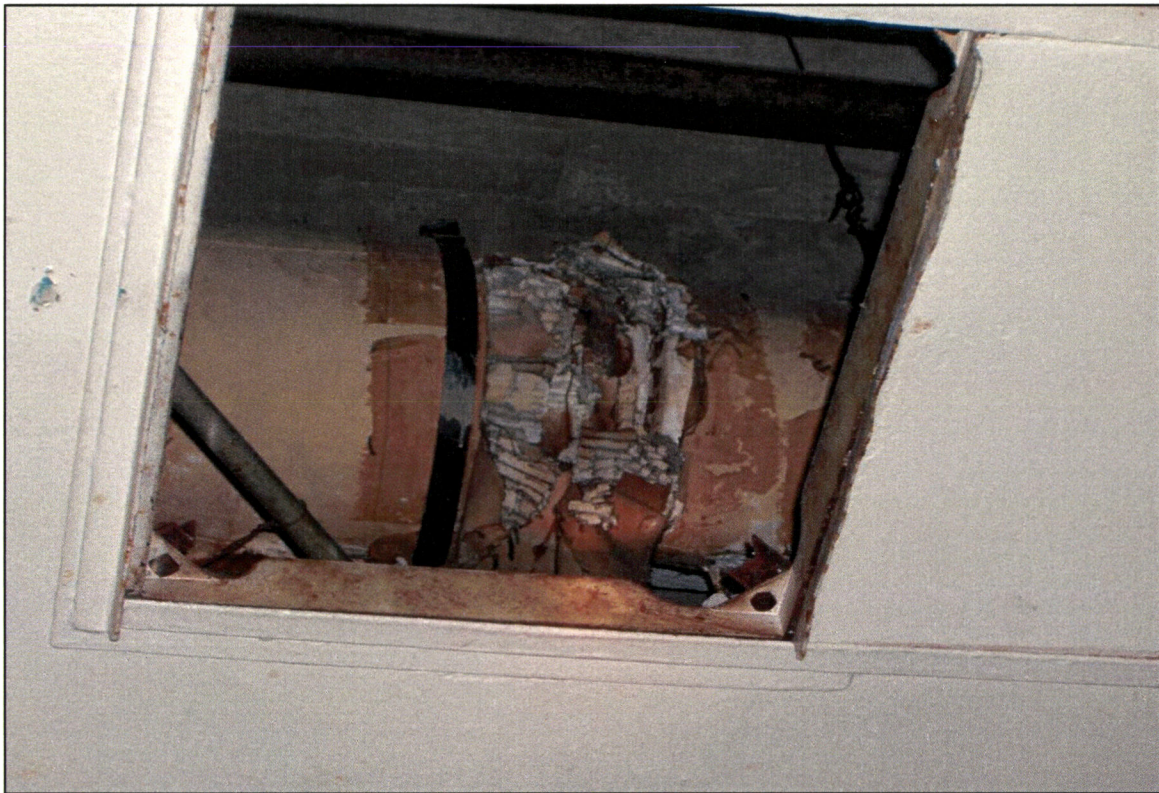
Photograph 4: Typical asbestos containing pipe insulation

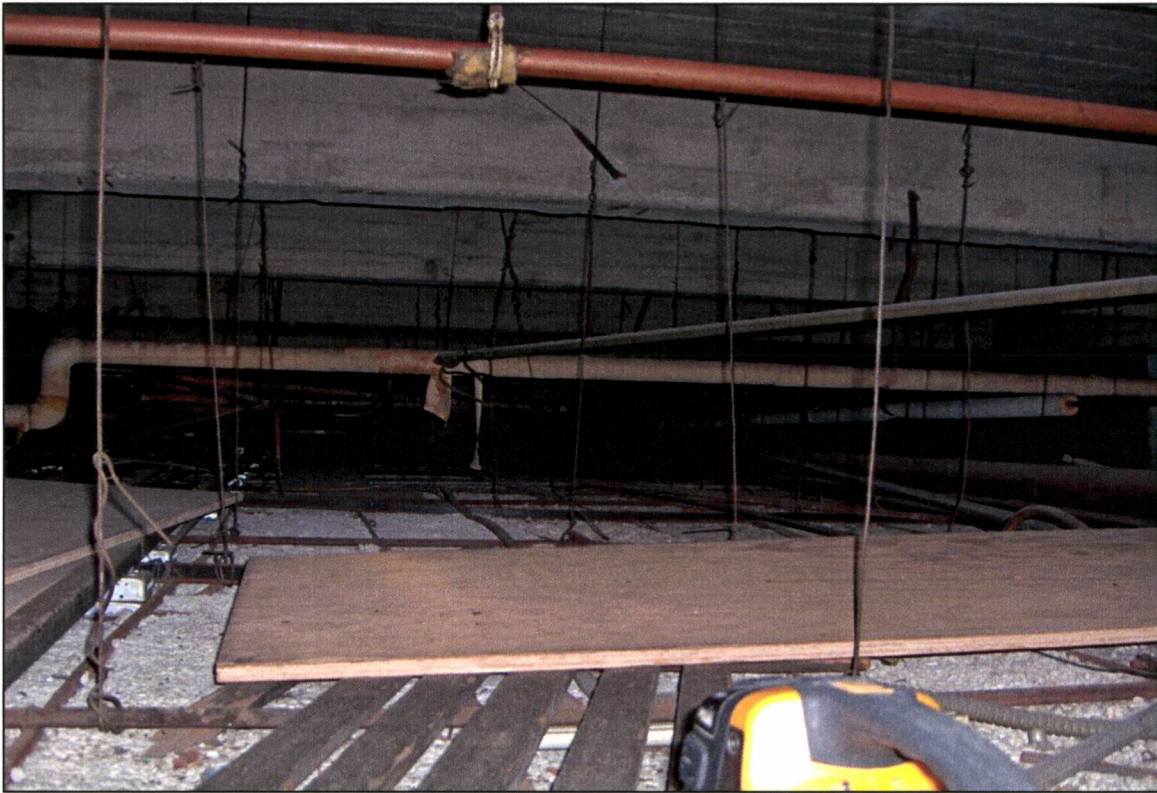
Photograph 5: Interstitial space above courtroom showing piping with asbestos containing insulation

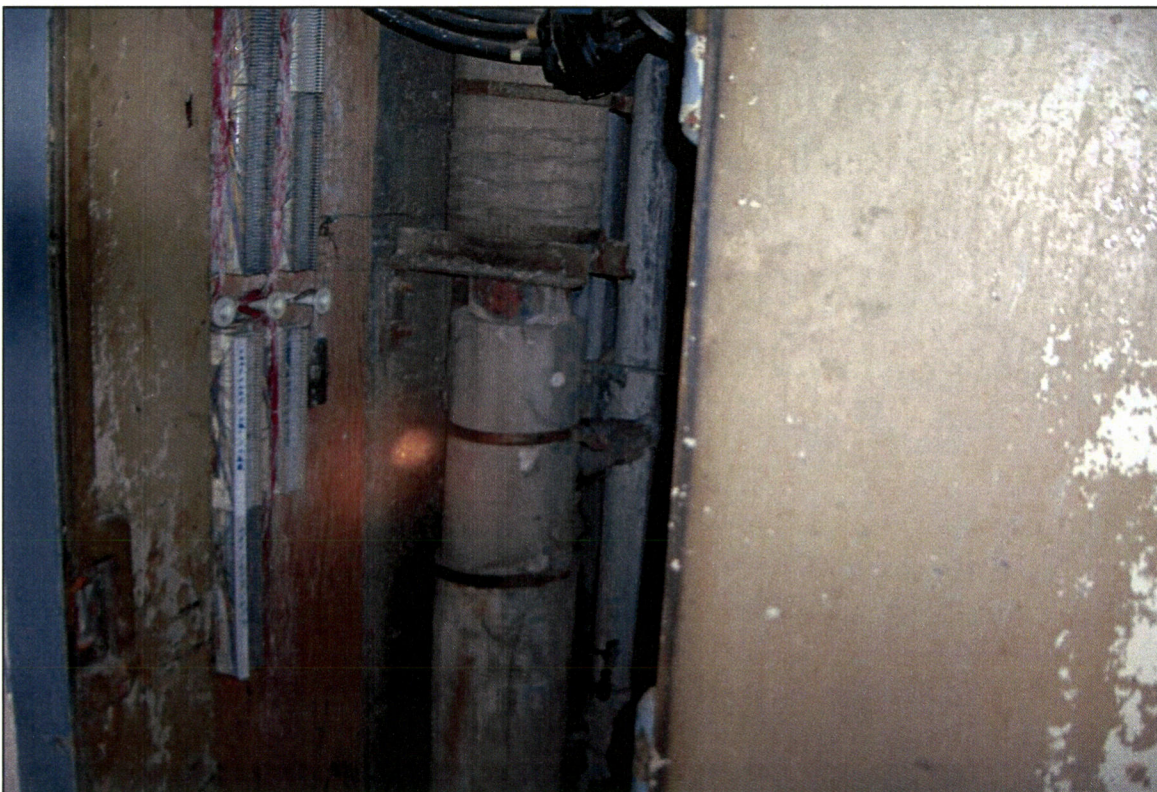
Photograph 6: Typical vertical piping with asbestos containing insulation

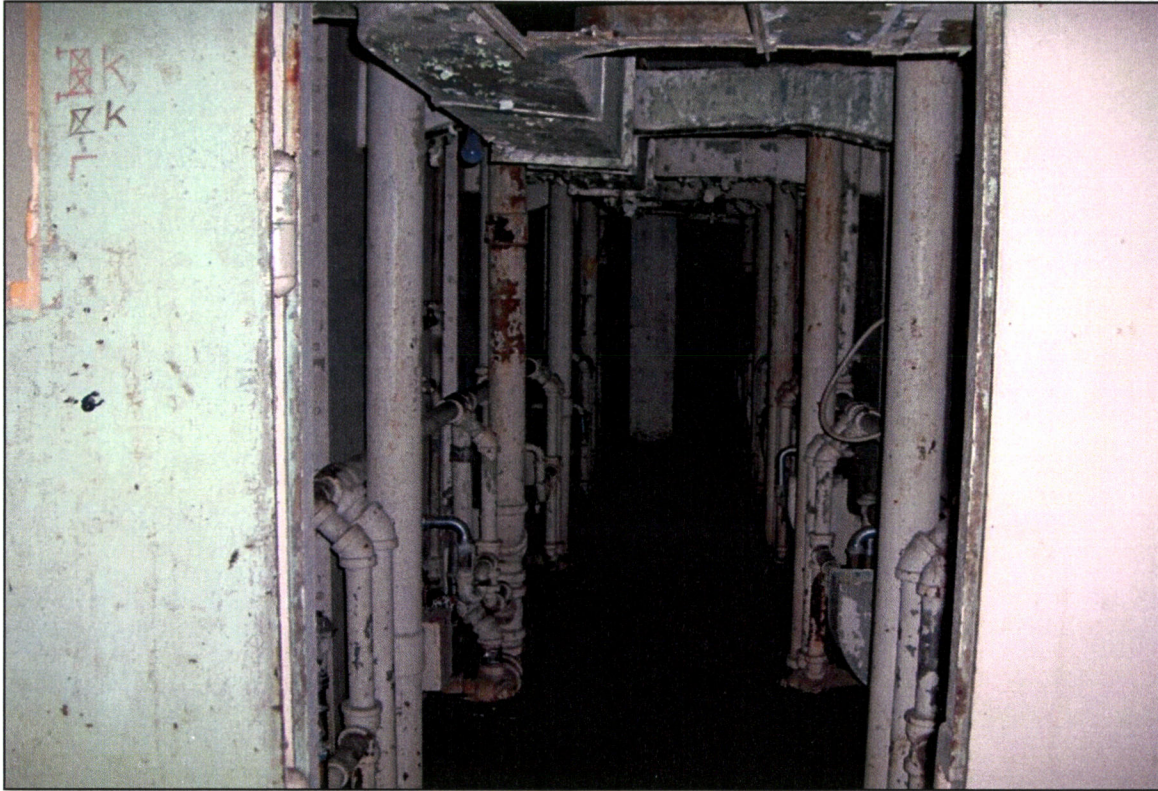
Photograph 7: Typical pipe chase between prison cells with asbestos containing insulation

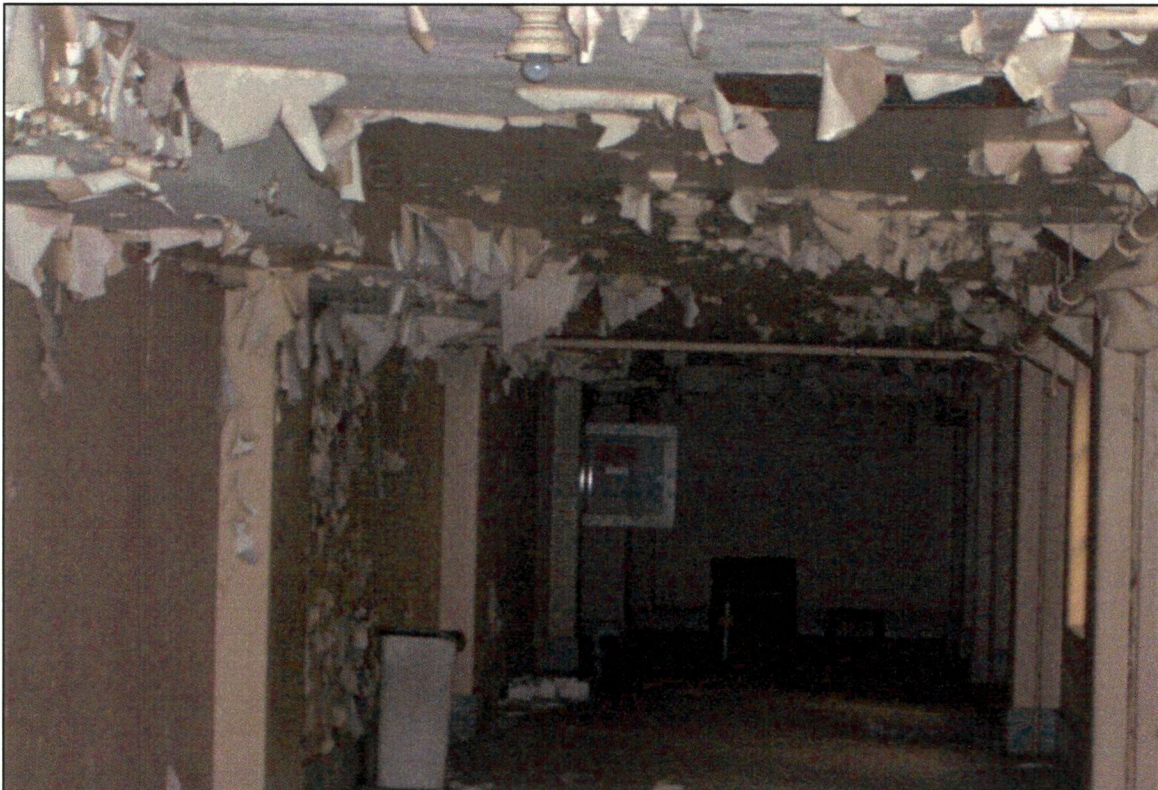
Photograph 8: Typical flaking lead-based paint

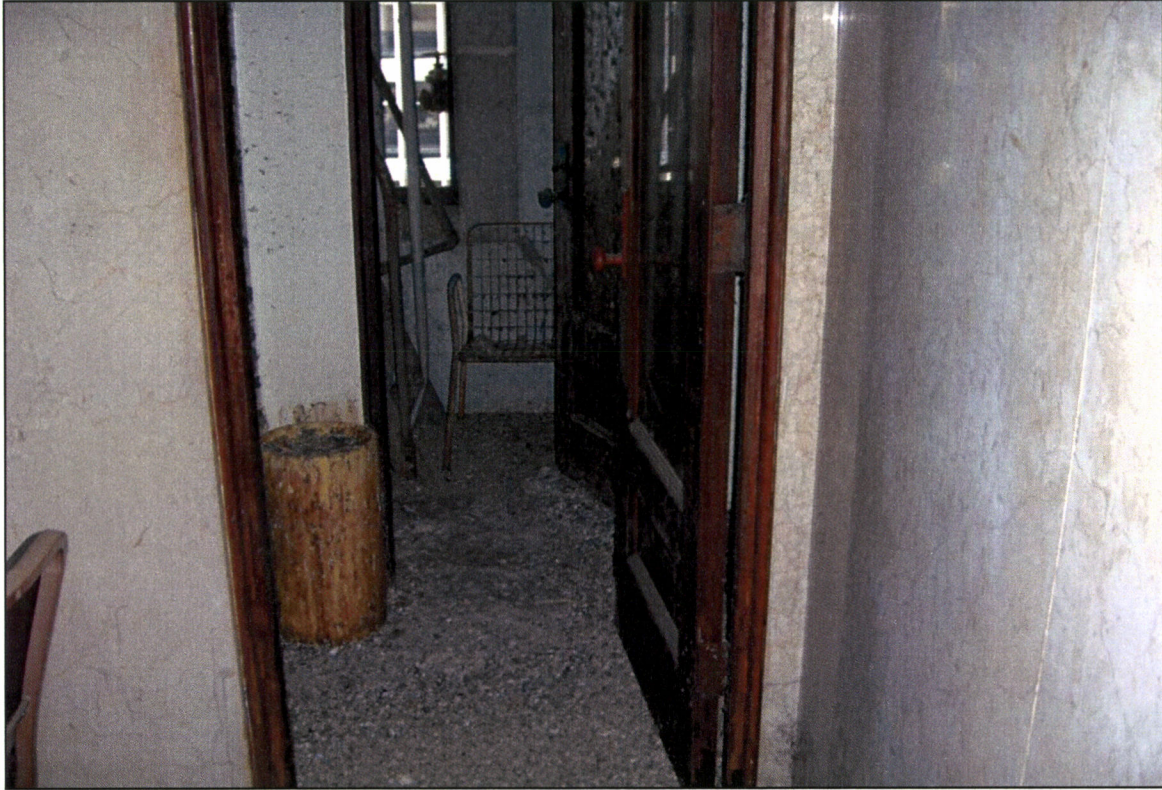
The building has been observed on numerous occasions during this work. Significant accumulations of pigeon feces have been identified in the stairwells on the northeast and southwest corner of the building and on the north end of the 6th floor (Columns N/1-6) and in rooms on the east side of the 9th floor (Columns E-H/1-3). One significant accumulation of rodent feces was observed. It is located in a room on the north end of the 14th floor (N-P/5-7) where pasta was left when the prison was abandoned. Several dead rat carcasses are associated with spilled syrup on the floor outside this room. These areas are noted on the figures in Appendix A.

Photograph 9: Typical Pigeon feces

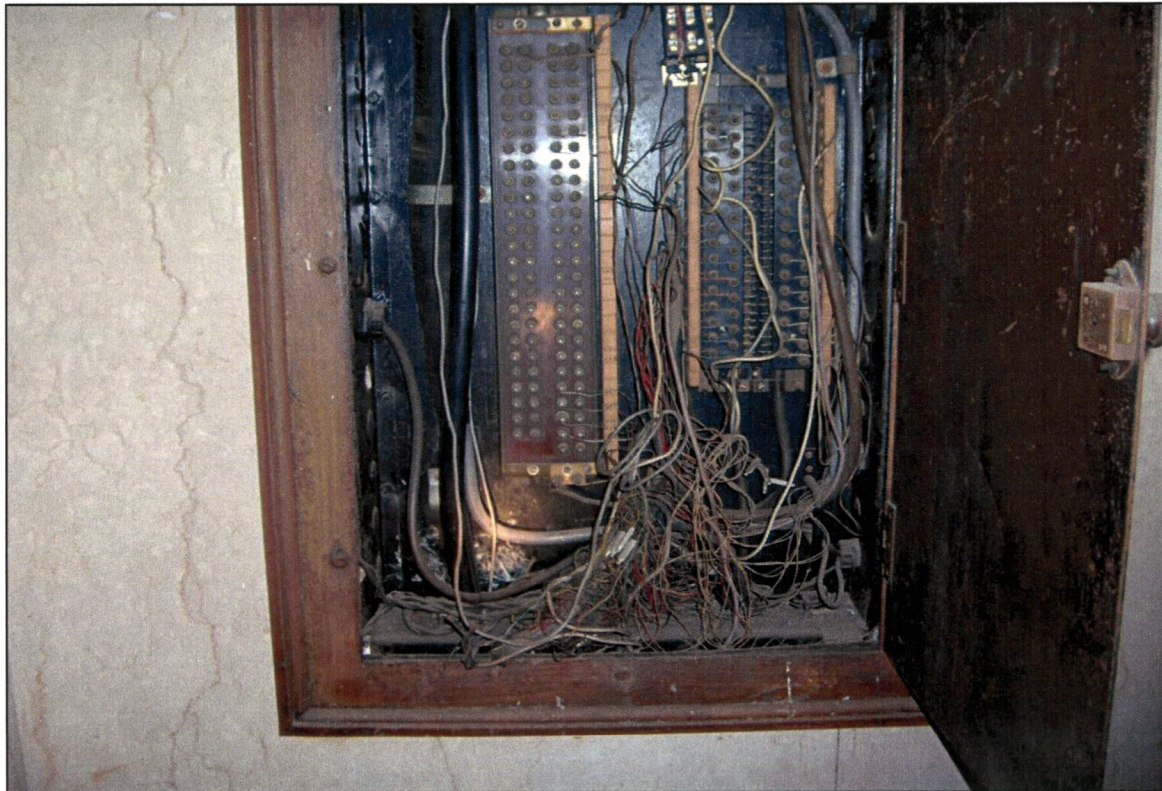
Photograph 10: Typical lead shielded cabling

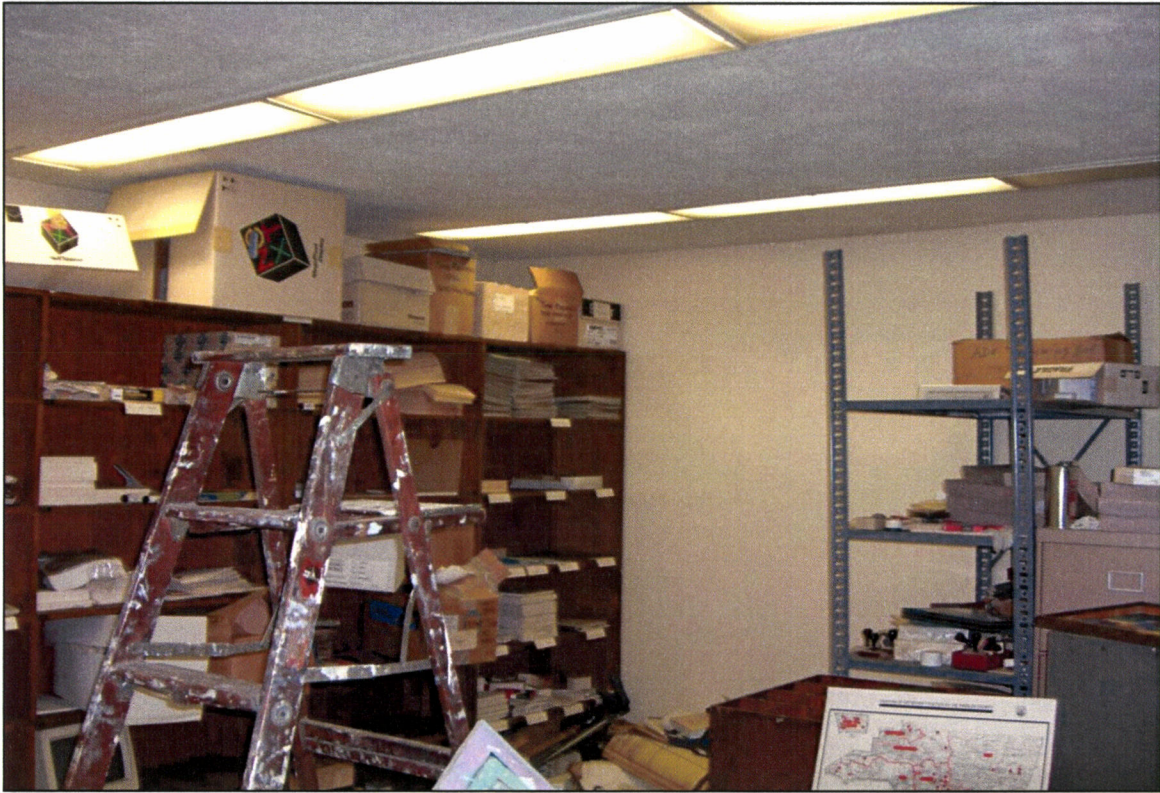
MACTEC's subcontractor Environmental Control Industries (ECI) inventoried the number of fluorescent light fixtures. Typically, ballasts in fluorescent light fixtures are assumed to contain PCBs unless labeling indicating the absence of PCBs (e.g., "No PCBs") is observed. Based on our observations, the majority of the lamp ballasts are relatively old and suspected of containing PCBs. All lamp ballasts should be reviewed for labeling during renovation and unlabeled or PCB-labeled ballasts segregated for disposal. The number of ballasts per floor is indicated on Table 5.1.

Photograph 11: Typical fluorescent light fixtures

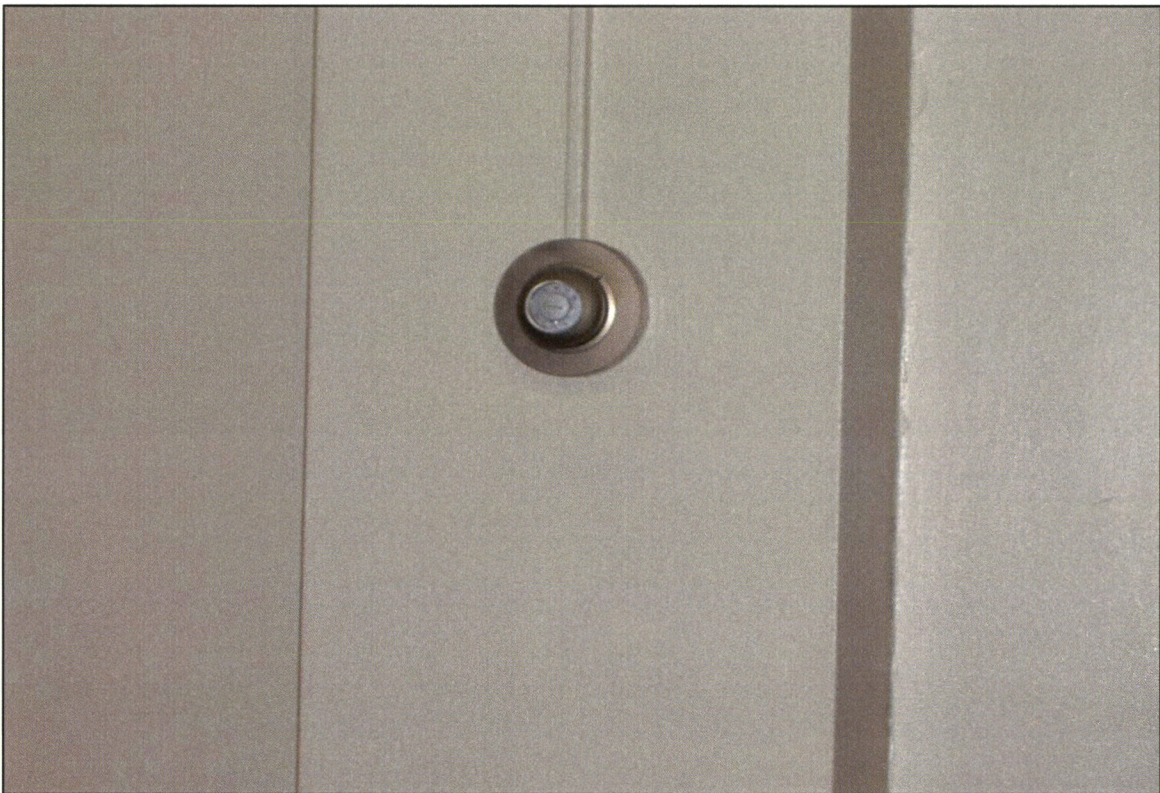
Photograph 12: Typical mercury containing thermostat

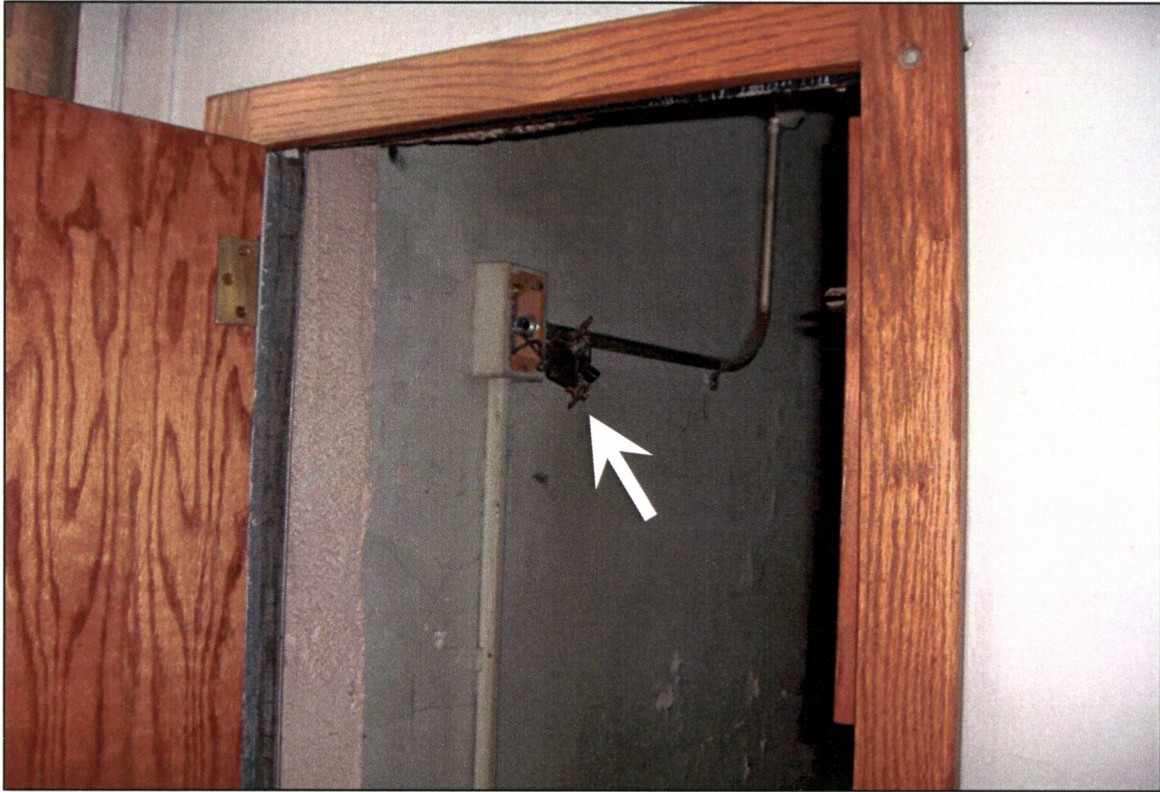
MACTEC inventoried light switches, thermostats and fluorescent light tubes for mercury. MACTEC operated about 1,450 light switches in the building. Three were determined to be mercury-containing based on the criteria provided above. All thermostats observed were assumed to contain mercury. No testing of these items was performed. ECI provided an inventory of the fluorescent light tubes. Table 5.1 presents the location of these three types of items.

Photograph 13: Typical mercury switch

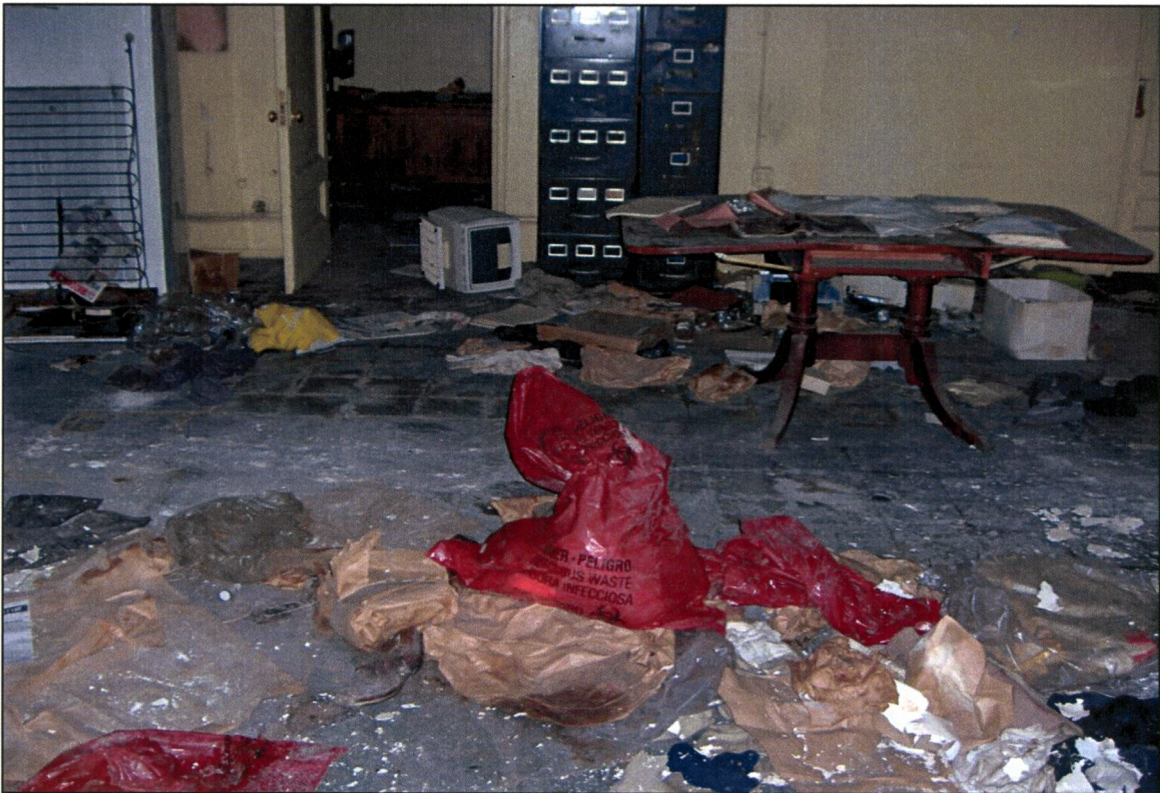
Several bags of bio-hazardous waste were observed in Room 100 during MACTEC's first walk of the building.

Photograph 14: Biohazard bags in room 100 on 1st floor

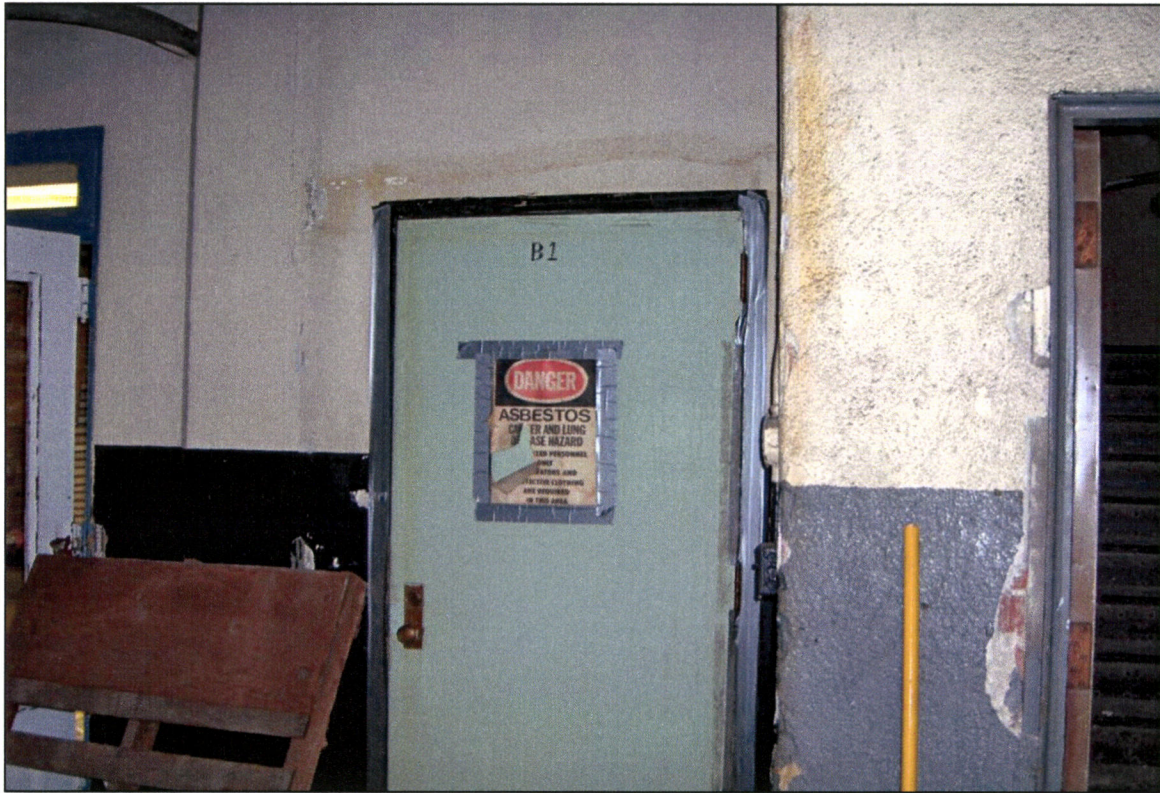
Photograph 15: Basement room containing bagged asbestos material
