**Devils Creek Culvert Concrete Strength
Evaluation, Kodiak, Shannon & Wilson,
September 20, 2012**

**RE: DEVIL'S CREEK CULVERT CONCRETE STRENGTH EVALUATION, KODIAK,
ALASKA**

This letter report presents the results of our visual assessment, site reconnaissance, concrete testing, and concrete strength evaluation for the existing box culvert at the above referenced project at the Kodiak Airport in Kodiak, Alaska. The purpose of our site visit and concrete testing is to provide data to be used in an evaluation of the integrity of the existing culvert that conveys Devil's Creek across the Kodiak Airport property. To accomplish this, the existing concrete culvert was tested in numerous locations throughout the length of each of the two bays with a Schmidt Hammer and four concrete core samples were taken from the top of the culvert to be tested for compressive strength. Presented in this report are descriptions of the site and project, our visual assessment observations, field and laboratory test procedures, an evaluation of the existing culvert, and our recommendations for future improvements to the culvert.

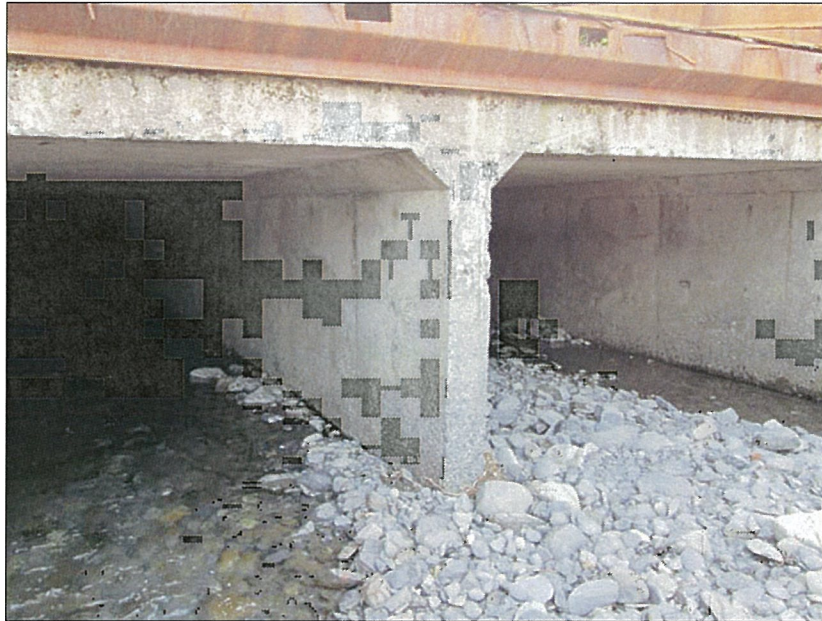
throughout both bays and appeared to be up to roughly ½ -inch into the walls, and was observed to be significant (estimated at more than 2 inches in some locations) in the culvert floor. Concrete erosion into the walls generally resulted in the exposure of aggregate. Photo 1 on Figure 6 shows a location with some of the more significant aggregate exposure due to concrete erosion. However, as shown in Photos 2 and 3 on Figures 6 and 7, erosion into the walls around the culvert bend (approximate Stations 0 through 275) of both bays was observed to be more extensive and resulted in the spalling of concrete and the occasional exposure of rebar near the bottom of the walls in some locations. The erosion of concrete in the floor of the culvert resulted in the exposure and undercutting of numerous pieces of lateral and longitudinal rebar throughout a significant portion of both bays of the culvert. Photos 4 through 6 on Figures 7 and 8 show exposed lateral and longitudinal rebar at the invert of Culverts 1 and 2.

PHOTO 1: CENTER WALL AT CULVERT INLET.

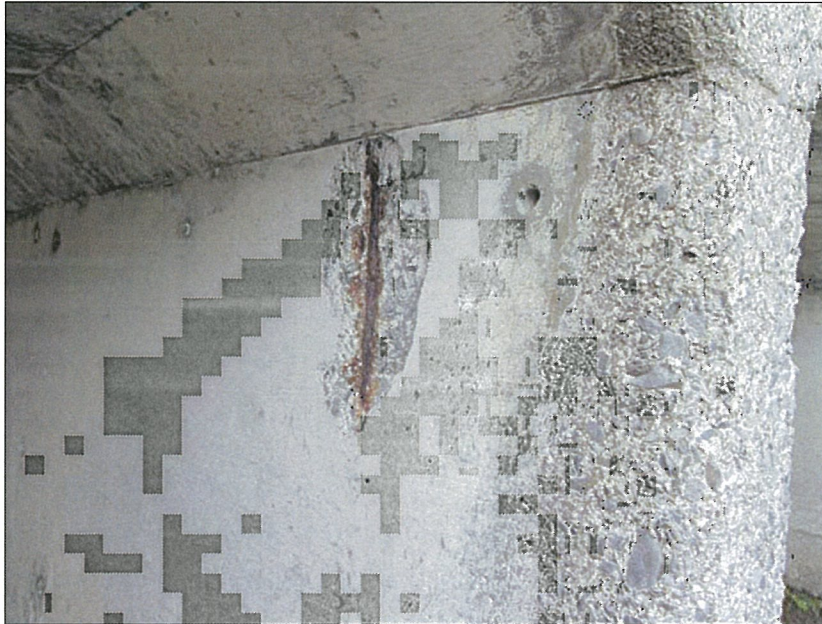
PHOTO 2: TOP OF CENTER WALL AT CULVERT INLET.

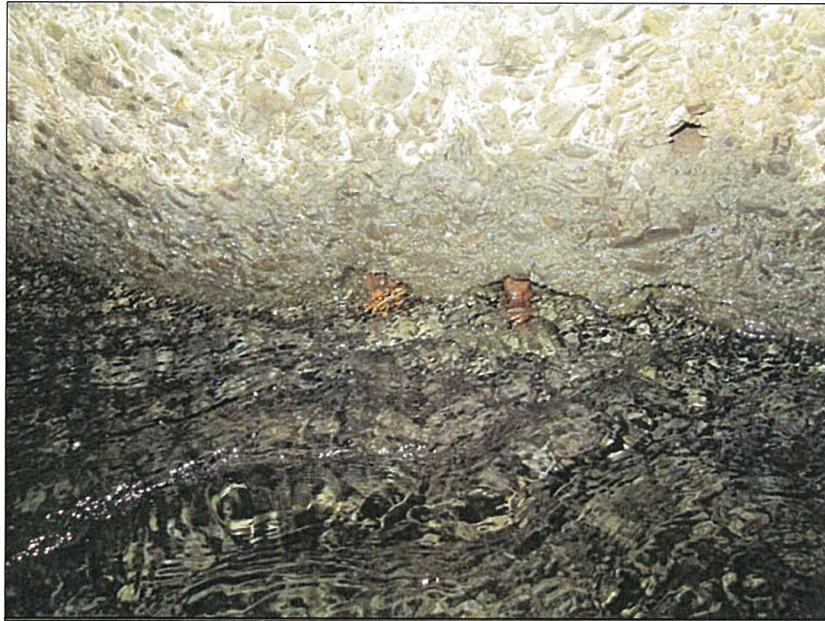
PHOTO 3: LOWER EAST WALL OF WEST BAY AT STATION 90.

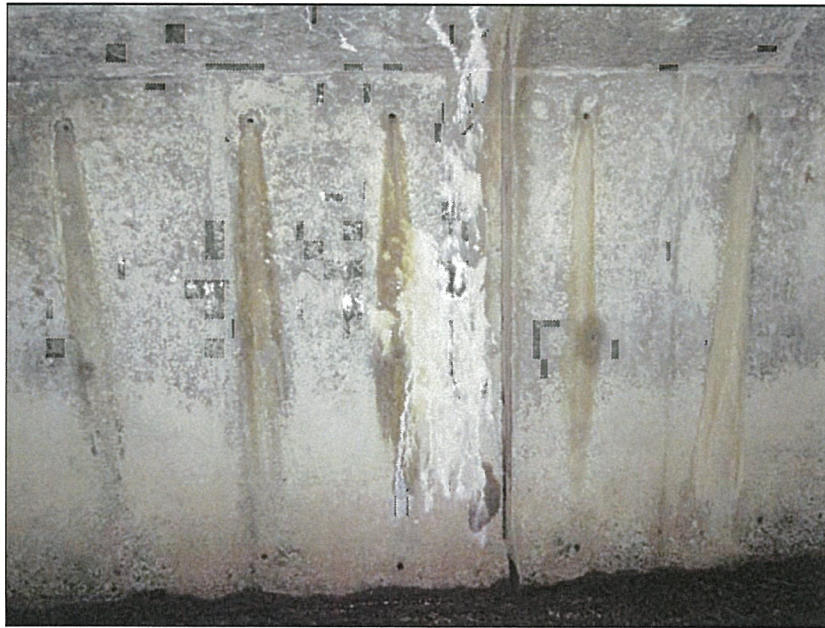
PHOTO 4: WEST WALL OF WEST BAY AT STATION 1955.

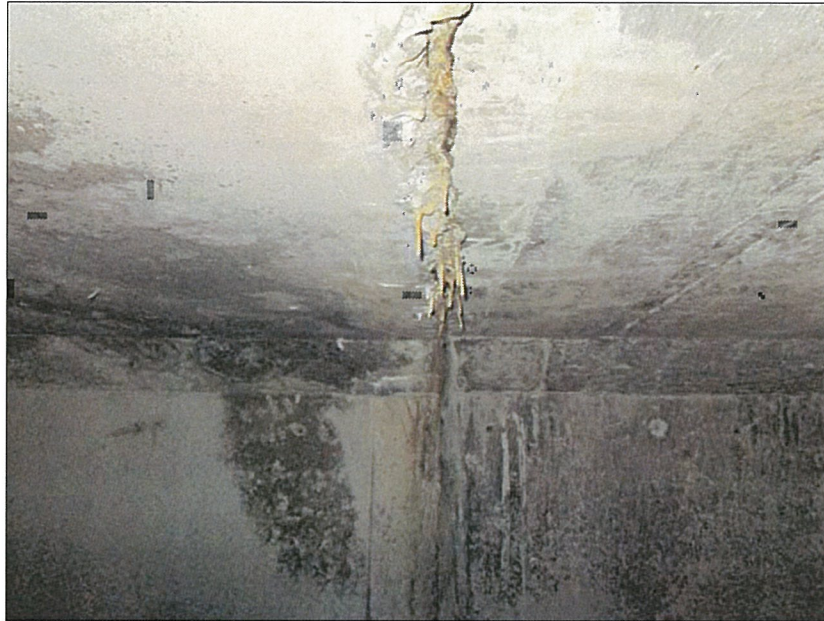
PHOTO 5: LOOKING EAST AT CEILING OF WEST BAY AT STATION 240.

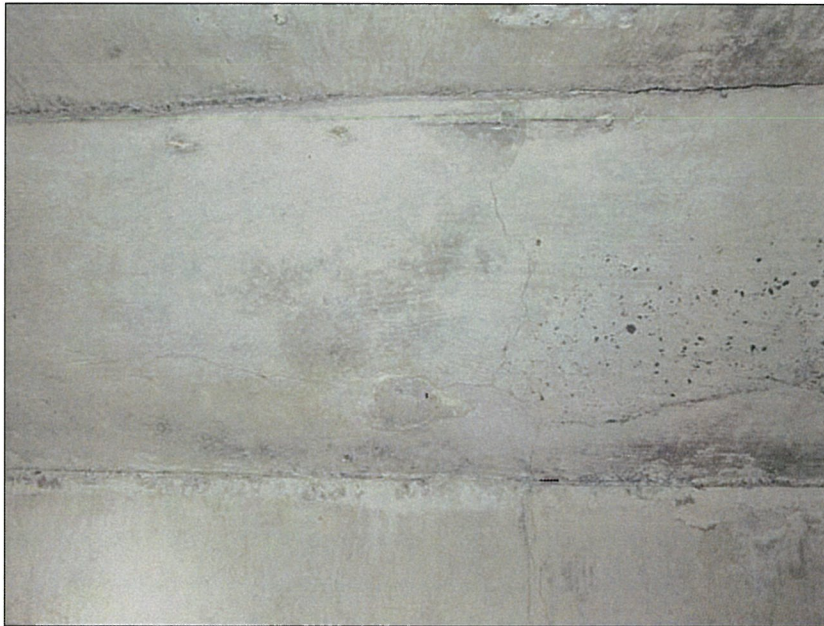
PHOTO 6: TOP CORNER OF WEST WALL OF WEST BAY AT STATION 260.

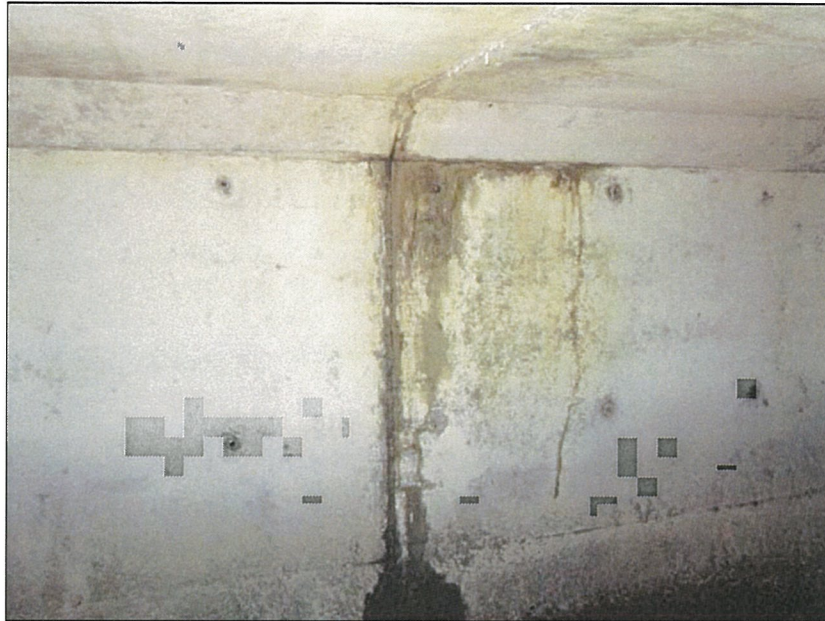
Concrete erosion was also observed on the side walls in occasional areas of the culvert beneath what appear to be form holes (from when the culvert was constructed) and near the inlet and outlet of Devil's Creek through the culvert. Photos 7 and 8 on Figure 9 show a portion of Culvert 1 and Culvert 2, respectively, where water appears to periodically seep through the form holes and erode the concrete down the wall of the culvert. We believe that the erosion of concrete at the inlet and outlet of the culvert; shown in Photos 9 and 10 on Figure 10, respectively; is due a the combination of weathering (exposure to rain, snow, wind, etc.) and the flow of Devil's Creek during the various water levels throughout the year. This can be seen in the decrease in the amount of erosion on the walls as the height above the invert increases.

PHOTO 7: WEST WALL OF WEST BAY AT STATION 420.

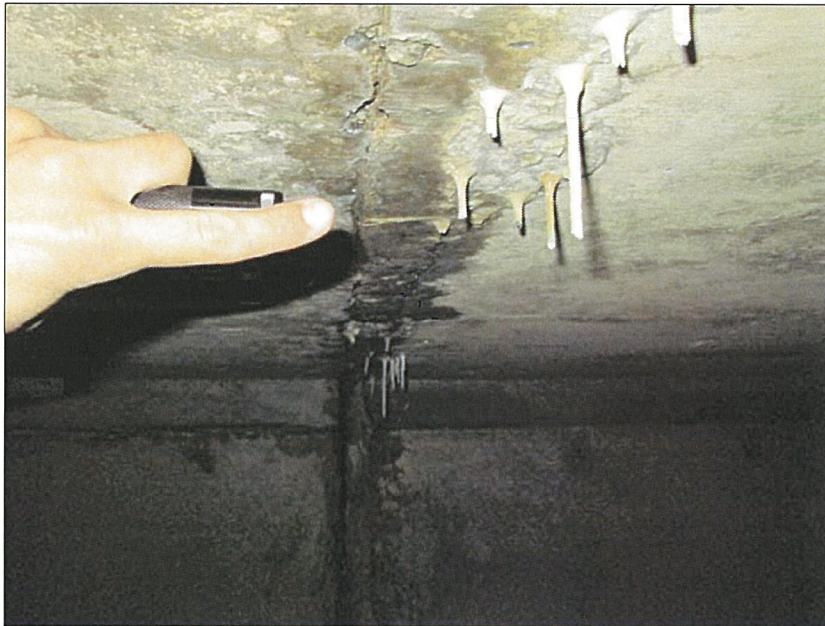
PHOTO 8: LOOKING WEST AT CEILING OF WEST BAY AT STATION 465.

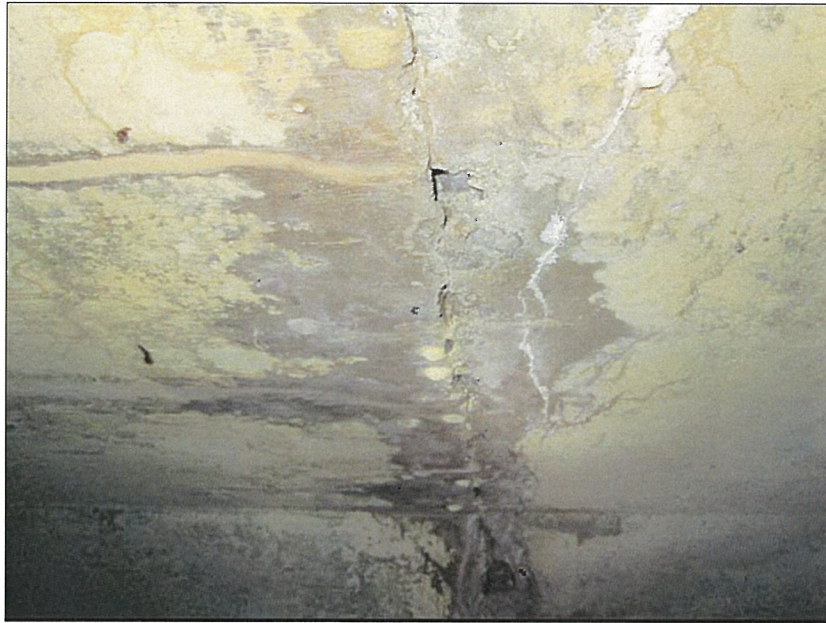
PHOTO 9: LOOKING EAST AT CEILING OF WEST BAY AT STATION 495.

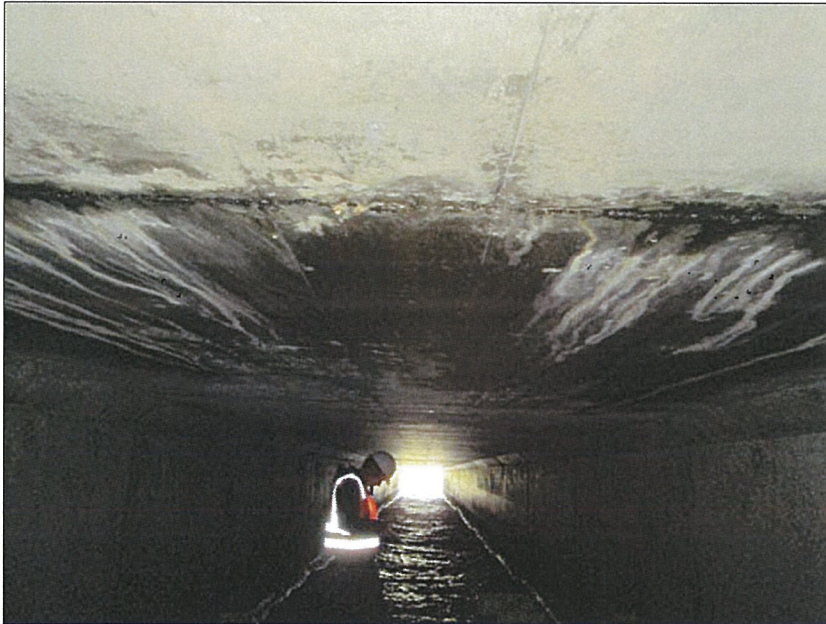
PHOTO 10: CENTER OF CEILING OF WEST BAY AT STATION 620.

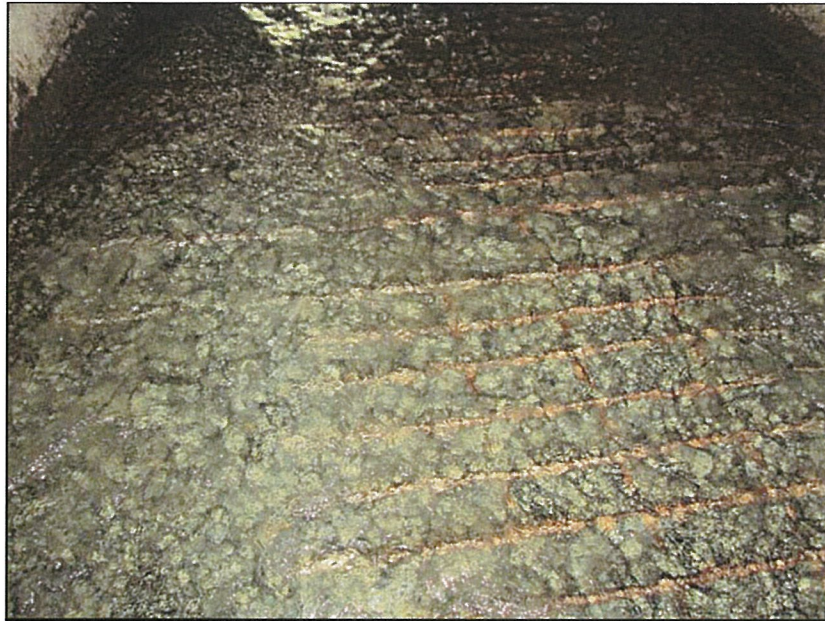
In addition to the erosion of concrete in the walls of the culvert, cracks were also observed throughout the majority of the walls in both bays of the culvert. These cracks generally consisted of hairline cracks as shown on Photos 11 and 12 on Figure 11, but larger cracks (commonly up to roughly ¼ to ½ -inch wide) were also observed to be scattered throughout both bays of the culvert as shown on Photos 13 and 14 on Figure 12. The larger cracks commonly resulted in a white, gray, or brown efflorescence on the wall; relatively minor spalling of the concrete; or water seepage through the crack. Spalling of the concrete was generally observed to be directly adjacent to the larger cracks, and usually occurred where water seepage was observed. Seeping water through the cracks was generally observed to be minor, and steady streams/drips of water were not observed to be running down the walls of the culvert during our site visit.

PHOTO 11: FLOOR OF WEST BAY AT STATION 685.

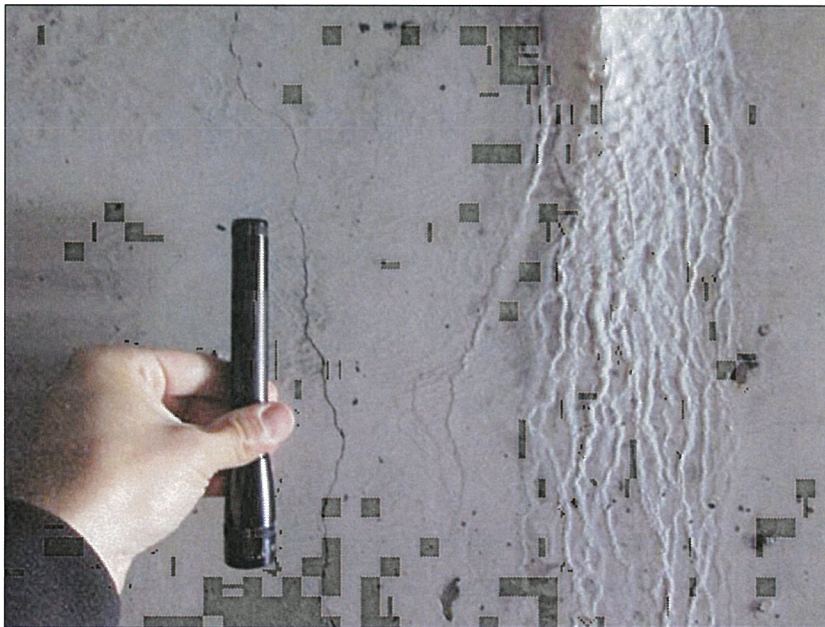
PHOTO 12: WEST WALL OF WEST BAY AT STATION 745.

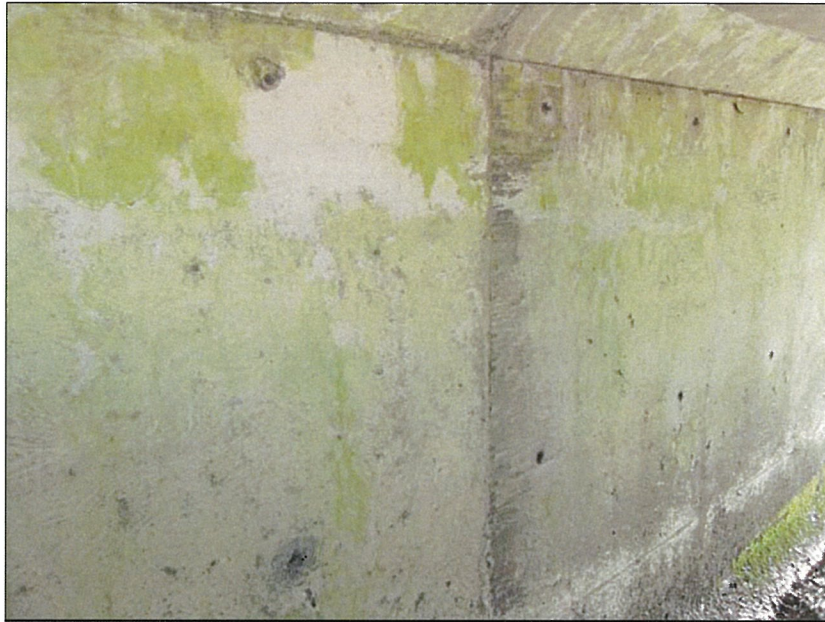
PHOTO 13: WEST WALL OF WEST BAY AT STATION 770.

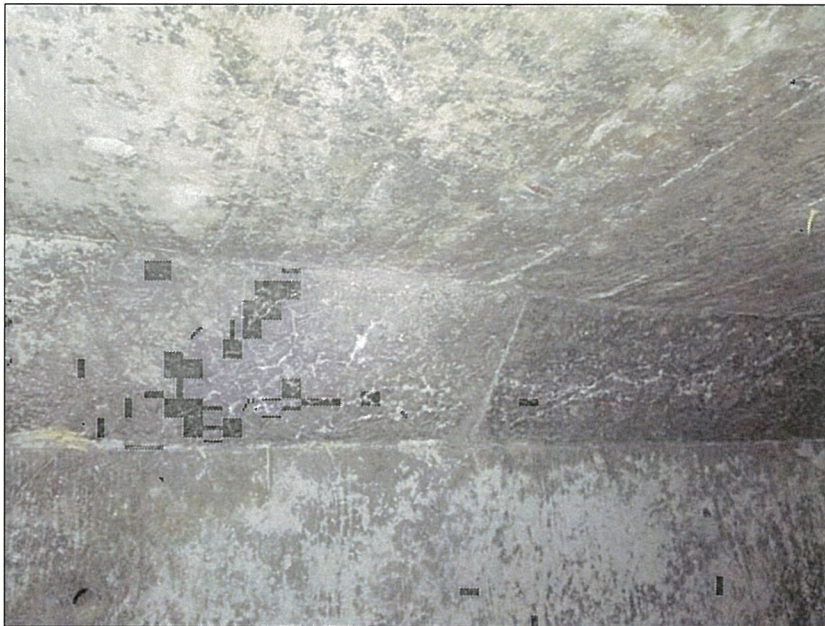
PHOTO 14: CEILING AND TOP CORNER OF WEST WALL OF EAST BAY AT STATION 55.

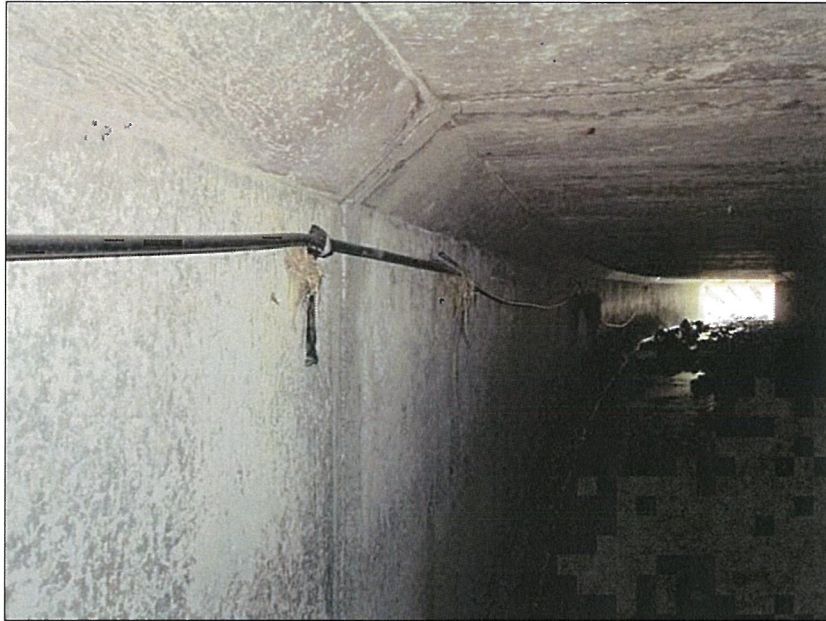
As shown on Photo 15 on Figure 13, this was generally observed to be confined to the last 20 to 30 feet before the outlet. Organic material near the inlet was observed to be caught on an abandoned utility wire hanging on the outer wall of Culvert 2 as shown on Photo 16 on Figure 13. This was observed near the top of the culvert, and seems to confirm the claim that there are times when the volume of water flowing through Devil's Creek puts the existing culvert at or over capacity.

PHOTO 15: EAST WALL OF EAST BAY AT STATION 90.

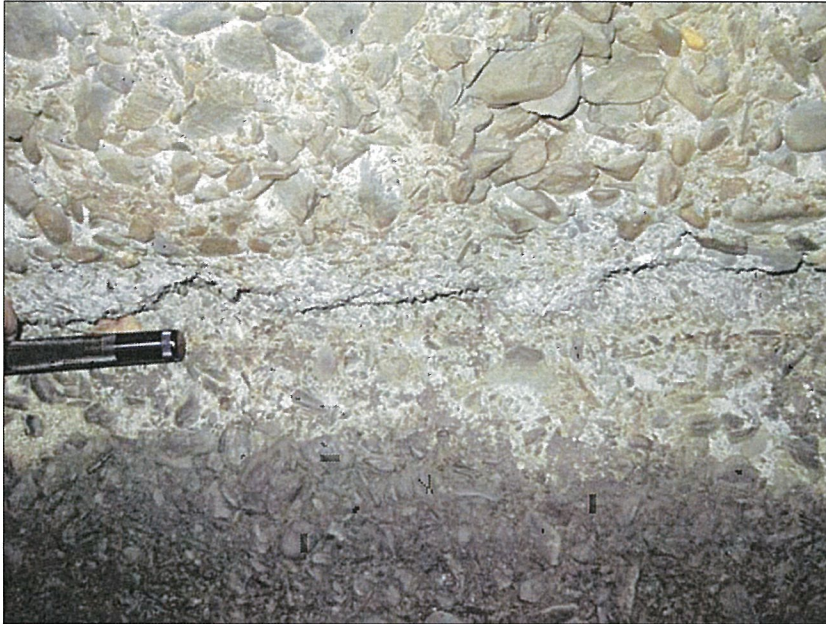
PHOTO 16: LOWER EAST WALL OF EAST BAY AT STATION 115.

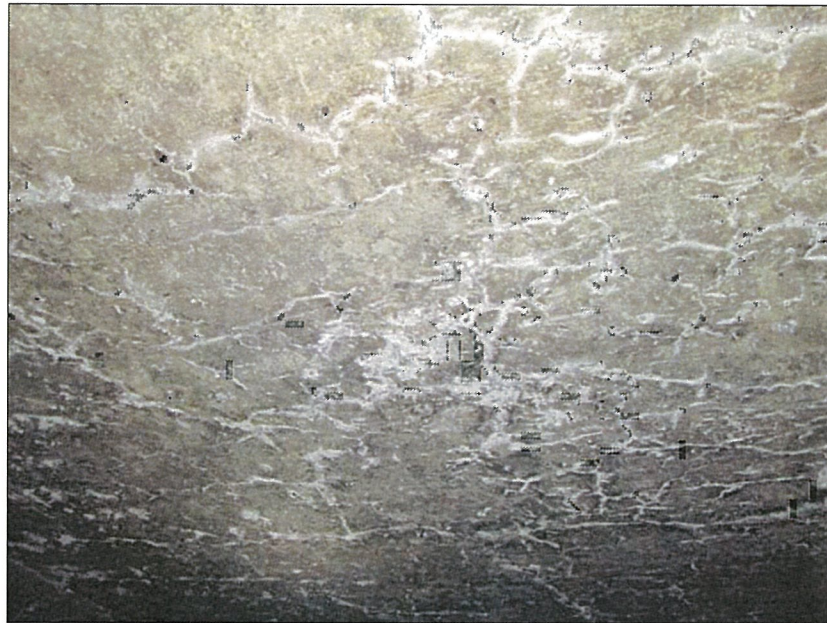
The ceiling of the culvert was also observed to contain cracks of various sizes. Map cracking in the ceiling was generally observed to consist of hairline cracks between roughly Stations 40 and 240 of both bays of the culvert. This generally coincides with the bend in the upstream 1/3 of the culvert. Where map cracking was observed, the ceiling commonly had minor efflorescence, and also had areas of "snowflake-like" particles hanging from the concrete. Photos 17 and 18 on Figure 14 show areas where map cracking was observed in Culvert 1 and Culvert 2, respectively.

PHOTO 17: CENTER OF CEILING OF EAST BAY AT STATION 145.

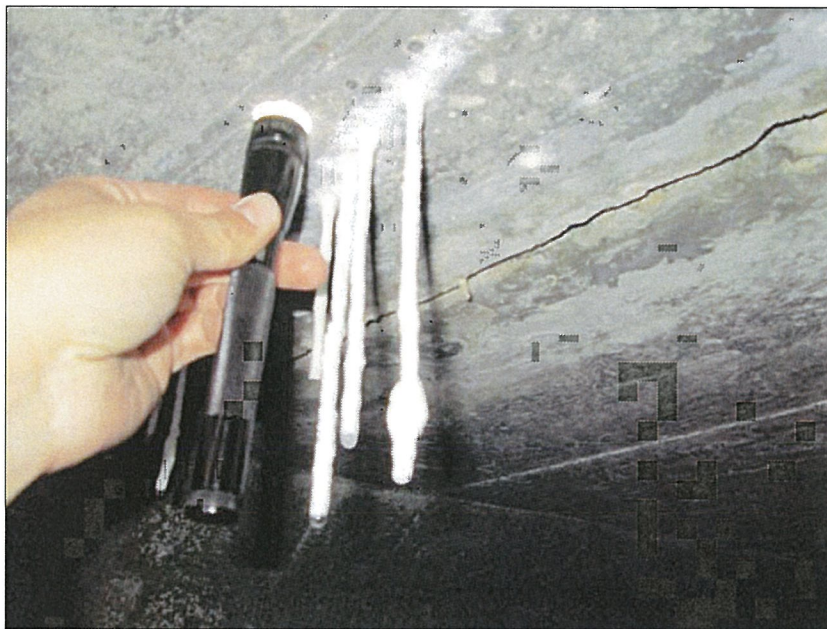
PHOTO 18: LOOKING WEST AT CEILING OF EAST BAY AT STATION 150.

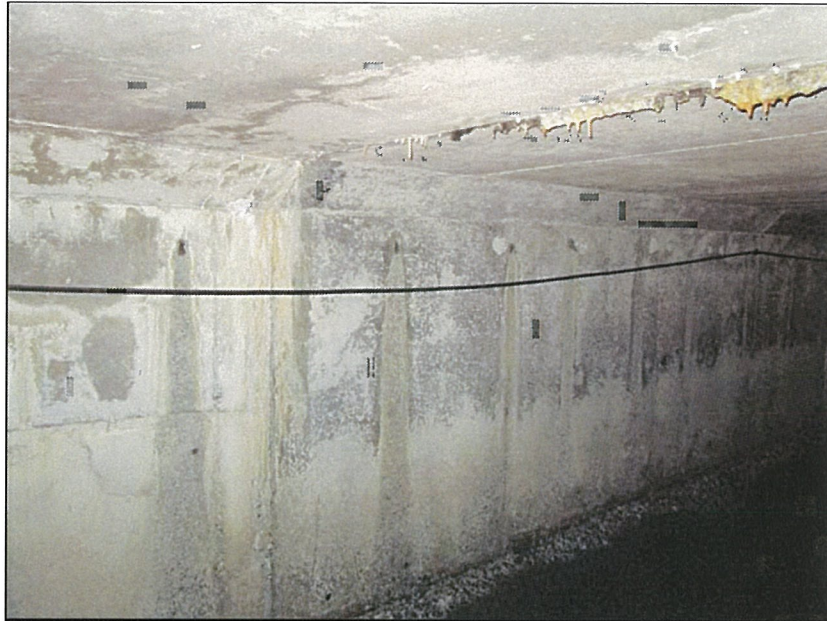
Significant cracks (with separation greater than roughly 1/4 inch wide) were observed to be relatively common in the ceiling of the culvert. Photos 19 through 24 on Figures 15 through 17 show examples of some of the more significant cracks observed in the ceiling of the culvert. These cracks generally were observed to have spalling of the concrete on either side of the crack, efflorescence, and water seepage. Photos 23 and 24 on Figure 17 show two of the locations where significant water seepage (dripping water through the crack) was observed during our site visit. The concrete on the ceiling appeared to be wet for up to approximately 20 feet downstream of the crack, and efflorescence was also observed in these areas.

PHOTO 19: EAST WALL OF EAST BAY AT STATION 240.

Considering the results of our compression testing alone, we believe the existing concrete culvert is likely strong enough to continue using provided that some repair work is performed. However, we believe that some of our observations of the concrete culvert (i.e., the condition and strength of Core Sample SW-2, significant cracks in the ceiling, water seepage, and the presence of stalactites) may show evidence of other areas of the culvert that have strength deficiencies that make the culvert less than desirable for continued use. As such, there appears to be a significant amount of repair work that may need to be performed in order to repair the potentially weakened areas of the culvert. Repair work may include maintenance to replace concrete that has eroded away from near the bottom of the culvert as well as near the inlet and outlet. We believe that the formation of stalactites may be the result of chemicals within the concrete being washed down through the crack as the condition of the concrete deteriorates. Therefore, many of the significant cracks in the ceiling that have resulted in water seepage and the formation of stalactites may also need to be repaired.

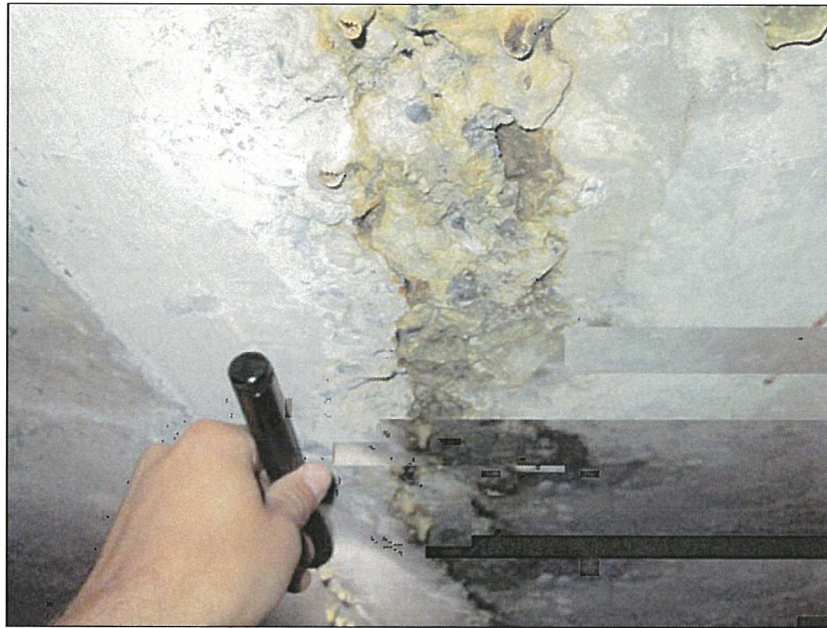
PHOTO 20: LOOKING WEST AT CEILING OF EAST BAY AT STATION 245.

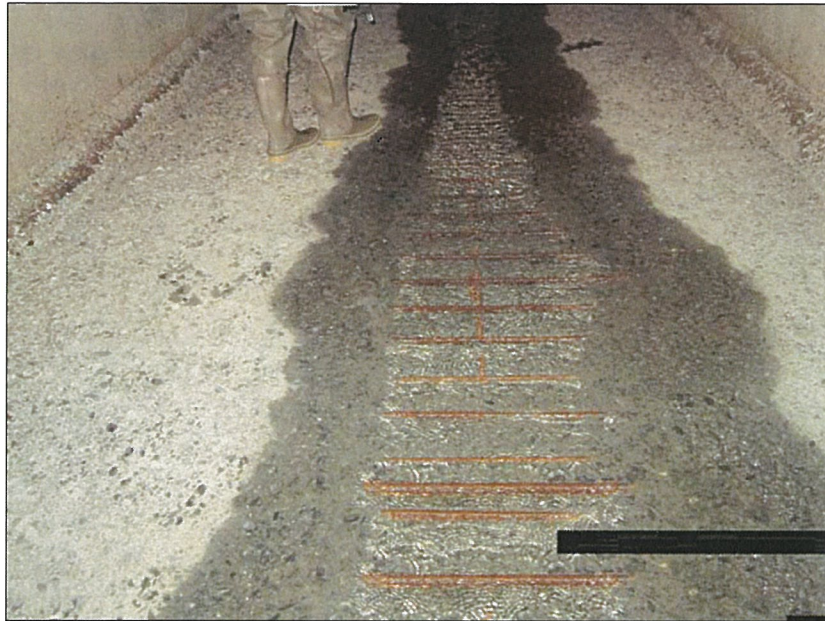
PHOTO 21: FLOOR OF EAST BAY AT STATION 300.

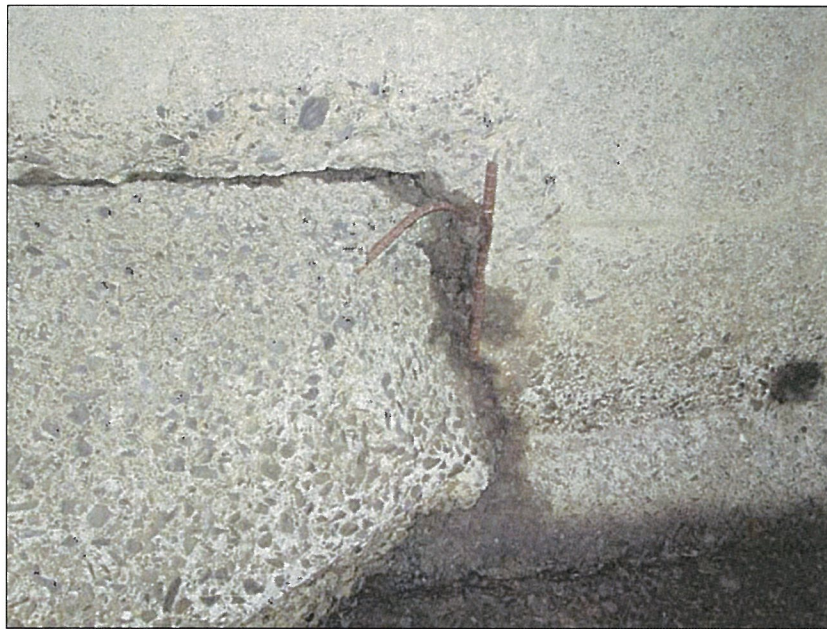
PHOTO 22: LOWER EAST WALL OF EAST BAY AT STATION 420.

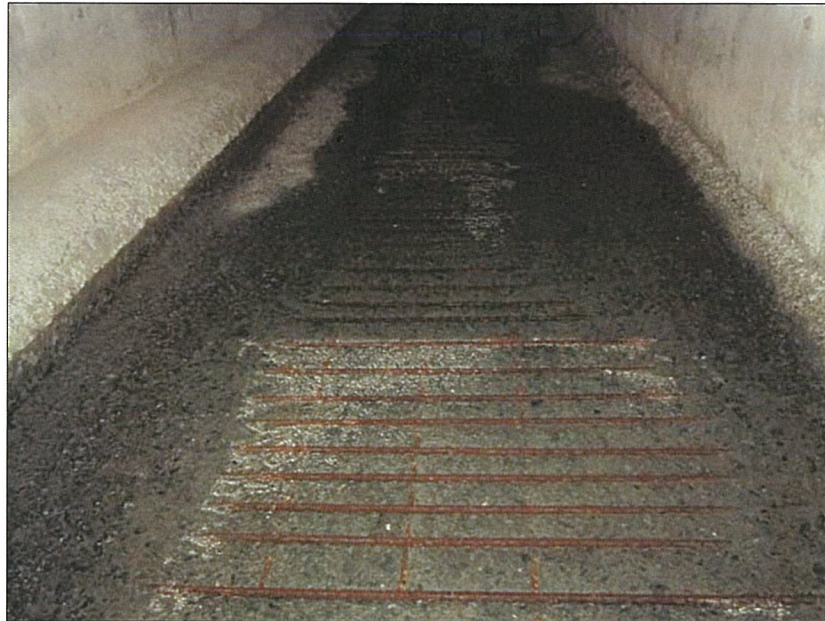
PHOTO 23: FLOOR OF EAST BAY AT STATION 605.

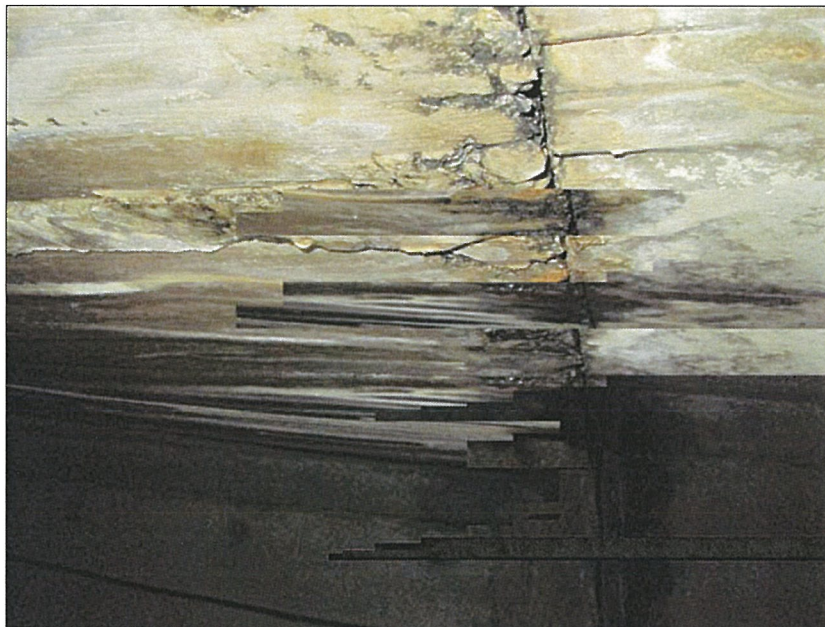
PHOTO 24: LOOKING EAST AT CEILING OF CULVERT 2 AT STATION 610.

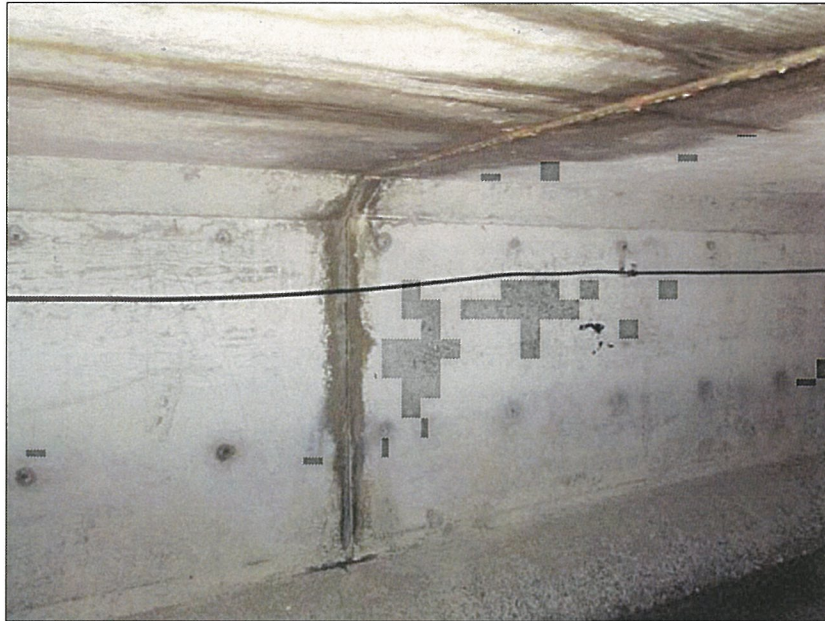
Many of these significant cracks in the ceiling were also observed to contain stalactites forming below them. Photos 25 and 26 on Figure 18 show examples of stalactites forming from the ceiling that were observed to be up to about 6 inches long. The stalactites were relatively common in the ceiling throughout both bays of the culvert. The longer stalactites were generally observed in the areas where significant water seepage was observed during our site visit.

PHOTO 25: EAST WALL OF EAST BAY AT STATION 650.

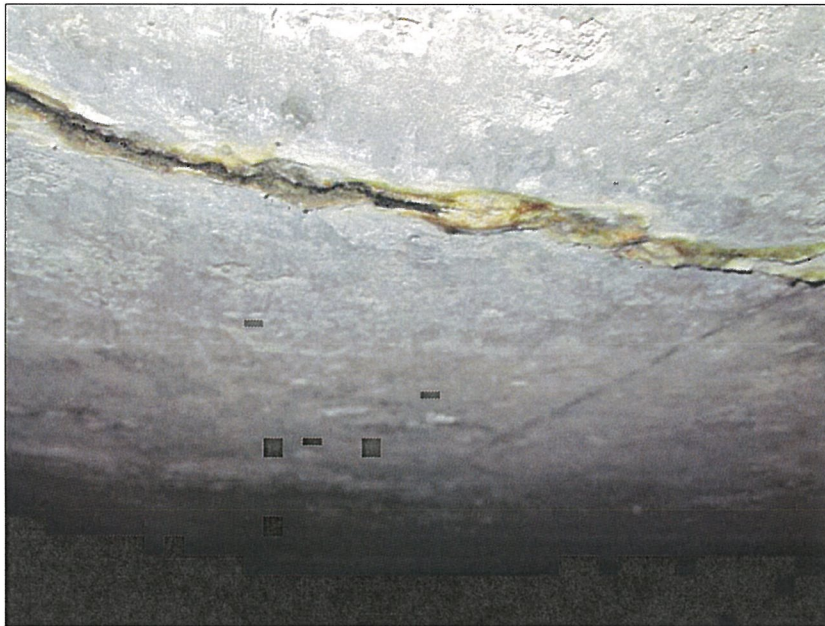
PHOTO 26: CENTER OF CEILING OF EAST BAY AT STATION 745.
