**Devils Creek at Kodiak,
Hydrology and Hydraulic Study,
HDR, March, 2014**

Devils Creek at Kodiak Airport

Hydrology and Hydraulic Study

FINAL REPORT

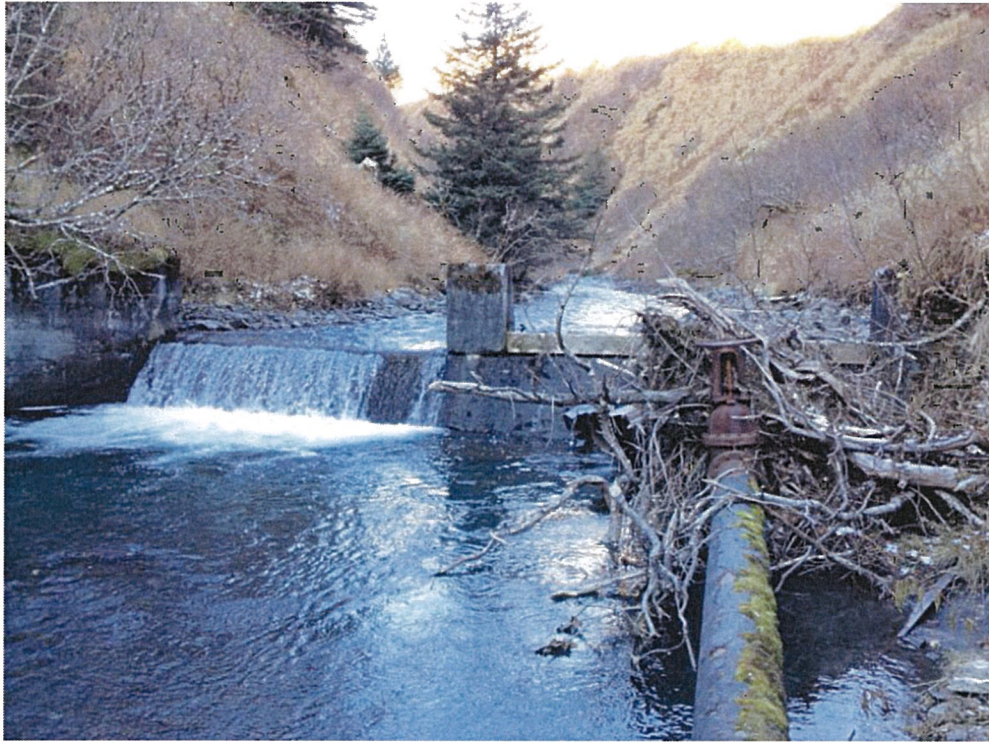
Abandoned concrete dam—note brush debris on valve operator. Stoplog support in center of photo.
Photograph looking upstream.

1. Remove concrete stoplog support, stoplog, and valve riser at abandoned concrete dam.
2. Remove all or a portion of the abandoned concrete inlet structure upstream of Rezanoff Drive.
3. Remove remnants of the relic wooden box culvert between the maintenance access road and Rezanoff Drive.
4. Construct a new debris rack upstream of the box culvert.
5. Remove the existing debris rack at the box culvert inlet.
6. Round the edges of the box culvert inlet to increase flow entrance efficiency, remove the sediment from the box and resurface the bottom of the box culverts.
7. Construct a berm to elevation 173.4 at the inlet of the box culvert.

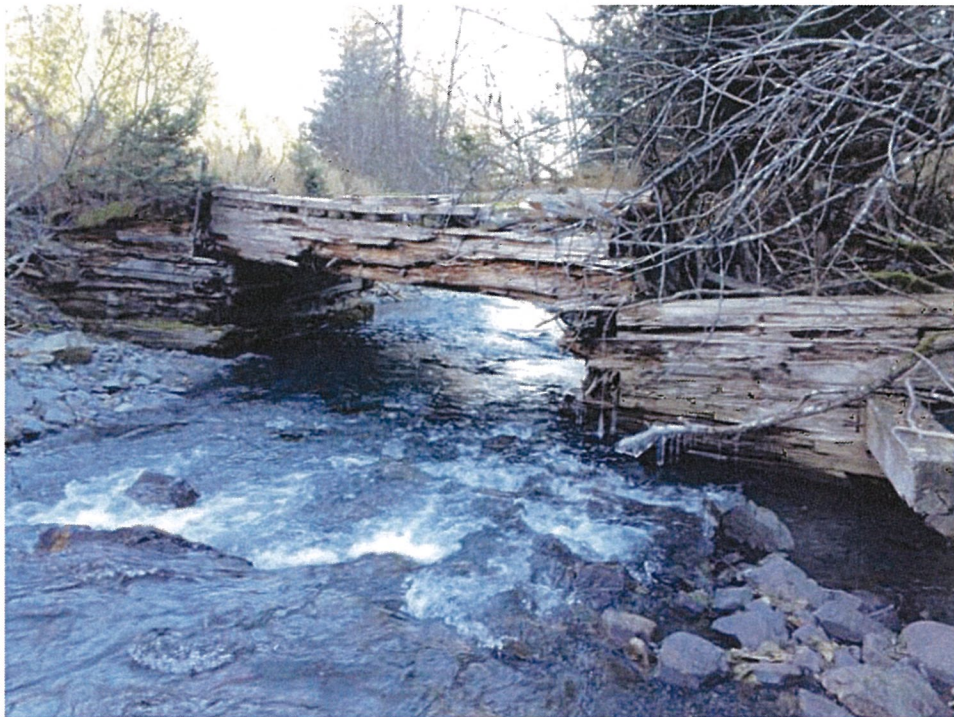
Abandoned wooden bridge
Photograph looking downstream. (Post note: Bridge was removed in 2012)

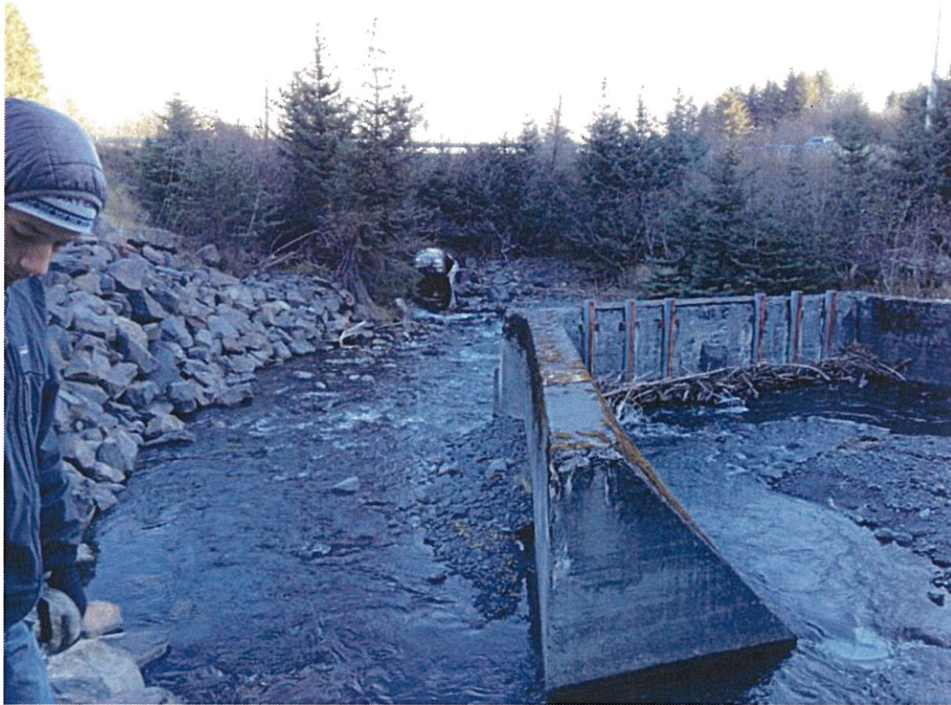
Abandoned concrete inlet structure—note Rezanoff Drive 12-foot-diameter aluminum CMP in background and riprap on left bank. Photograph looking downstream.

The mechanism of this jamming is unknown and is likely affected by the existing relic concrete inlet box. Removal of all or a portion of this relic structure and realignment of the channel in this area will improve the hydraulics of the Rezanoff Drive culvert inlet and may reduce future ice jamming.

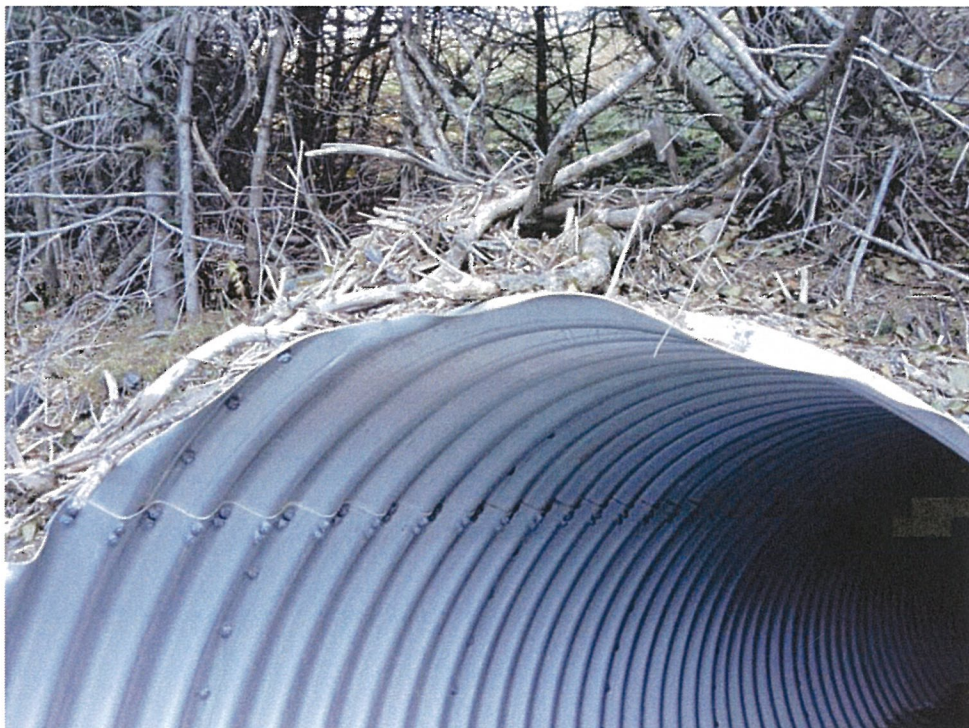
Inlet to Rezanoff Drive 12-foot-diameter aluminum CMP—note flood debris above culvert inlet. Photograph looking downstream.

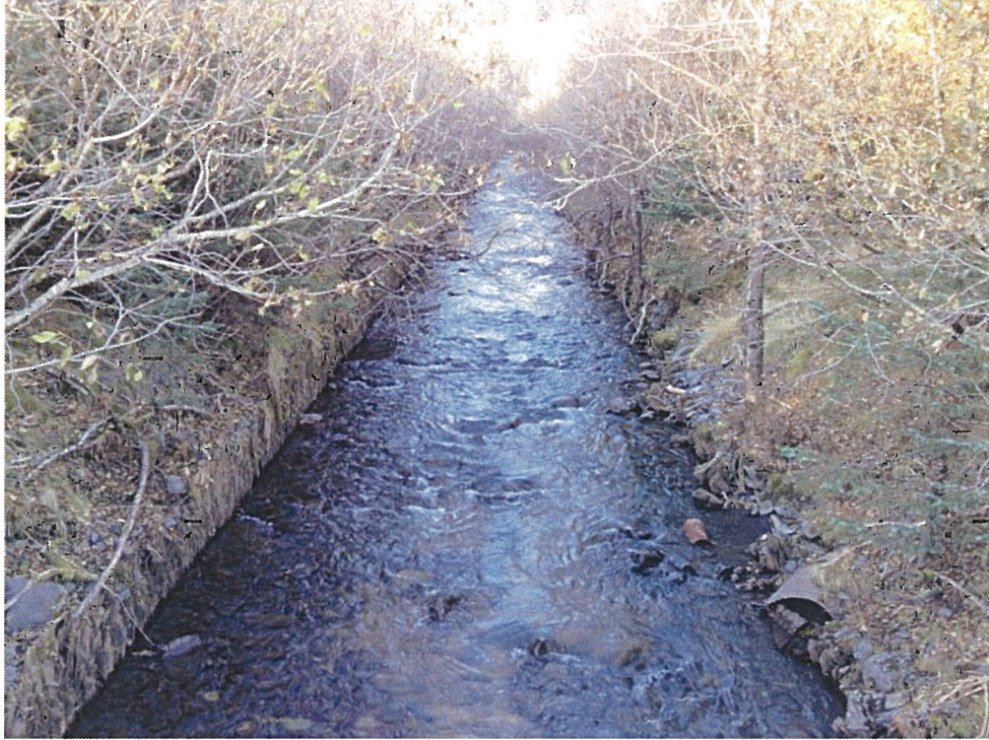
- Between Rezanoff Drive and Airport Maintenance Road Bridge:
 - The floor and partial height sidewalls of a relic wooden box culvert exist in about 400 linear feet of this reach. Ideally these would be removed as, over time, the wood will wash out, and potentially cause downstream debris issues.

Remnants of relic wooden box culvert between Rezanoff Drive and maintenance road bridge.
Photograph looking upstream.

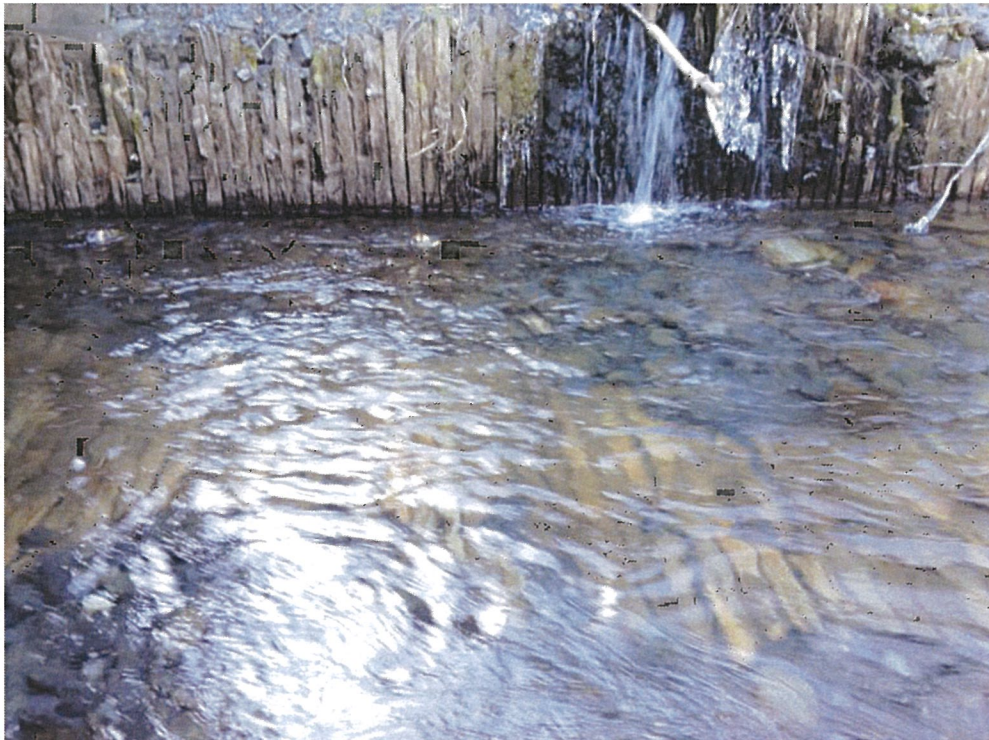
Relic wooden box culvert; detail of timber bottom.

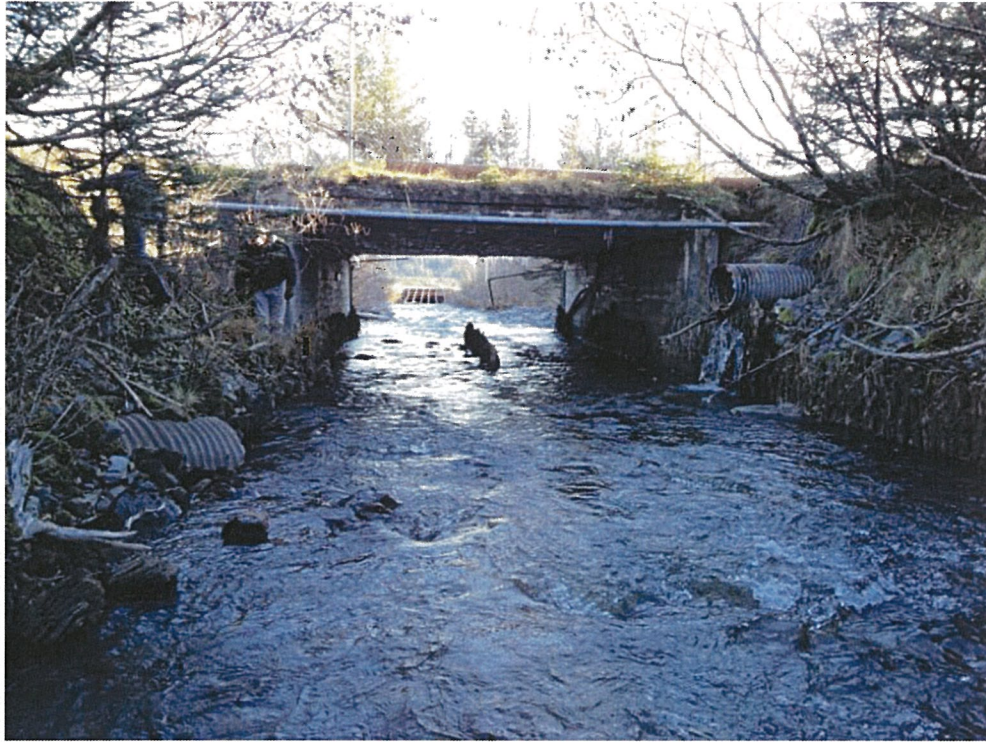
Maintenance road bridge—note airport culvert intake in background.

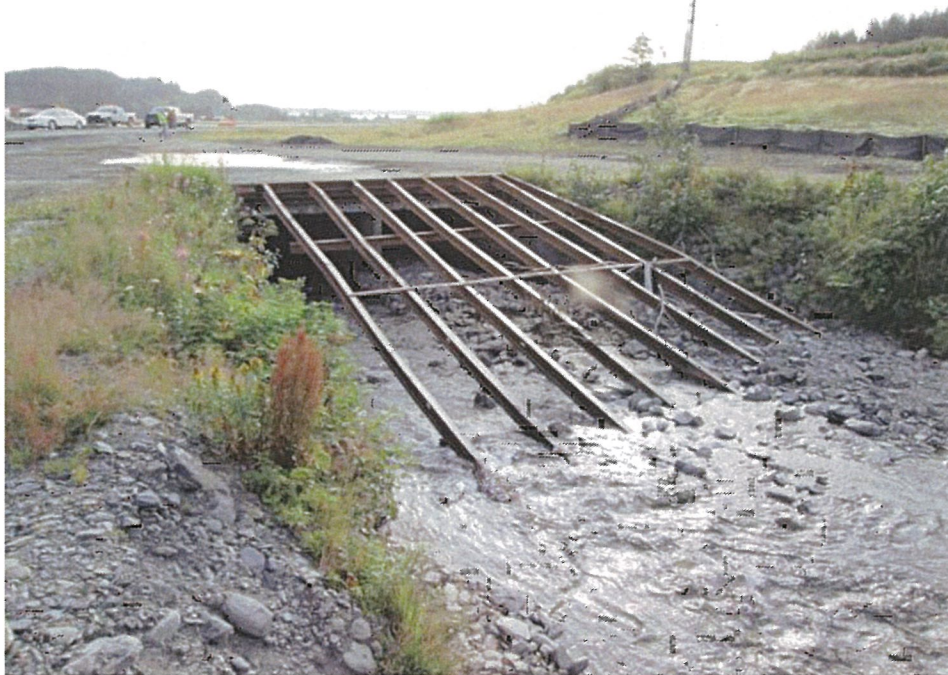
The existing culvert has a debris rack installed at the face of the inlet. The existing debris rack was installed after the October 2009 storm. The prior debris rack was more vertical with less open area between the bars. Therefore, the existing debris rack should be less susceptible to clogging by debris than the debris rack that existed during the October 2009 storm. If this rack contains debris or ice it will greatly limit flows in this culvert. Hydraulic calculations assume no debris rack (see Section 7.0, Sediment Evaluation).

Airport culvert intake and debris rack.
Photograph looking downstream.

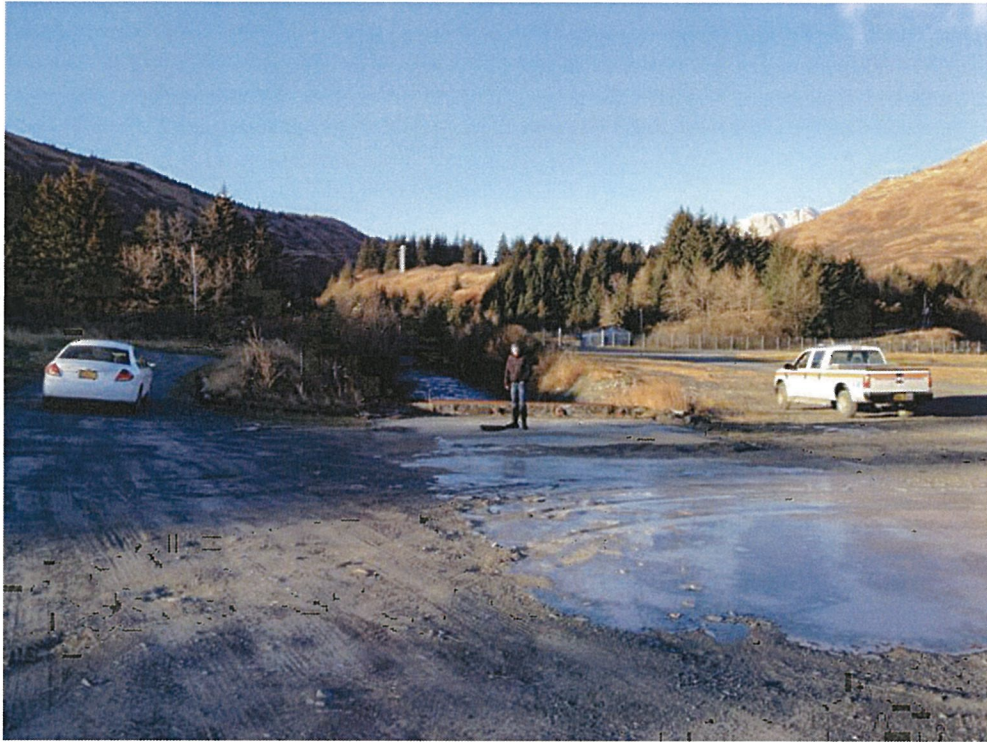
Airport culvert intake
Photograph looking upstream

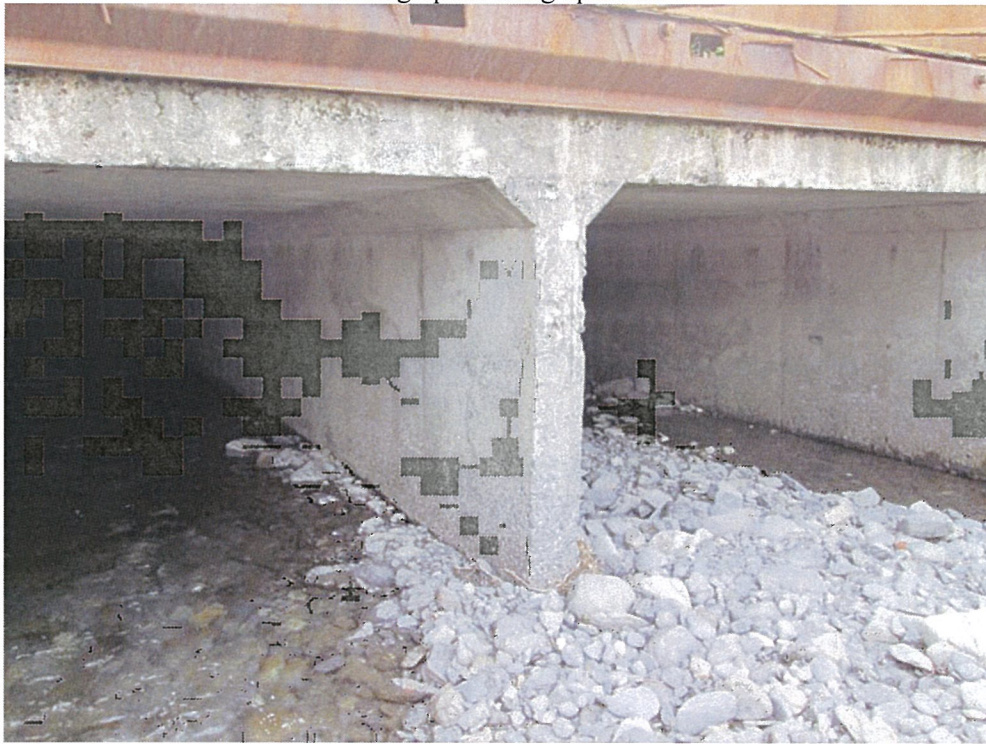
The existing culvert has approximately a 1 foot depth of angular cobbles deposited in both sides of the inlet. This deposition will be removed to resurface the invert of the box culverts. Hydraulic calculations assume the deposition is removed, the bottom resurfaced and that future maintenance includes sediment removal if necessary.

At the time of the site visit, the Devils Creek culvert had approximately 1 foot of angular cobbles deposited at the inlet. In the east (right, looking downstream) box, this deposition extends downstream the full length of the newer portion of culvert (276 feet) with the amount of deposition decreasing quickly in a downstream direction, and deposition beyond the upstream 50 feet of culvert is minor and is primarily on the inside bend of the culvert. The west box carried the majority of the flow at the time of our reconnaissance and deposition was unable to be observed, but review of photos from the August 27, 2012 structural reconnaissance, showed it had deposition extending approximately 50 feet downstream of the inlet. In theory, this deposition may reoccur as the upstream channel has slightly higher tractive forces than the upstream portion of the culvert. In practice, observed deposition decreased quickly downstream of the inlet, indicating it may have been initiated by the original debris rack at the inlet.

Airport culvert intake—note sharp edges on concrete inlet and gravel in invert.
Photograph looking downstream.

The inlet hydraulics can be improved by rounding the square inlet edges. The decrease in headwater due to this change is minor and cannot be calculated. This improvement is still considered worthwhile.

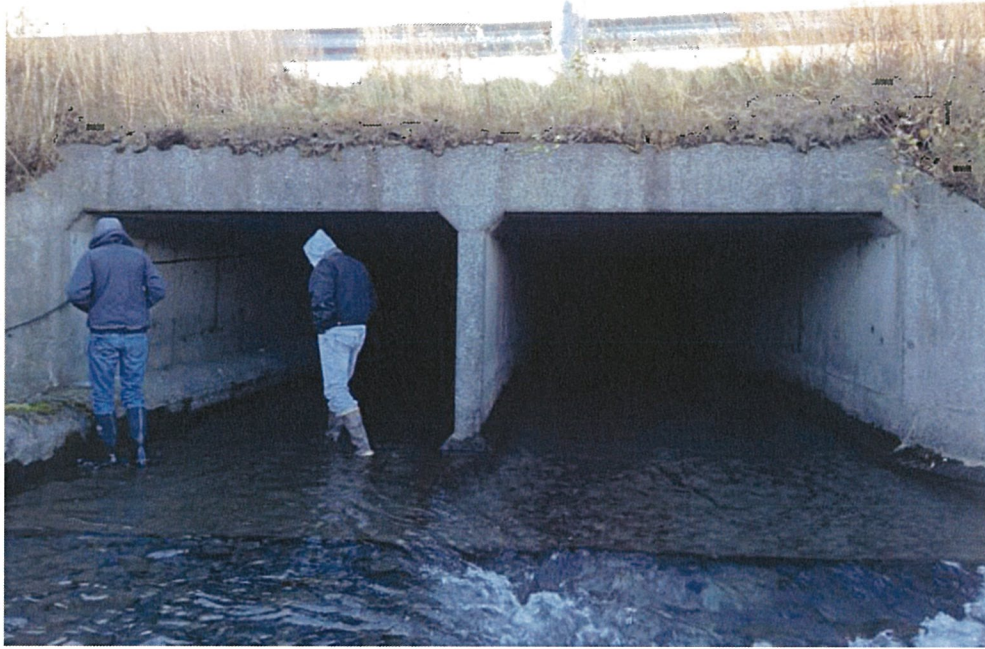
The original 500 foot long portion of the east culvert has an 8" concrete encased pressure sewer line along its bottom on its east (right side). The dimensions of this concrete encasement are approximately 2-foot-wide x 1.5-foot-tall. The protrusion of this concrete into the culvert may be causing a slight backwater, potentially causing deposition in the upstream section of the culvert. Relocation of this sewer would provide a consistent culvert section but would require open cut replacement of approximately 500 feet of pressure sewer line; a portion of this across the primary runway. From a culvert hydraulics perspective, removal of this sewer is not justified. However, since the bottom of the box culvert is to be resurfaced and this pipe is over 39 years old (it is shown as existing on a 1974 Apron and Taxiway Plan), DOT&PF may want to evaluate the replacement of this pipe along with the structural rehabilitation of the culvert.

Airport culvert outlet—note concrete encased pressure sewer in culvert on left side of photo.
Photograph looking upstream

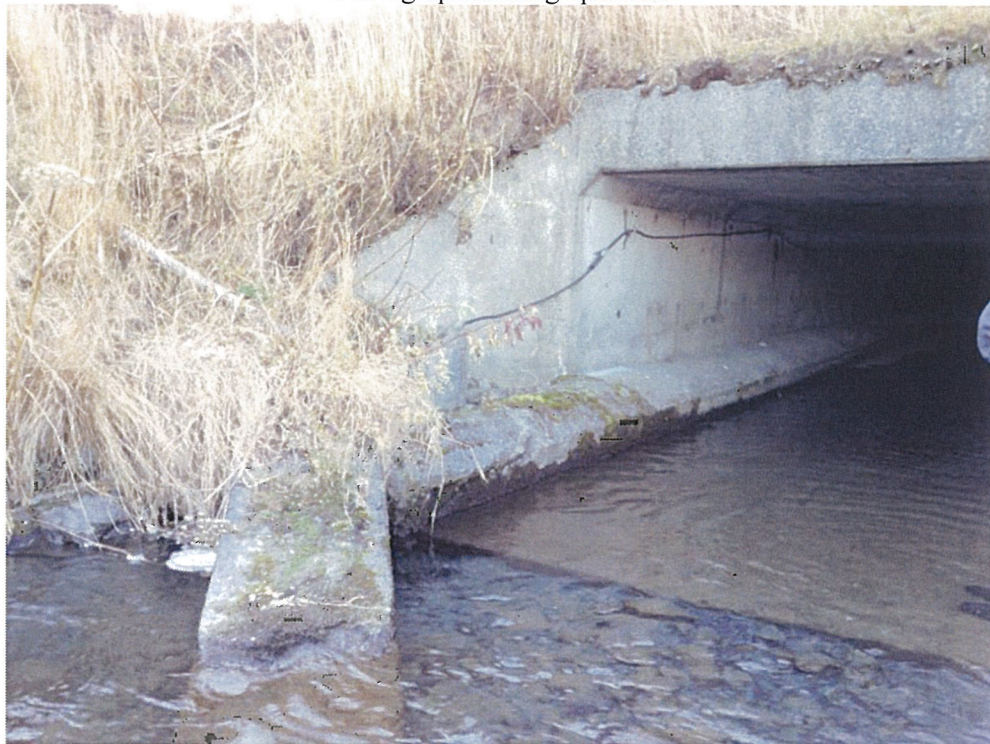
Airport culvert outlet. Detail of concrete encased pressure sewer in culvert.
Photograph looking upstream

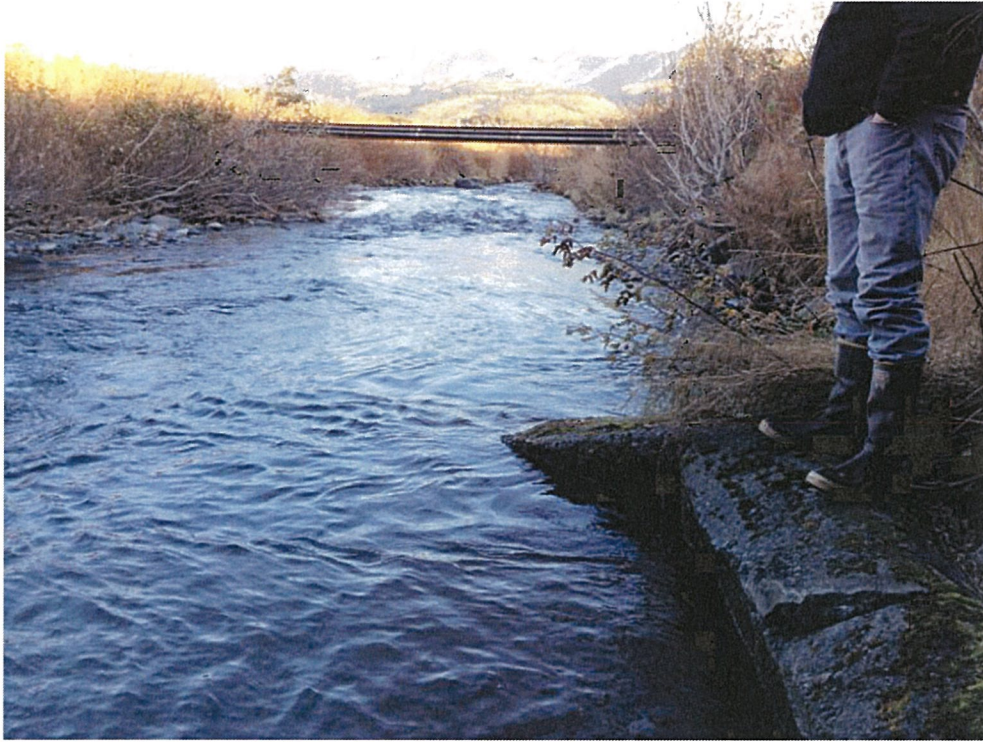
Tailwater section for airport culvert outlet.
Photograph looking downstream

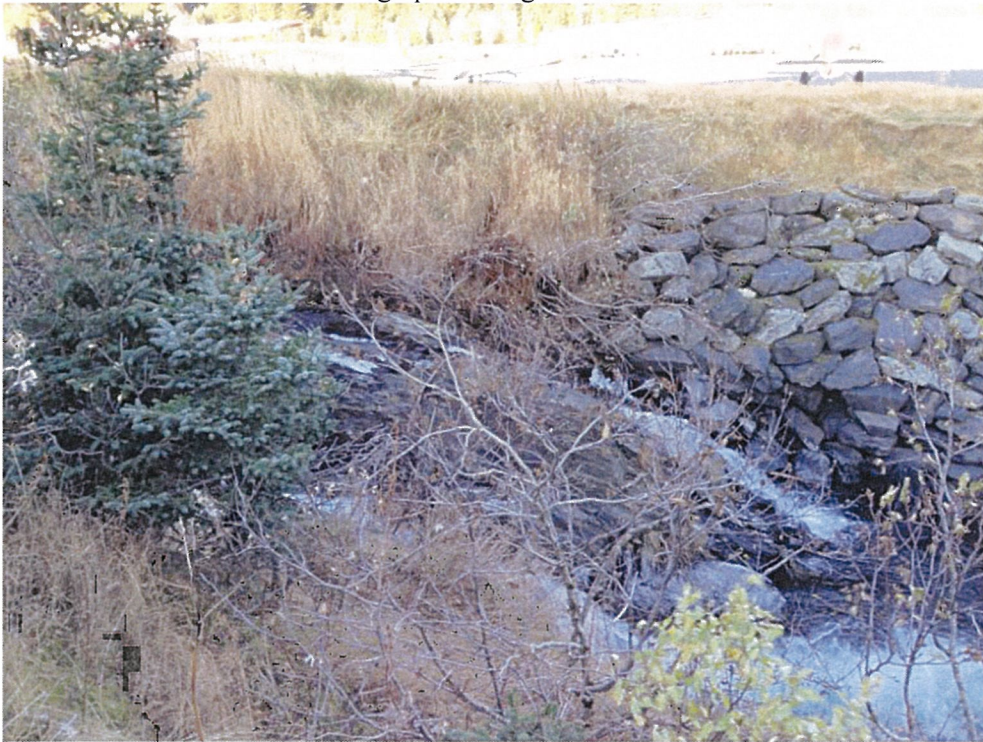
Waterfall downstream of airport culvert outlet.
