Kodiak Airport
Devils Creek Culvert Repair
Project No. 57474/AIP 3-02-0158-01x-201x

Hydrology and Hydraulics Review

Devils Creek Culvert Kodiak Airport

July 2, 2010

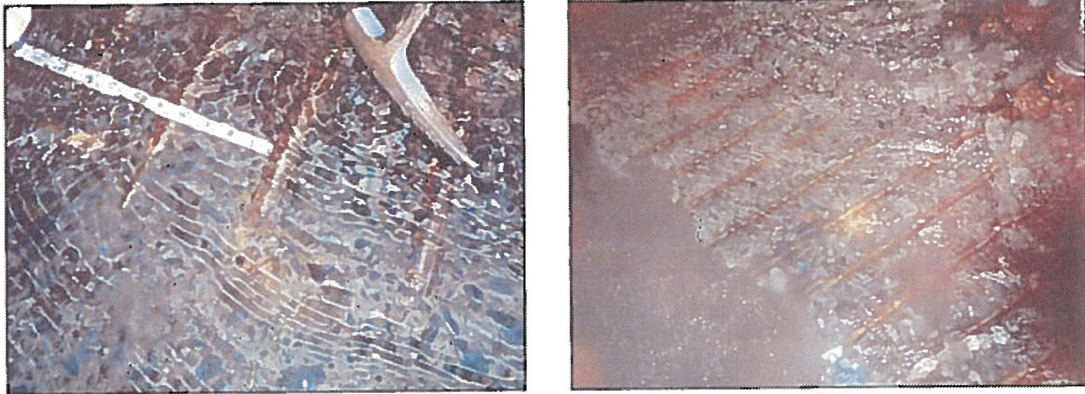
The March 9, 2010 inspection revealed that reinforcing steel is exposed along much of the culvert length. Longitudinal reinforcing bars were also visible in a few locations. The loss of the protective concrete cover is due primarily to abrasion by passing gravels and cobbles during high flows. According to M&O staff, the culvert was visually inspected about 15 years ago and, at that time, there was no indication of exposed reinforcing steel.

FIGURES 1&2. Exposed rebar along the invert of the Devils Creek culvert (March 9, 2010).

While the culvert is carrying loads now, the ongoing loss of concrete cover over the reinforcing steel along the culvert bottom will eventually become a significant structural problem. Recollections by M&O staff that that reinforcing steel was not exposed 15 years ago during prior inspection are informative. It is likely that the exposure of rebar to flowing water (and the associated bedload transport) has accentuated abrasion along the concrete floor.

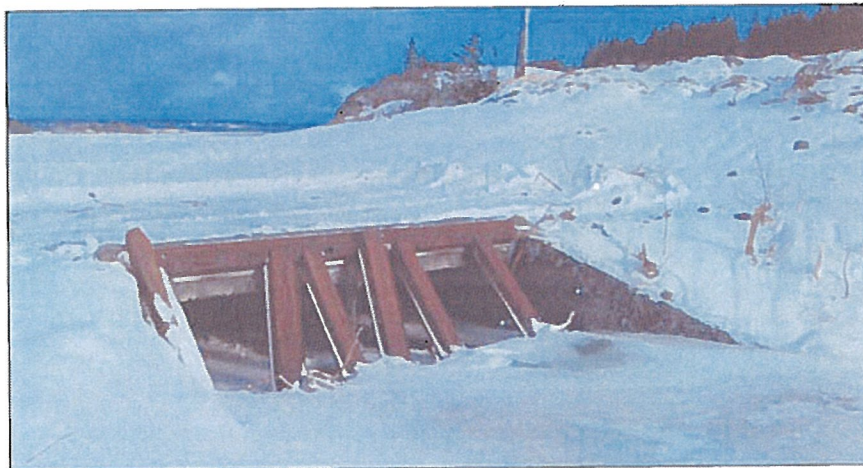
A “debris rack” at inlet appears to negatively affect hydraulic performance during floods by impeding flow.

FIGURE 3. The inlet of the Devils Creek Culvert at the Kodiak Airport (March 9, 2010).

According to M&O crews, the reach above the culvert produces a lot of woody debris. Much of this wood reportedly comes from the remnants of an old timber culvert that once covered the creek. To reduce the potential for blockages *inside* the culvert barrels, M&O fabricated a near-vertical debris rack at the inlet using 18 inch wide sheet piling material. This is a wise provision that greatly simplifies the mechanical removal of debris. Unfortunately, the provision also contributes to flooding during extreme flood events. For

As with the existing structure, the incorporation of debris control provisions at the inlet is warranted. My preference would be a debris rack system with longer, narrower vertical members that extend upstream at a shallow angle. Sloping extensions of the culvert center walls, sometimes referred to as “debris fins,” could be added for support.

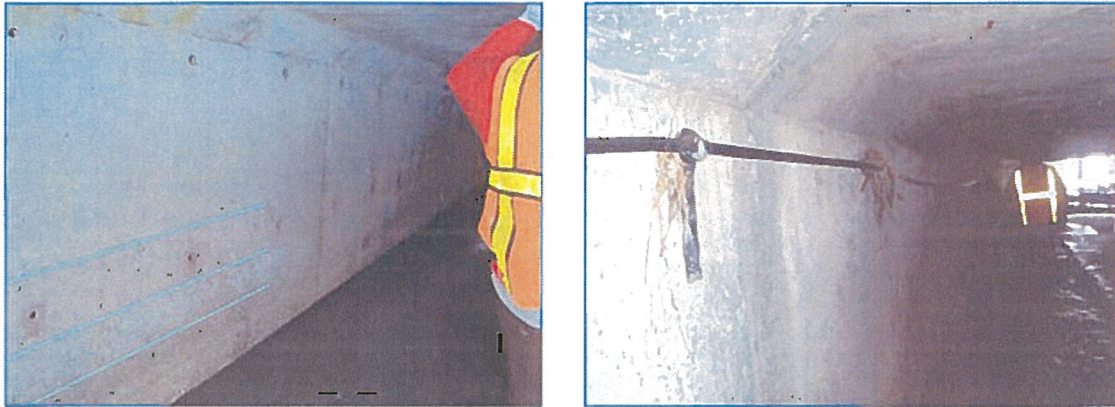
Insight into flood stage frequency can be gained from water stains inside the culvert, particularly at mid-length. For this hydraulically “long” culvert, the energy grade line, hydraulic grade line, and culvert slope should be parallel over much of the length. This is also referred to as “normal depth” conditions. Water stains (at mid length) can therefore be used as a “reality check” to evaluate hydraulic modeling results. (While not a precise form of calibration, it serves as a reasonable surrogate to calibration for a planning/scoping level of analysis.)

FIGURES 4&5. Water “stains” can offer insights into flood flow stages inside the culvert. Drift on the utility hooks similarly serve as high water indicators.

Near the inlet, we noted debris on a utility hook *near the top of the culvert!* This indicates the culvert has flowed near full *at this location* in the past. Given the close proximity of this debris to the inlet, it is possible the debris was deposited during a short “pulse” of water, such as following the release of stored water behind a debris blockage.

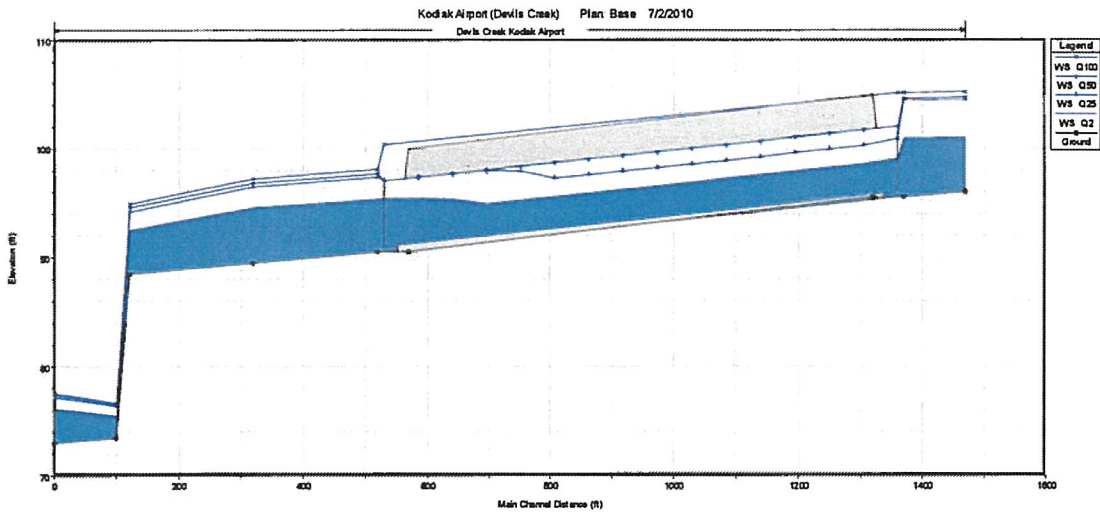
The model indicates that the existing culvert, *without any obstructions at the inlet*, might be capable of passing a 2% chance flood (50-year), but I feel the 4% chance flood (25-year) is a more reasonable capacity estimate.

FIGURE 6. Profiles for the 2-year & 25-year (partially full), the 50-year (full), and the 100-year flood (over-topping). These profiles assume no blockages or other flow impedance at the inlet.

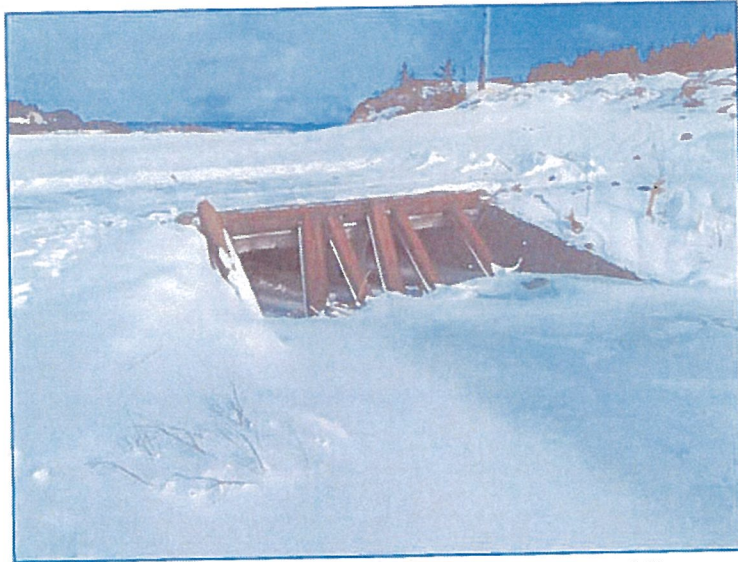
FIGURE 1. Culvert inlet and “debris rack”.

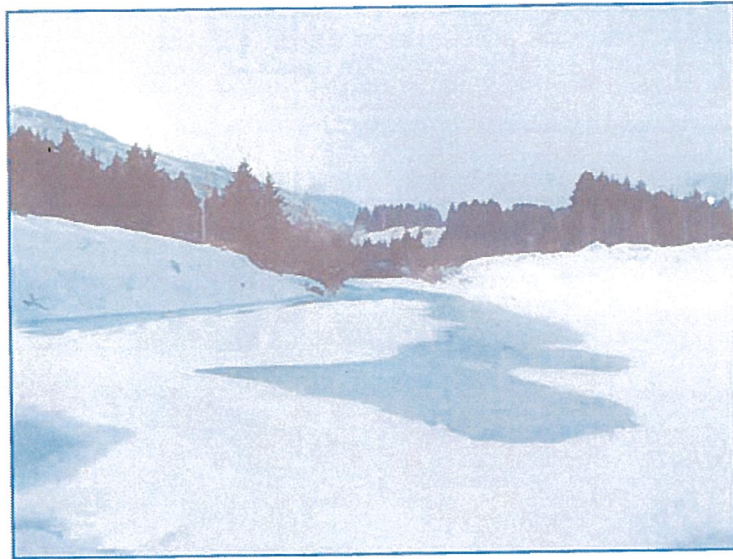
FIGURE 3. Upstream view from the culvert inlet. According to M&O staff, the width of the channel immediately upstream of the culvert has increased over time.

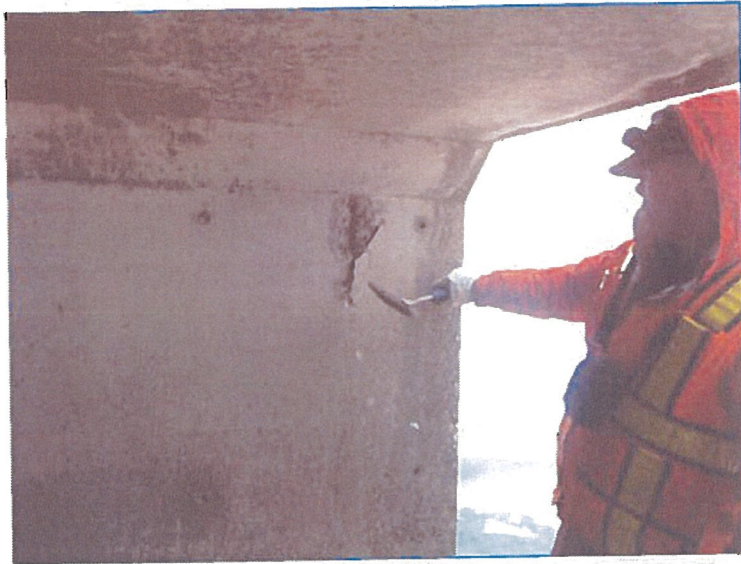
FIGURE 5. Minor concrete spalling at the culvert outlet.

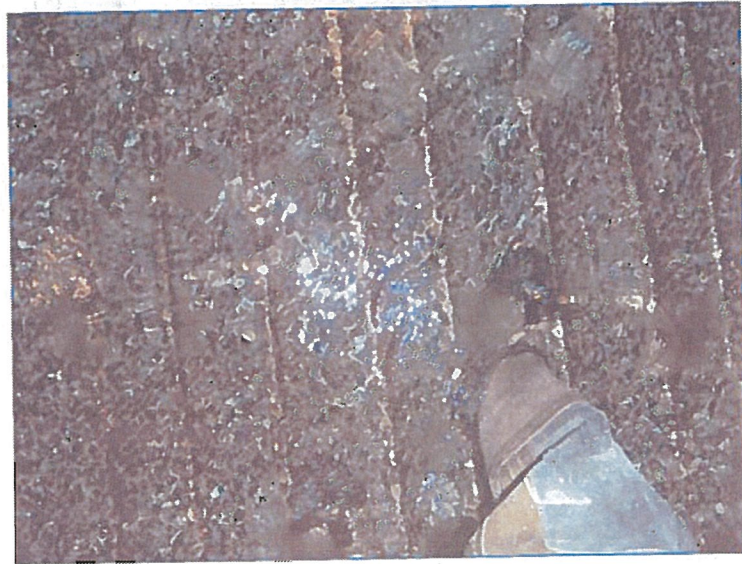
FIGURE 6. Exposed rebar along the culvert invert.

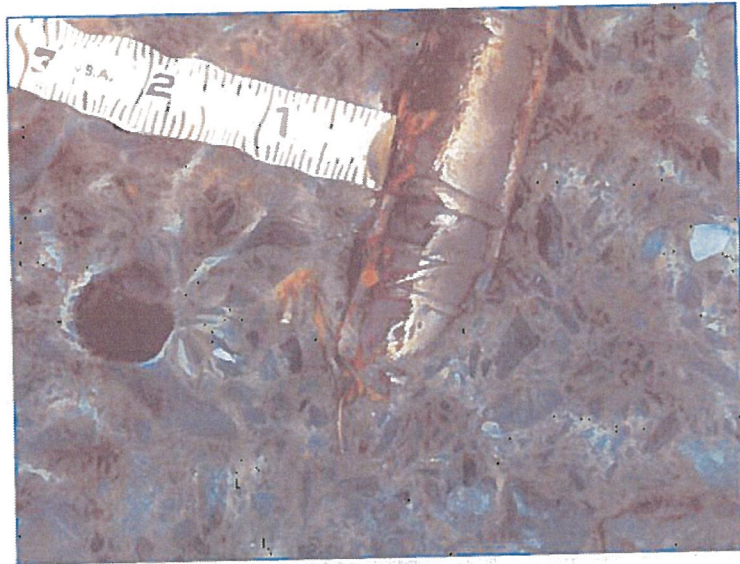
FIGURE 7. Rebar marked with "N" on the invert.

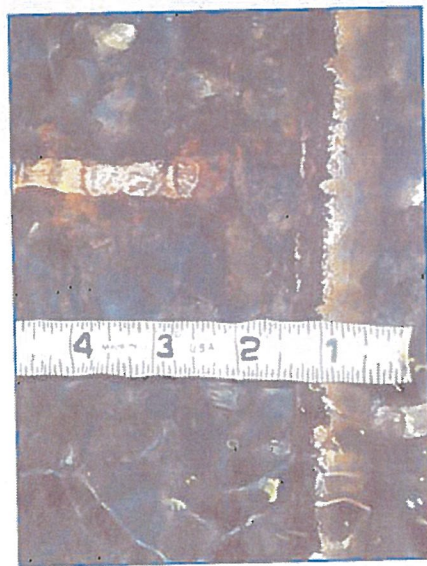
FIGURE 8. Note that longitudinal bars are also exposed in some areas.

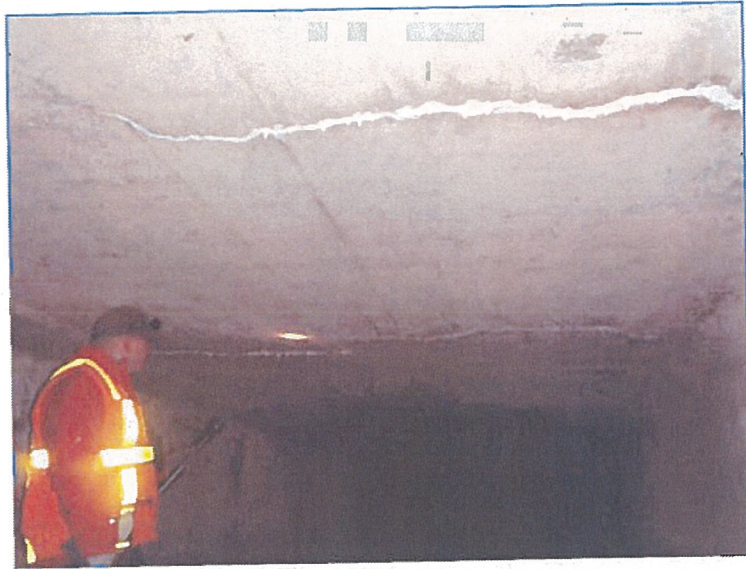
FIGURE 9. Efflorescence evident with cracks.

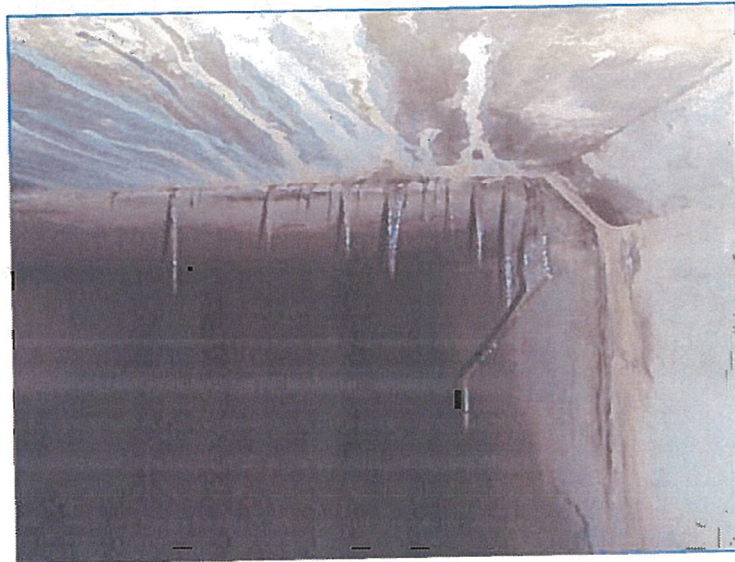
FIGURE 10. Minor seepage (icicles) and efflorescence at a joint.

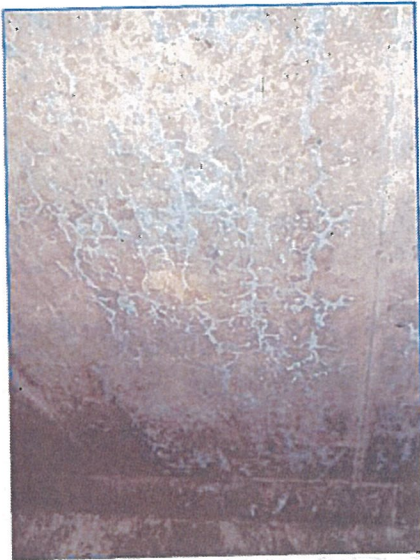
FIGURE 11. "Map cracking" along the top of structure, mostly evident in the upstream 1/3 of the culvert

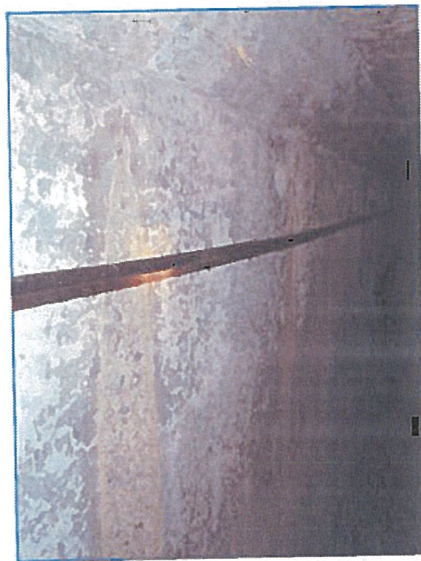
FIGURE 12. Minor seepage and surface damage through form tie holes. Also shown here is an abandoned utility cable that is not in service.

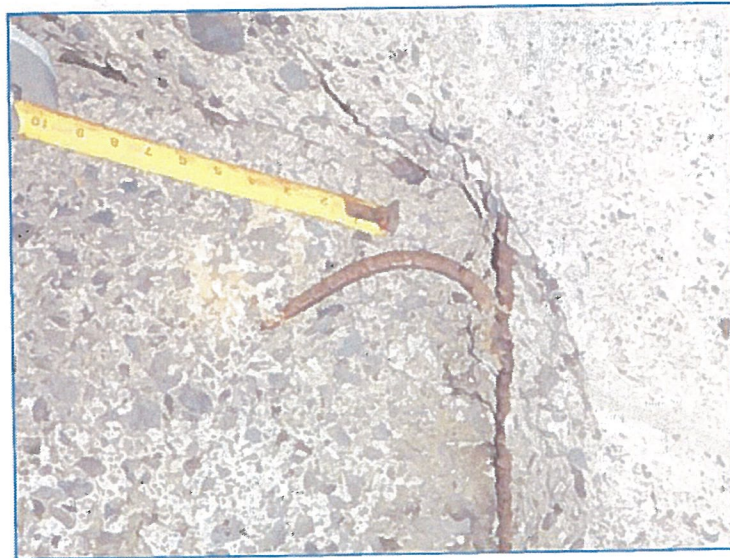
FIGURE 14. Reinforcing steel at the location where the encased utility enters/leaves the box culvert.

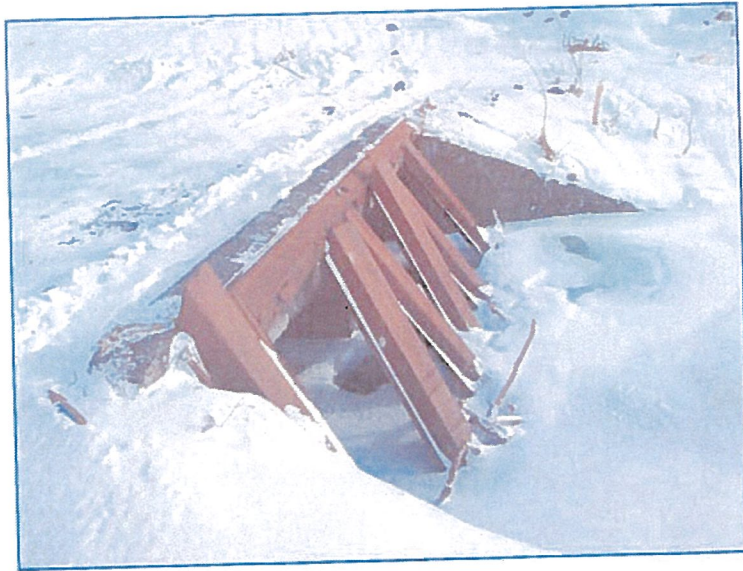
FIGURE 15. "Debris rack" at the culvert inlet with ice accumulation.

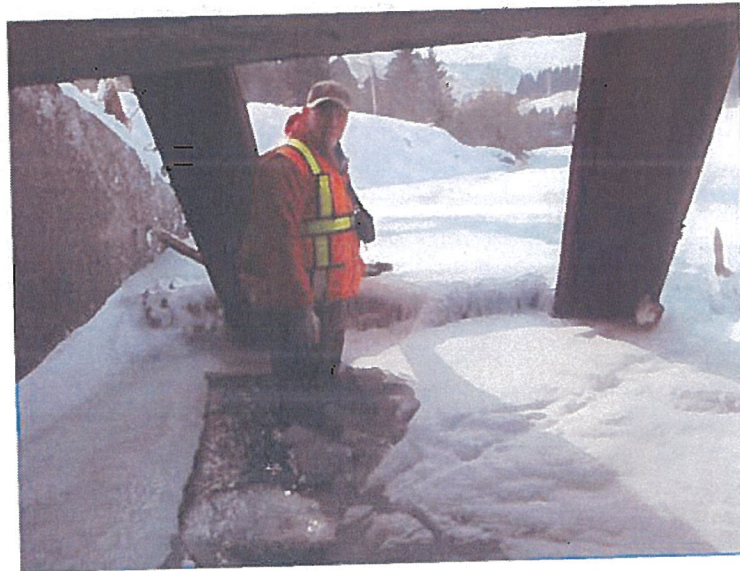
Icing in the channel and at the inlet can also adversely affect the hydraulic performance of the culvert. During the March 9, 2010 inspection, a frazil ice terrace was present at the inlet. It is likely that the steel sheet piling promotes ice growth and the presence of debris encourages frazil ice accumulation.

FIGURE 16. A frazil ice terrace at the culvert inlet.

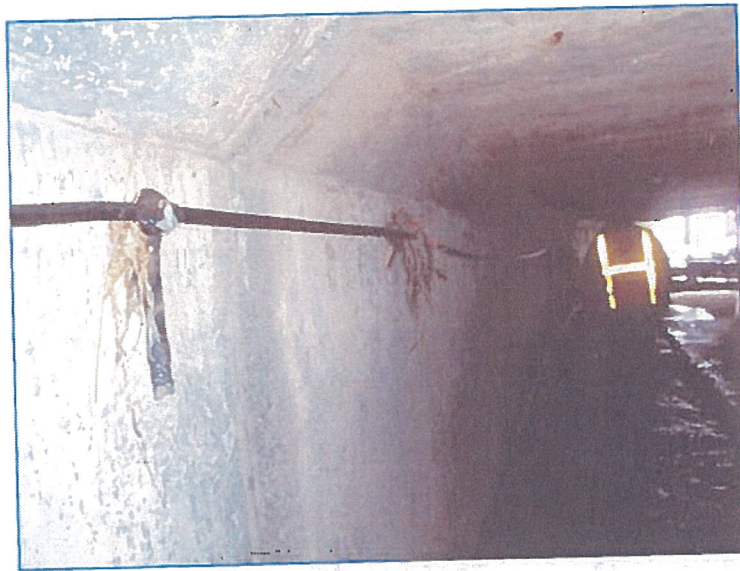
FIGURE 17. Debris caught on utility hooks near the inlet. This high water mark is near the inlet. Therefore, it is unclear whether this represents “normal depth” conditions or a short-duration “pulse” of water, such as that which would follow a debris blockage removal at the inlet.

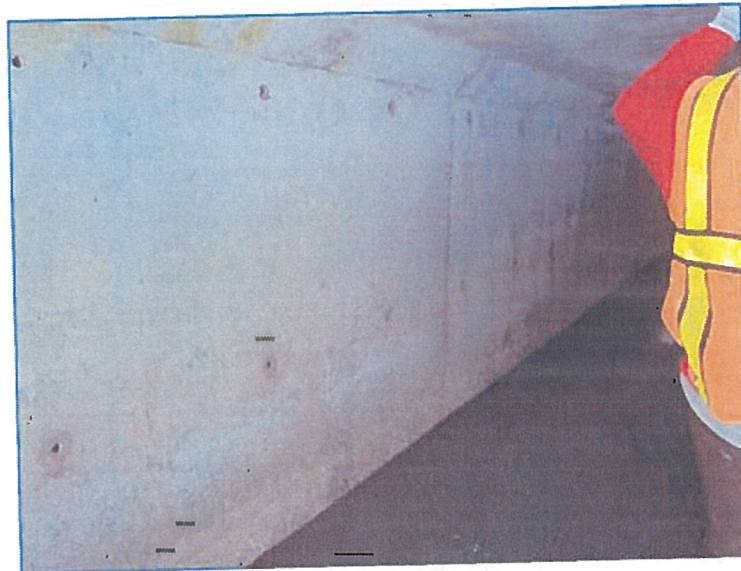
FIGURE 18. Though difficult to see in the photograph, water “stains” on the sides of the culvert are useful indicators of flow depths and recurrence. Shown here are indications that flow depth regularly exceeds the mid-height (form tie) holes.

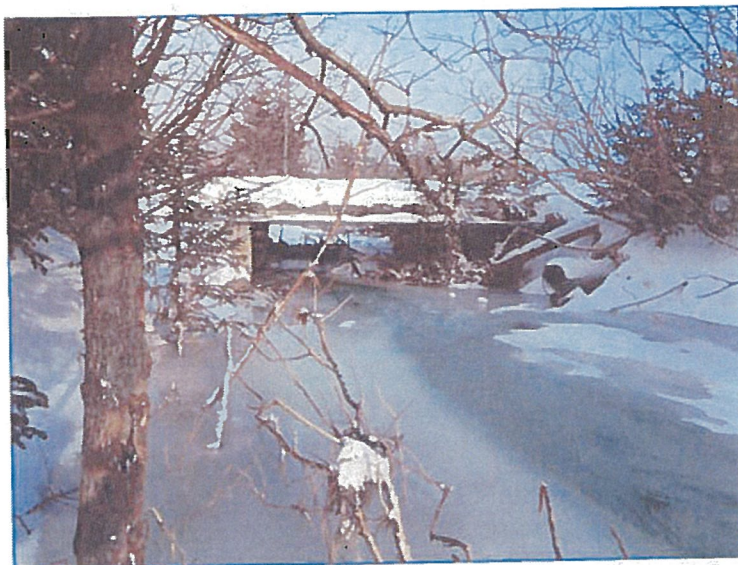
FIGURE 21. Maintenance access road/bridge upstream of the culvert. Note the debris accumulation at the bridge.

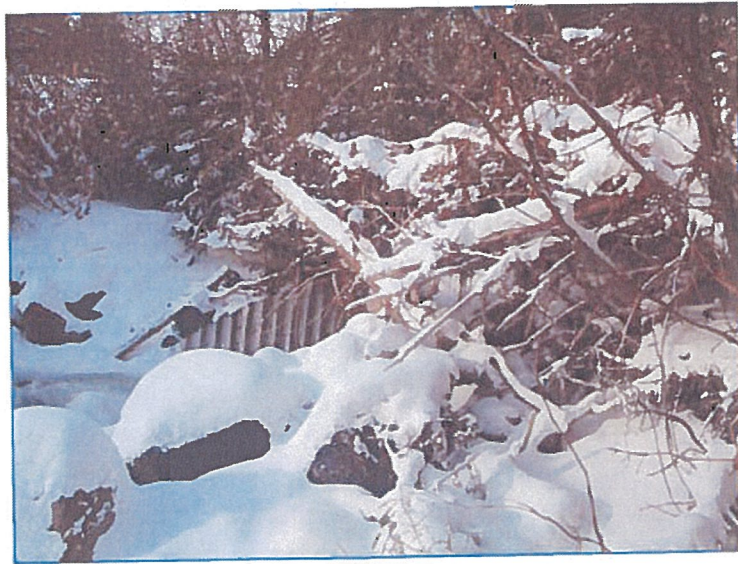
FIGURE 23. Upstream culvert beneath Rezanof Drive with debris accumulation at the inlet.

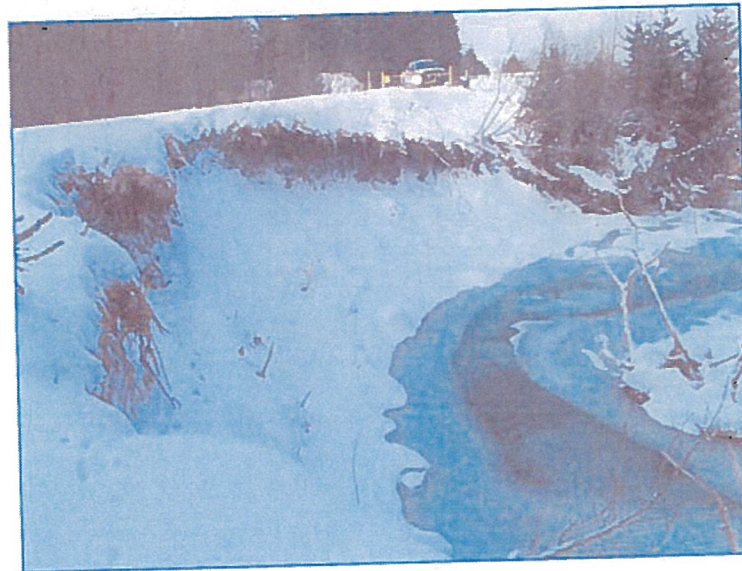
FIGURE 26. Active erosion along an access road upstream of Rezanof Drive. The erosion is caused by flow around the concrete structure.

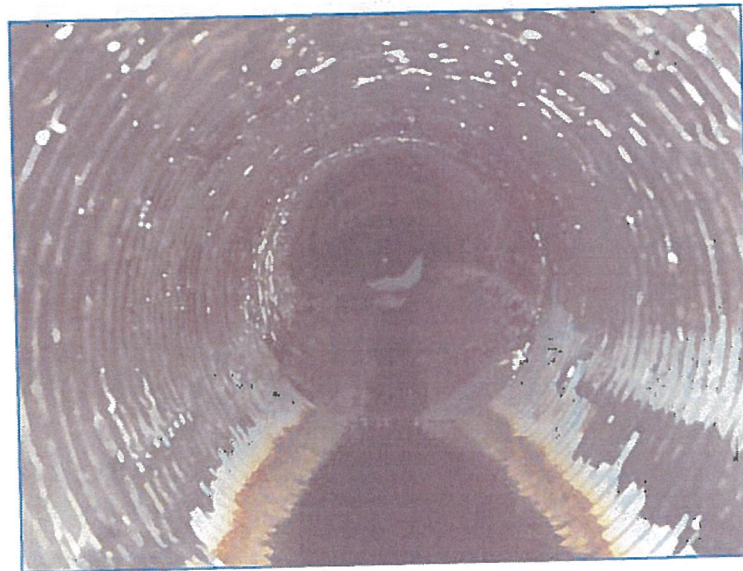
FIGURE 28. Minor corrosion and loss of bituminous coating.
