LA County Hall of Justice, 211 W. Temple, Los Angeles Subject: Structural Investigations and Materials Testing Accu-Test Job No. 305421

TEST
 REPORT

Subject:	Modulus of Elasticity Tests on Masonry Walls	Test ID: FJ-1, 1st Floor(#4		
	Hall of Justice, 211 W. Temple Street, Los Angeles. California	Test Dates:	6/24 - 7/10/03	
Report By	: V Jain/WK/AA/m Checked By:	S. Sethee, P	h.D.

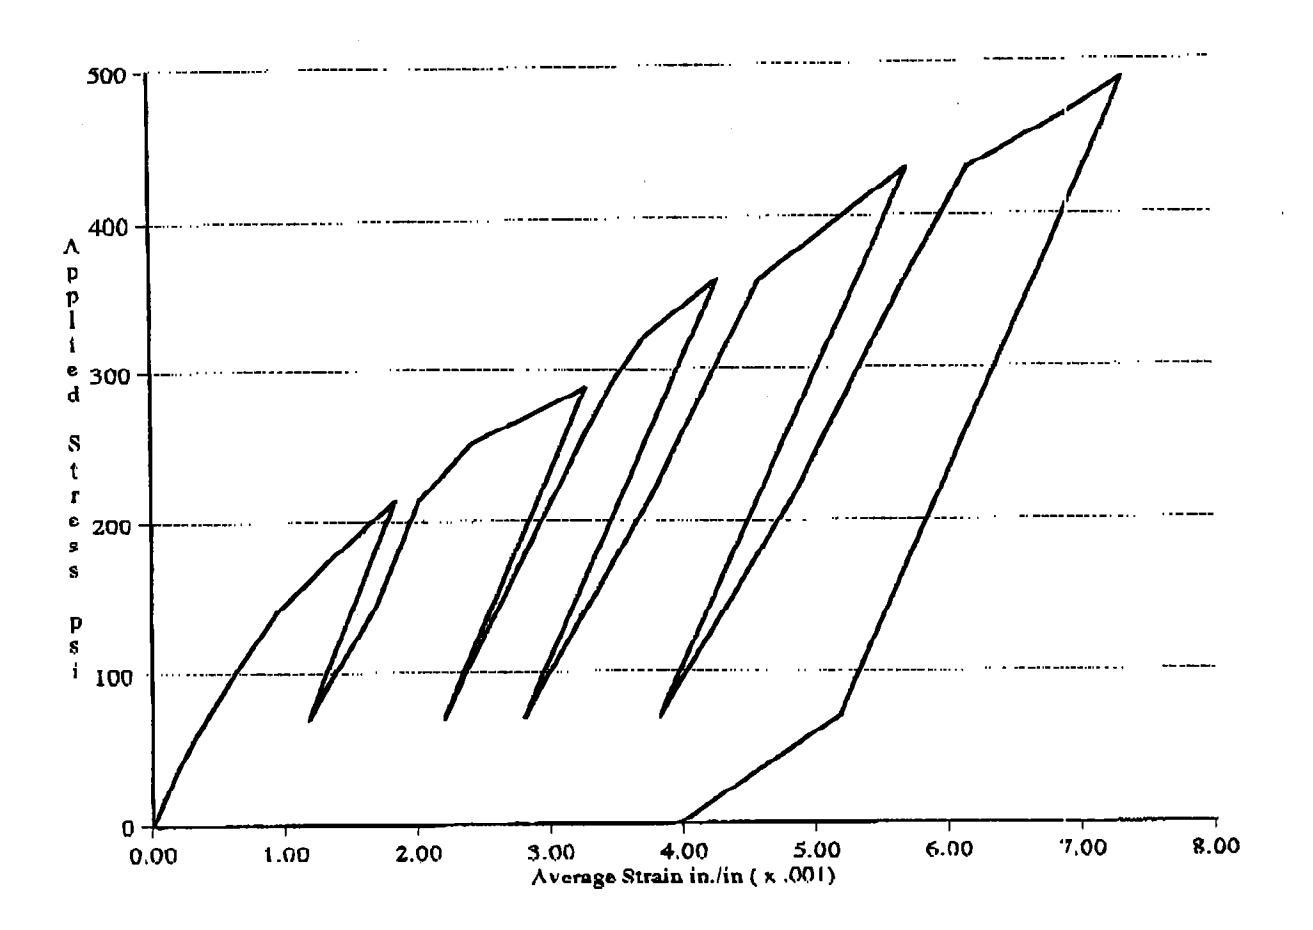
#### Figure 2.1A Compression Stress-Strain Curves for Brick Wall Obtained from In-Situ Flatjack Tests Test ID: FJ-1, Location #41, 1st Floor "Mid-North Wall", Interior Wythe

[1] Noticed beginning of crack(s) in the masonry.

[2] Cracks continued to develop

[3] Cracks became longer and wider.

[4] Masonry showed significant deformations, loading was stopped at this level to prevent potential damage to the structure.

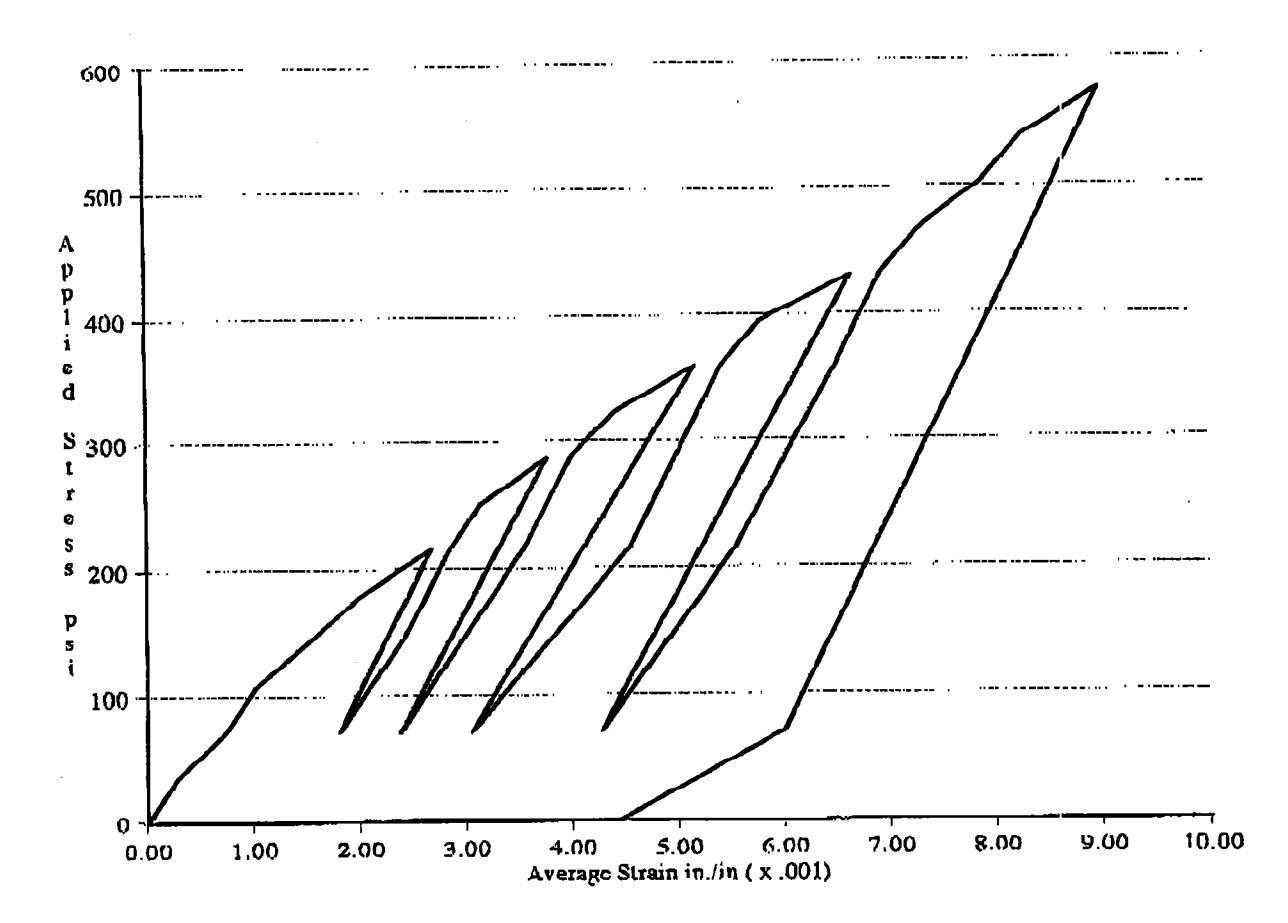
[1] Noticed beginning of crack(s) in the masonry.

[2] Crack(s) became longer and wider.

[3] Masonry showed significant deformations, loading was stopped at this level to prevent potential damage to the structure.

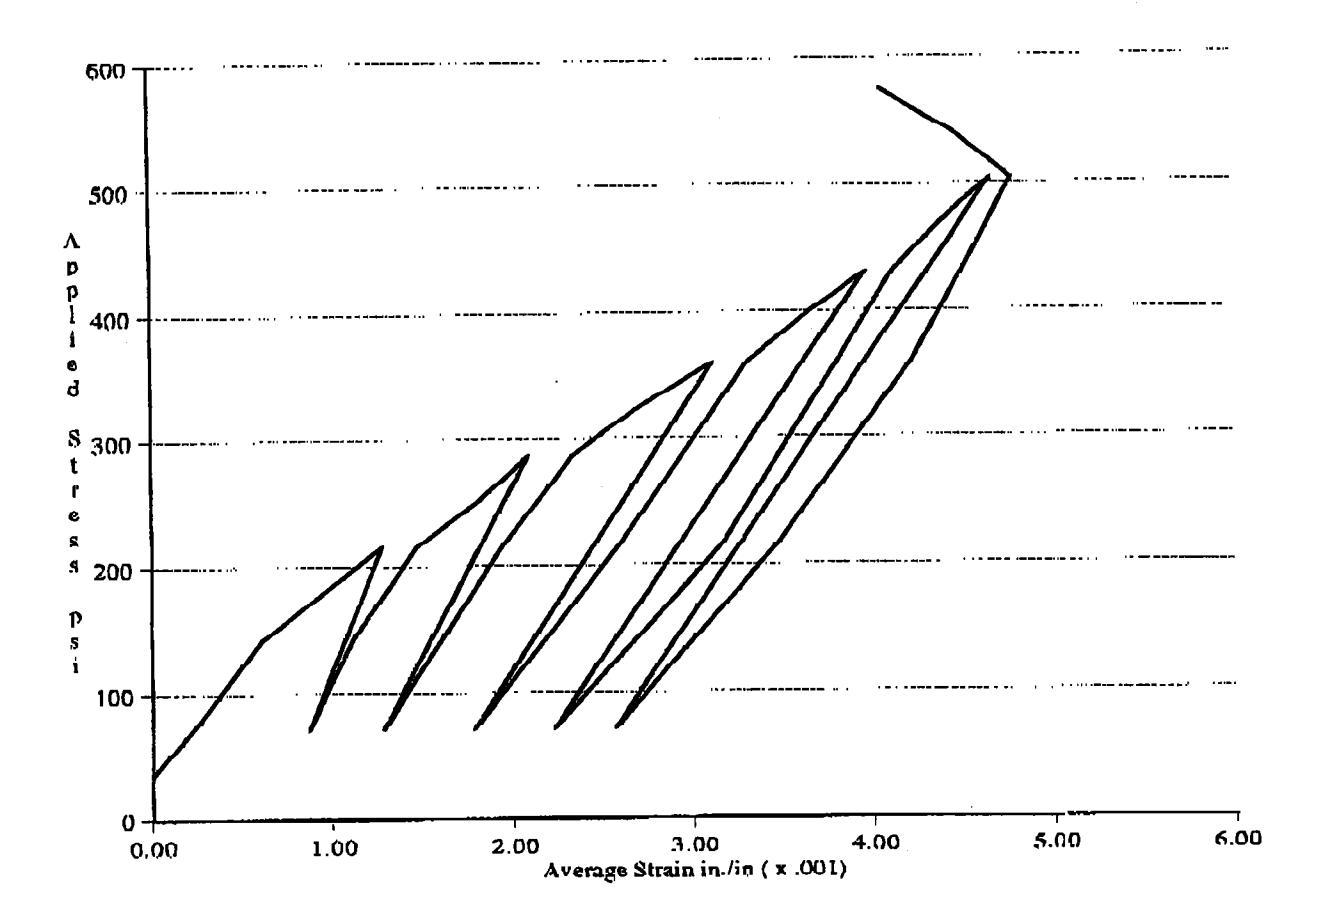
#### Figure 2.3A Compression Stress-Strain Curves for Brick Wall Obtained from In-Situ Flatjack Tests Test ID: FJ-3, Location #38, 6h Floor, "Mid-Wall", Interior Wythe

[1] Noticed beginning of cracks in the masonry.

[2] Aditional cracks developed going away from the flatjack corners.

[3] Cracks became longer and wider.

[4] In spite of increased compressive load, the deformations began to decrease. This exceptional strain reversal may have been due to crushing of mortar and/or brick in the rear part of the test wythe.

[5] Masonry showed significant deformations, loading was stopped at this level to prevent potential damage to the structure.

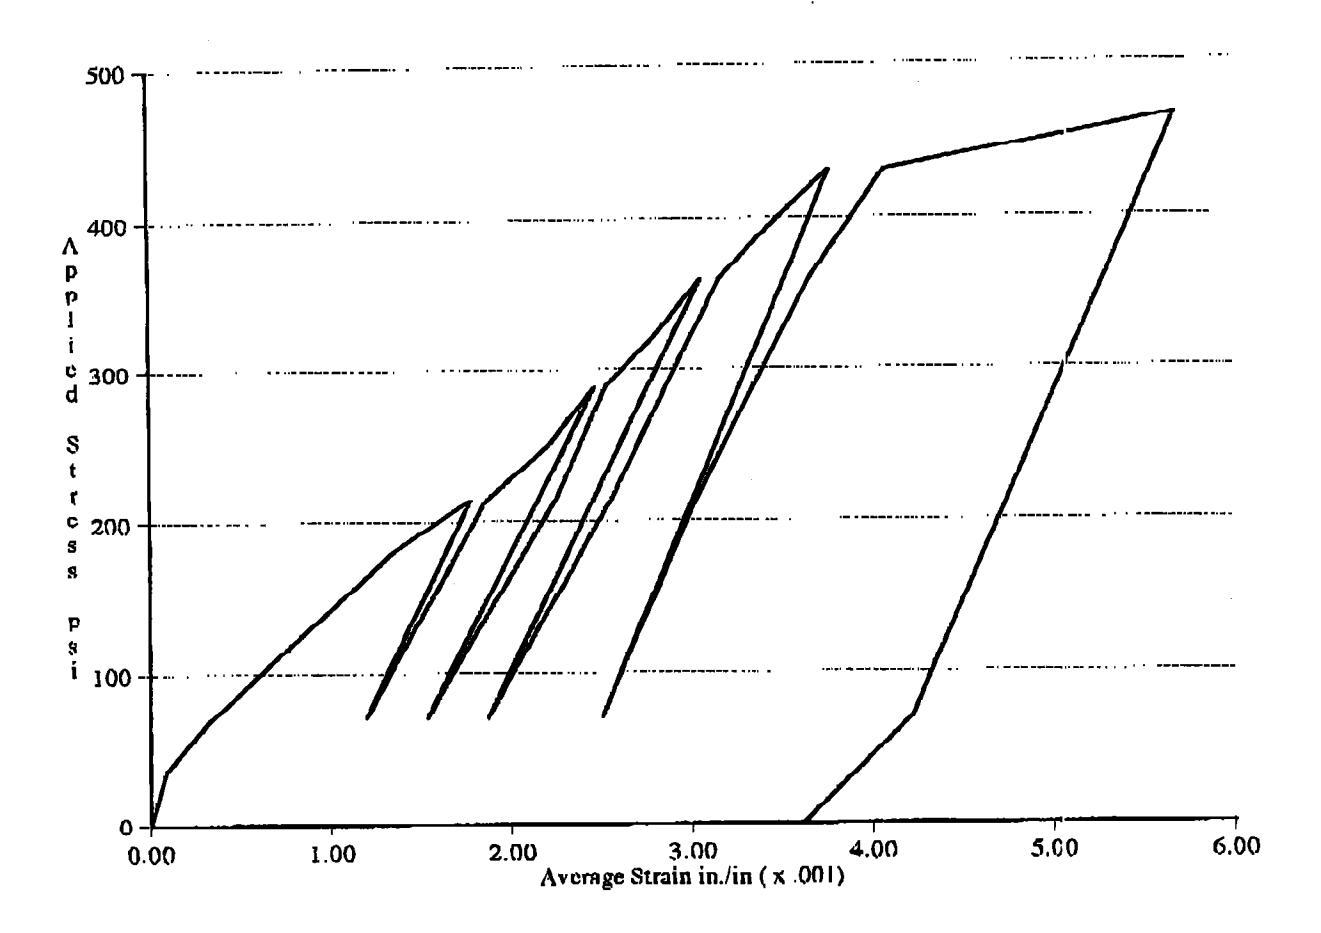
[1] Noticed beginning of cracks in the masonry.

[2] Aditional cracks developed.

- [3] Cracks became longer and wider.
- [4] Masonry showed significant deformations, loading was stopped at this level to prevent potential damage to the structure.

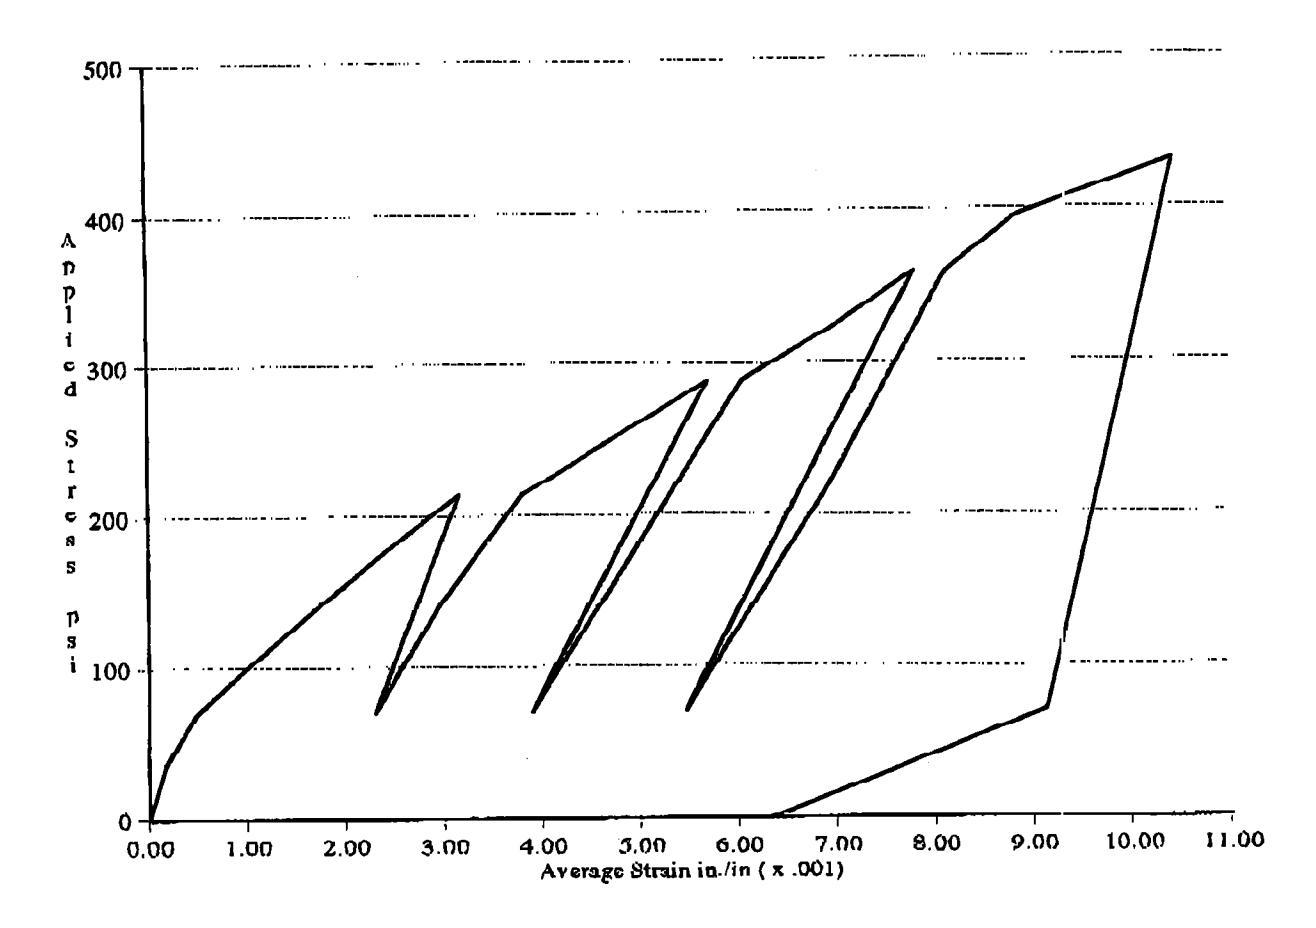
[1] Noticed beginning of cracks in the masonry.

[2] Cracks continueed to develop.

[3] Cracks became longer and wider.

[4] Masonry showed significant deformations, loading was stopped at this love to prevent potential damage to the structure.

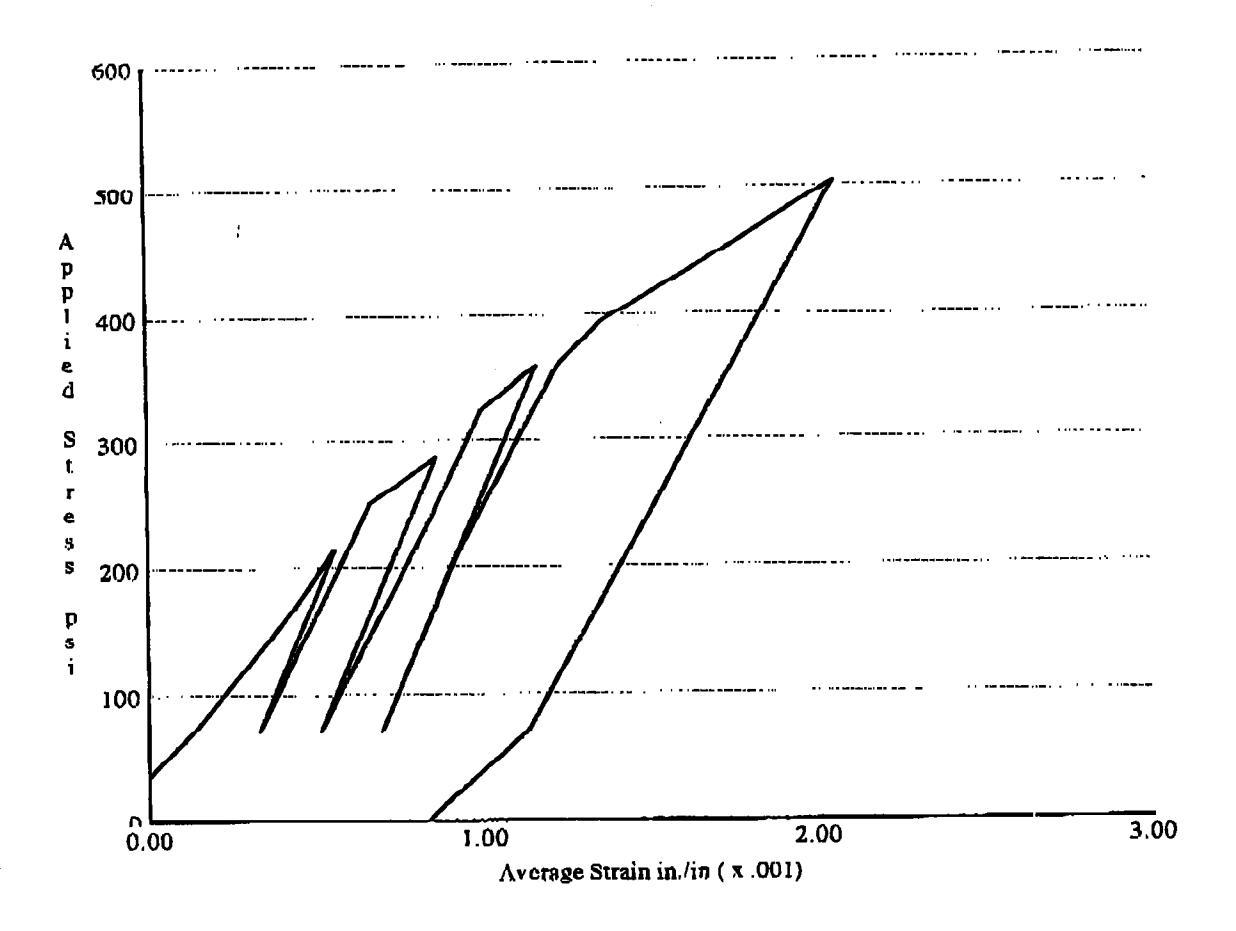
#### Figure 2.6A Compression Stress-Strain Curves for Brick Wall Obtained from In-Situ Flatjack Tests Test ID: FJ-6, Location #33, 14th Floor, "South Light Court", Interior Wythe

(1) Noticed beginning of cracks in the masonry.

- [2] Cracks continued to develop
- [3] Cracks became longer and wider.
- [4] Masonry showed significant deformations, loading was stopped at this level to prevent potential damage to the structure.
