**SR 534 MP 0.53 Unnamed Tributary 1 (west) to
Carpenter Creek (CR2) /
SR 534 ROW MP 0.60 Unnamed Tributary 2 (east) to
Carpenter Creek (995265):
Final Hydraulic Design Report**

**Julie Heilman, PE, State Hydraulic Engineer
WSDOT Headquarters Hydraulics Office – FPT20-00157**

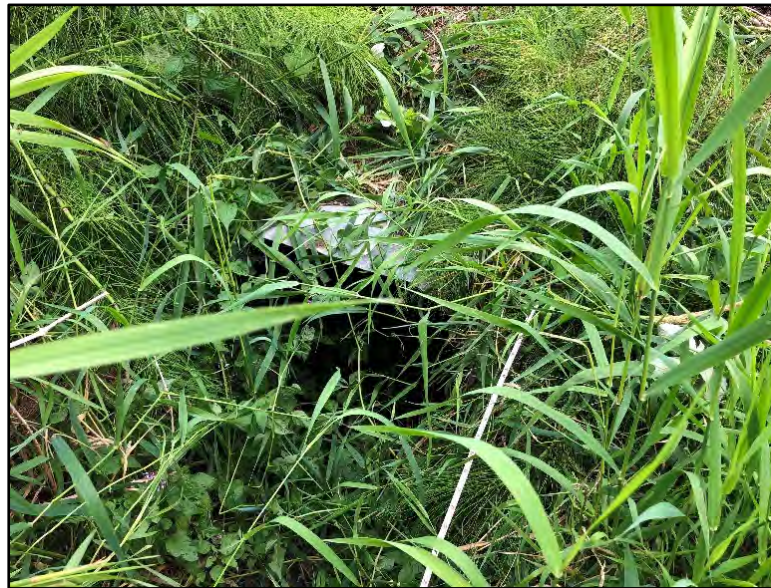
Figure 2.2. Inlet to WDFW ID 995265 (looking downstream)

The site assessment began where the unnamed tributary to Carpenter Creek inlets to the SR 534 storm sewer (Site ID 995265) (Figure 2.2). An exposed corrugated metal watermain casing was observed running parallel to the roadway at the stream channel bottom 7 feet upstream of the inlet to barrier ID 995265 (Figure 2.3). Only the top few inches of the casing were exposed within the streambed for a length of approximately 3 feet. The diameter and material of the water main itself was not determined during the site visit. From approximately 50 to 100 feet upstream of the inlet to culvert ID 995265, cobbles and boulders were observed in the stream channel ranging from 6 to 36 inches in diameter (Figure 2.4).

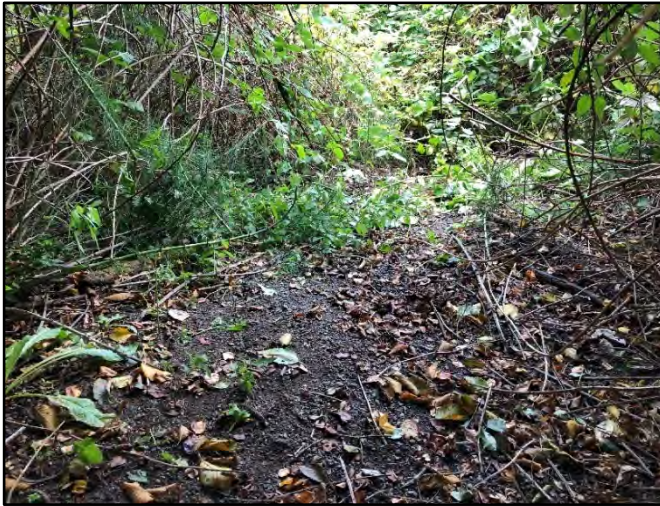
Figure 2.5. Shallow section of channel with limited constraint (looking downstream)

At 57 feet upstream from the ID 995265 storm sewer inlet, the bankfull width was measured to be 6.8 feet; at 75 feet upstream, the bankfull width was measured to be 5.6 feet. The WSDOT site survey ended 87 feet upstream of the storm sewer inlet. At 112 feet upstream the presence of a pool was noted. At 176 feet upstream of the existing inlet, the channel constraint is diminished in relation to the channel upstream and downstream of this location, and the left floodplain extends gradually outward into a forested area west of the channel (Figure 2.5). A bankfull width measurement was taken 251 feet upstream of the storm pipe inlet, measured to be 6.2 feet (Figure 2.6). Pebble counts 1 and 2 of the upstream reach were based on measurements taken at 281 feet and 384 feet upstream, respectively.

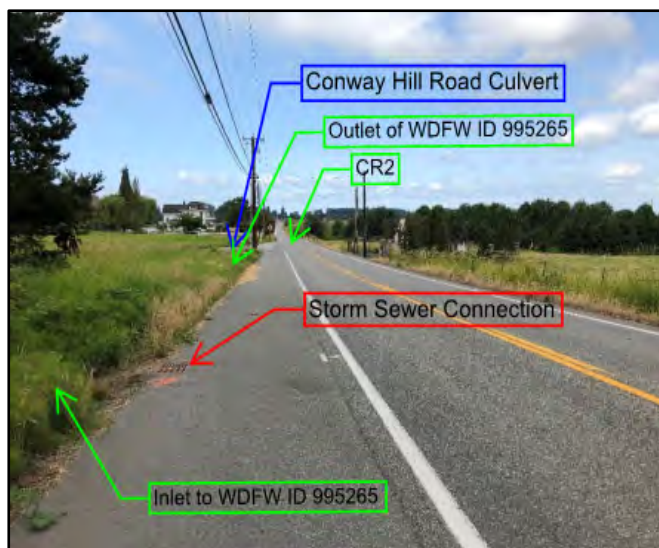
Figure 2.7. Layout of the Barrier WDFW ID 995265 (looking west down SR 534)

A 6-foot-long 30-inch diameter corrugated metal pipe forms the inlet to WDFW ID 995265. This pipe segment then connects to a 54-inch diameter WSDOT 54-inch Type 2 catch basin at the edge of SR 534. WDFW ID 995265 then includes, as is indicated from survey, a 219-foot-long, 30-inch diameter corrugated metal pipe that conveys the tributary to Carpenter Creek west where it outfalls to open channel (Figure 2.7). The ID 995265 segment is the most downstream segment of a storm system comprised of 18-inch corrugated metal pipe and catch basins that extends approximately 1,880 feet east to Bulson Road along the south side of SR 534. The storm system serves a drainage area of approximately 30 acres or 10 percent of the total tributary area serving the SR 534 crossing. Downstream of the outlet of ID 995265, approximately 15 feet of open channel conveys the tributary to the Conway Hill Road culvert (WDFW ID CR3), which measures 30 inches in diameter and 76 feet long.

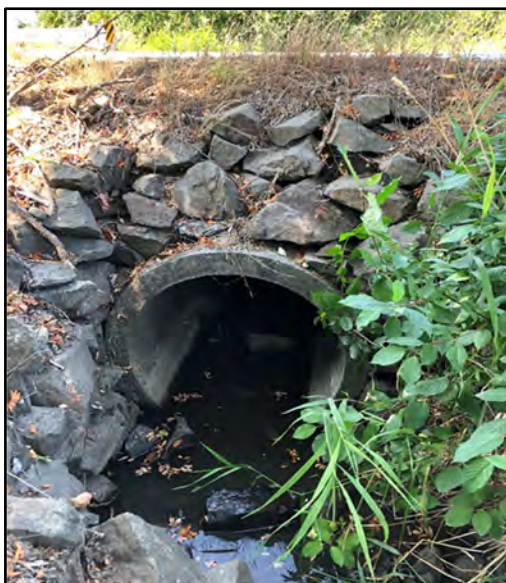
Figure 2.9. Inlet of the culvert at the downstream crossing of SR 534

The SR 534 culvert (WDFW ID CR2) inlet is 250 feet downstream of the Conway Hill Road culvert outlet (Figure 2.9). The existing SR 534 culvert is a 35-foot-long, 36-inch concrete pipe placed at a slope of 1.1 percent, as determined from WSDOT site survey. The roadway surface is about 6 feet above the culvert inlet invert elevation. Riprap between 6 and 24 inches in size protects the inlet to this culvert. In the reach between the SR 534 crossing and its confluence with Carpenter Creek, the stream is characterized by a steep-banked channel narrower than the sections observed upstream. The banks are marked by extremely dense reed canarygrass and Himalayan blackberry, which has overgrown into the main channel in most portions of this reach (Figure 2.10). A bankfull width measurement of 5.8 feet was taken at 47 feet downstream of the SR 534 crossing outlet, and a bankfull width measurement of 7.2 feet was taken at 69 feet downstream. The confluence of the tributary with Carpenter Creek occurs 176 feet downstream of the SR 534 culvert outlet (WDFW ID CR2). All bankfull width measurements are recorded in Table 3.1.

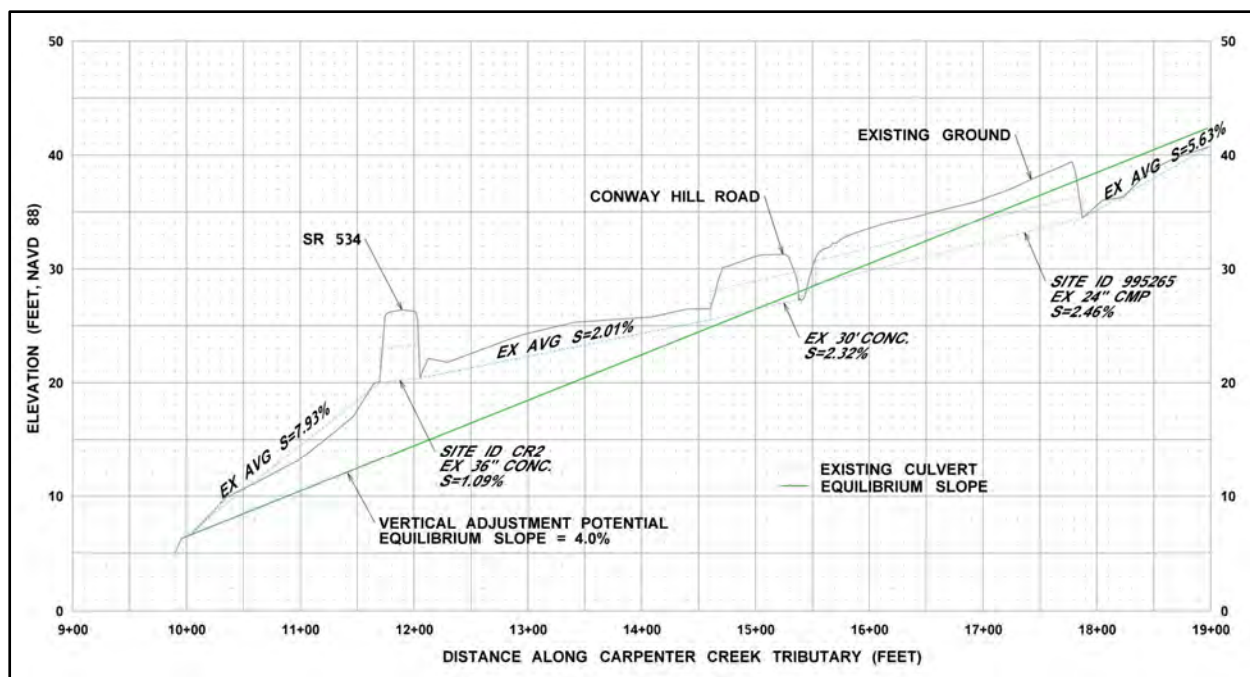
Figure 3.4. Longitudinal Profile of the Unnamed Tributary to Carpenter Creek – Project Vicinity

The existing SR 534 culvert is functioning as grade control to vertical adjustment. Following removal of the existing crossing, long term degradation is possible. An existing slope ratio of 4.0 exists between the downstream gradient (7.9 percent) and the upstream gradient (2.0 percent). Figure 3.4 depicts the longitudinal profile of the channel from approximately 110 feet upstream of the inlet to the storm sewer

(Site ID 995265) downstream to the confluence with Carpenter Creek, along with a vertical adjustment potential (VAP) line. The VAP line represents a potential lower limit regrade of the channel if a head cut in the relatively steeper gradient downstream of SR 534 were to propagate upstream due to the removal of the existing crossing. This VAP line was assumed to be 4.0 percent as described in Section 3.4.1 above. A regrade along this VAP line would result in up to approximately 6.75 feet of degradation at the existing SR 534 crossing. The rate and degree of potential degradation depends on many factors including the stability of the cobble material in the channel downstream of SR 534 and is difficult to predict with certainty. During the final hydraulic design phase, the long-term degradation potential was further assessed and documented in Section 12.2.

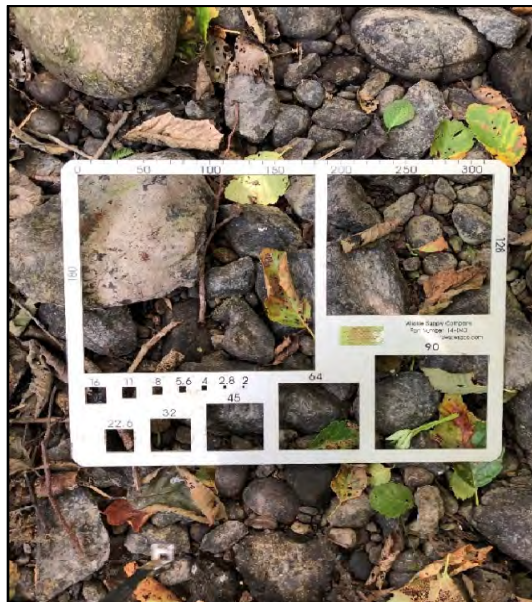
Figure 3.7. Upstream Pebble Count 2

Upstream Pebble Count 2 was conducted at a location 384 feet upstream from culvert WDFW ID 995265 where the channel substrate comprised a mix of gravel, sand, and cobbles. The Wolman analysis results indicated that the streambed of count 2 consisted of 47 percent coarse gravel, 17 percent sand, 17 percent medium gravel, and 12 percent cobble, 6 percent fine gravel, and 1 percent boulders. The local gradient at this location was estimated to be approximately 6 percent.

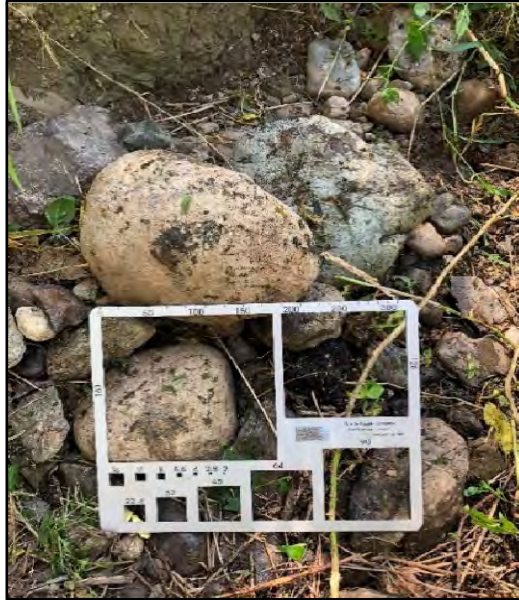
Figure 3.8. Downstream Pebble Count 1

Downstream Pebble Count 1 was conducted at a location of 47 feet downstream of the outlet of the WDFW ID CR2 barrier. Here, cobbles and large boulders were observed in the stream channel. The pebble count analysis results indicated that the streambed was composed of 57.9 percent cobbles, 21.1 percent coarse gravel, 10.5 percent medium gravel, 7.9 percent boulders, and 2.6 percent fine gravel. The slope in this reach is 6.9 percent as determined by WSDOT site survey.

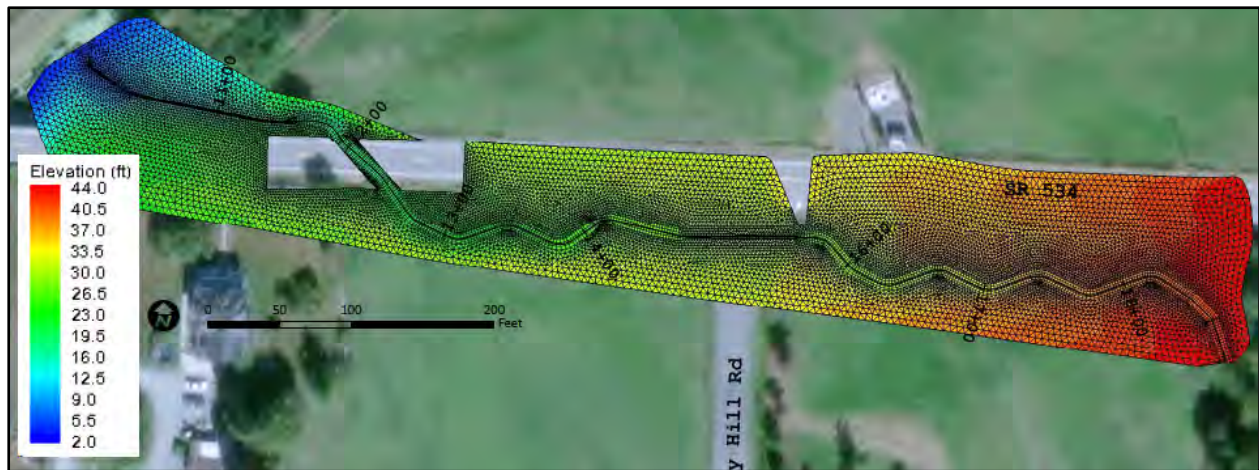
The model begins approximately 610 feet upstream of the existing SR 534 road crossing and extends 200 feet downstream of the crossing. The upstream boundary condition was placed at 55 feet upstream of the WDFW crossing 995265 to exceed the recommended minimum of 3 to 4 times the estimated existing floodplain width of 9 feet. The proposed model conditions of 34,400 mesh elements and covers an area of 2.1 acres (Figure 7.2). The elements along the stream and floodplain have approximately 2 to 5-foot vertex spacing. The proposed culvert was represented in the mesh by removing elements allowing the model to read those empty spaces as the encroachment created by the minimum hydraulic opening.

Figure 7.21. Proposed conditions Computational Mesh with Underlying Terrain

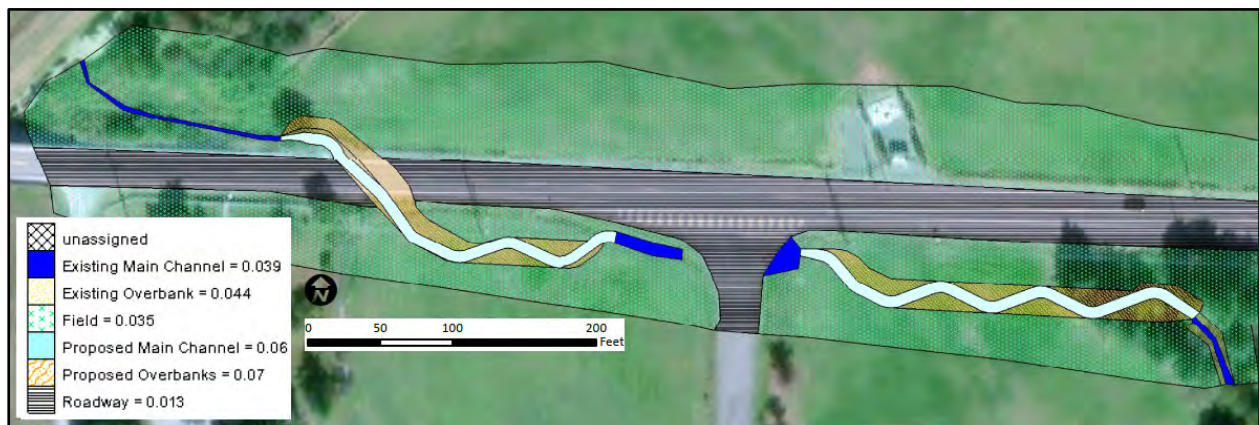
A roughness coefficient for the channel and overbanks was computed based upon the criteria developed by Chow (1959) with applied factors (Arcement and Schneider 1989). The proposed channel roughness is based on a proposed material of coarse gravel, with a moderate degree of surface irregularity, alternating flow that shifts from side to side, and appreciable obstructions upstream and downstream of the proposed structure due to the inclusion of large woody material. Roughness in the existing channels matched those selected for the existing condition model. Roadway was given a roughness typically used for asphalt and areas outside of the floodplains was described as 'Field' and assigned a value of 0.035 to represent tall grasses and other vegetation. Figure 7.3 below shows the roughness coefficients in terms of Manning's n value.

Figure 7.3. Spatial Distribution of Proposed-conditions Roughness Values in SRH-2D Model

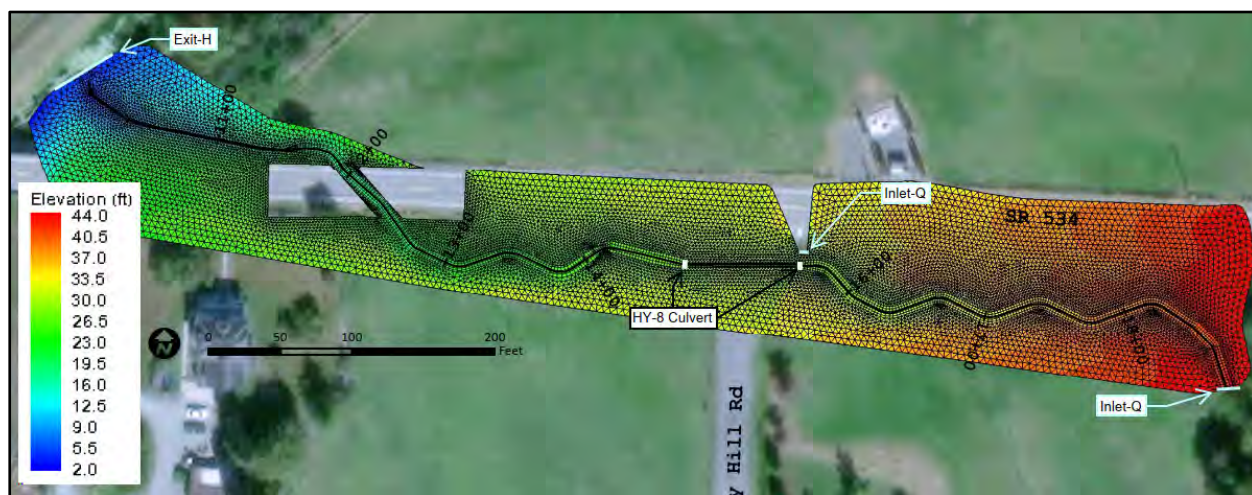
boundary condition used a tailwater water elevation of 12.7 feet based on the FEMA 100-year flood elevation of 3 feet above existing general ground level of the SFHA. HY-8 was used to model the Conway Hill Road crossing and its input values are shown as Figure 7.5. Due to the designed location of the outfall for the SR 534 storm system near the inlet of the Conway Hill Road culvert (CR3), flow inputs were split into two Inflow boundaries (one representing the open channel of the tributary downstream of the Conway School culvert, and one from the SR 534 storm system. MGSFlood modeling indicates that approximately 30 percent of the overall peak flow rates reported in Section 6 are conveyed through the SR 534 storm system, with the other 70 percent conveyed through the open channel downstream of the Conway School culvert.

Figure 7.4. Proposed Conditions Boundary Conditions

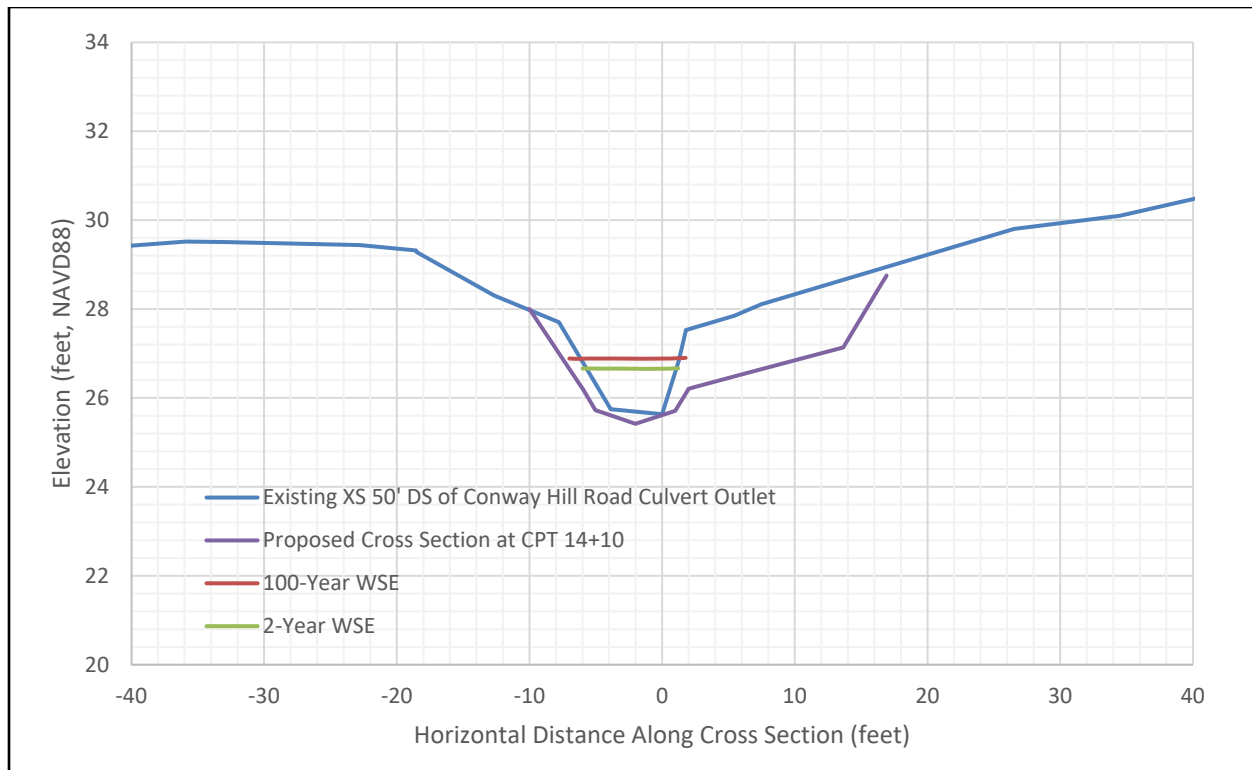
Figure 9.2 depicts a comparison of the design channel section with the existing cross-section near the same location in the channel. The water surfaces shown are those of the existing condition. Figure 7.8 above depicts the proposed water surfaces in relation to the design section. Figure 9.3 depicts the design cross section with an existing cross section from upstream of the crossing and downstream of the crossing shown for comparison. Appendix D contains the final design drawings.

Figure 9.2. Existing (with Water Surfaces) and Proposed Channel Cross Sections in Vicinity of SR 534 Crossing

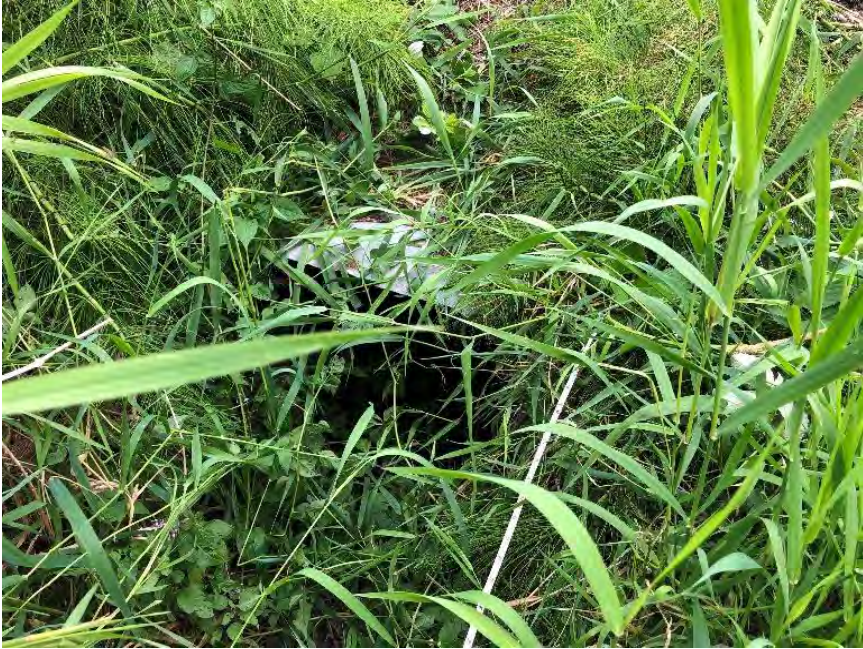
Photo 1 – Upstream of Culvert WDFW ID 995265

meters	feet	Notes
0	0	Culvert Inlet - 2.5' ϕ (Photo 1)
2	7	Exposed pipe (water main) running parallel to roadway through stream channel (Photo 2)
7	23	Channel looking downstream (Photo 3)
16	52	Large boulders 6" to 30"-plus (Photo 4)

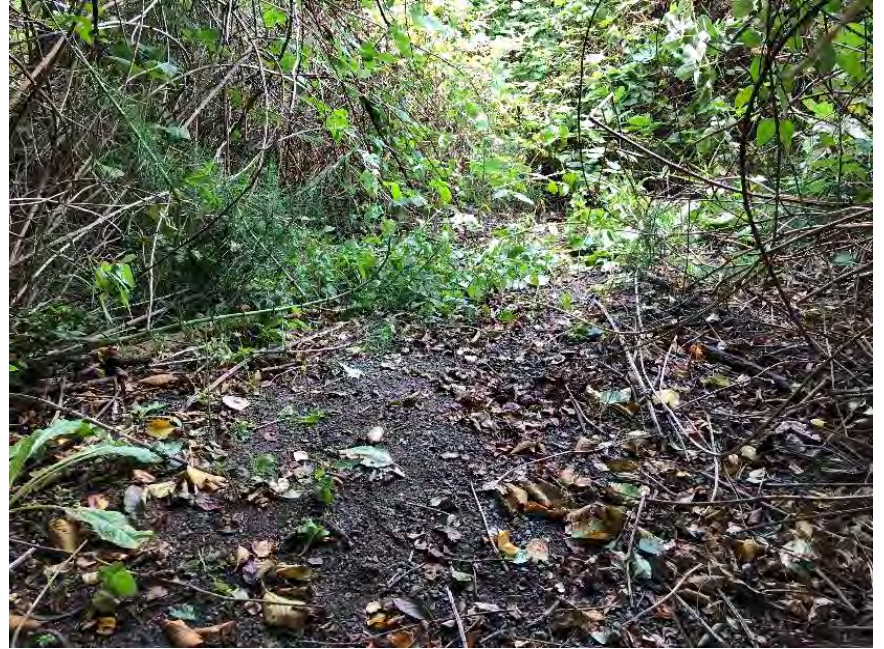
Photo 6 – Upstream of Culvert WDFW ID 995265

53.5	176	Decrease in channel constraint, shallower section (Photo 6)
58.5	192	Substrate consists of sandy silt with some boulders
61.5	202	BFW 5.6' (Photo 7)
64	210	BFW 6.0'

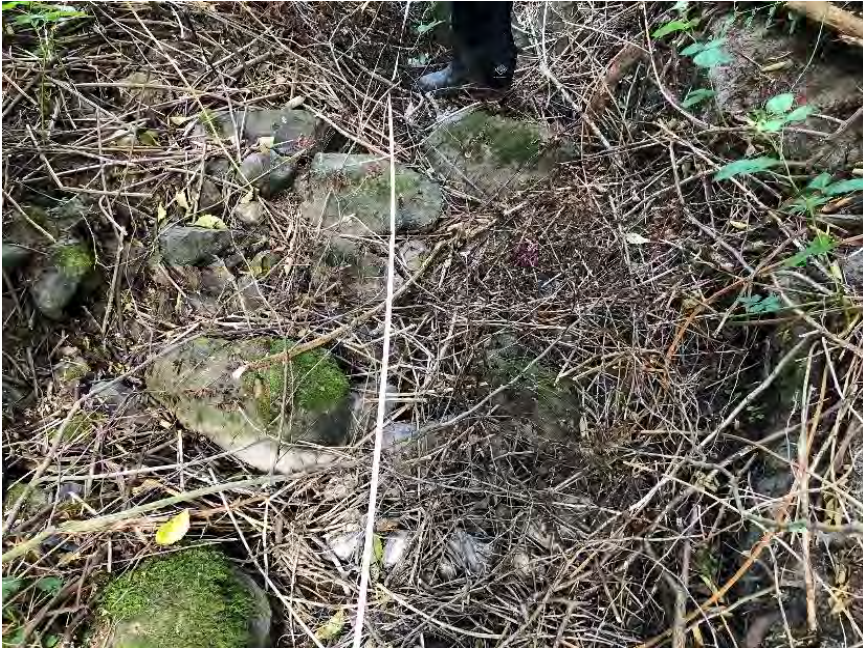
Photo 5 – Upstream of Culvert WDFW ID 995265

17.5	57	BFW 6.8' (Photo 5)
22.9	75	BFW 5.6'
26.5	87	End of cross section land survey conducted by WSDOT
34.1	112	Pool
42.5	139	Stream has dense blackberry presence on overbanks areas

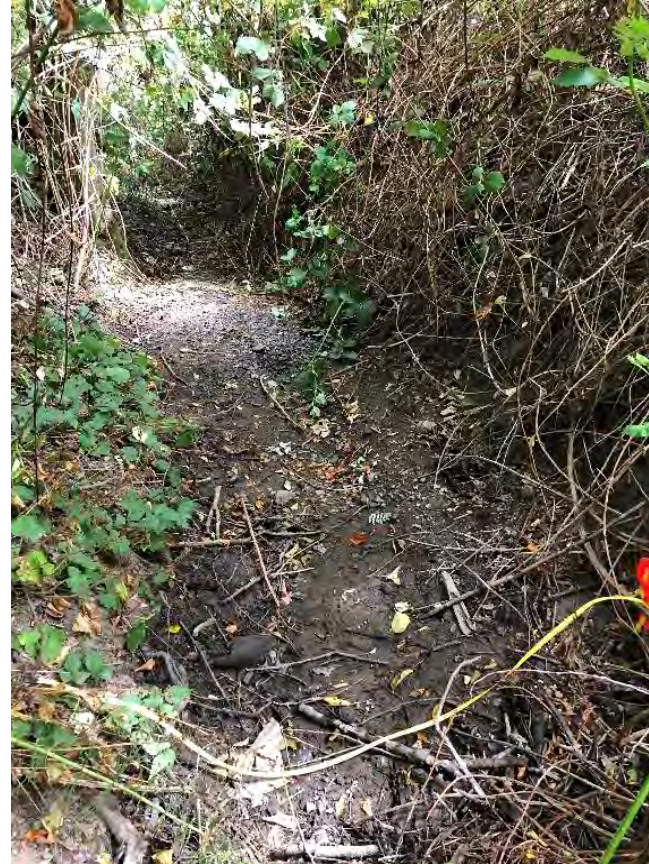
Photo 8 – Upstream of Culvert WDFW ID 995265

70.9	233	BFW 4.8'
76.5	251	BFW 6.2' (Photo 8)
85.5	281	Downstream Observation
		Pebble Count 1 (Photo 9 and 10)
117.0	384	Access to stream through thick Himalayan blackberry
		Pebble Count 2 (Photo 11)
		BFW 7.6'
		Channel substrate comprised of mix of Gravel, sand, cobbles - 50/50 angular/ round rock
		Estimated channel gradient over 20 linear foot local drop $1.2'/20' = 0.06$

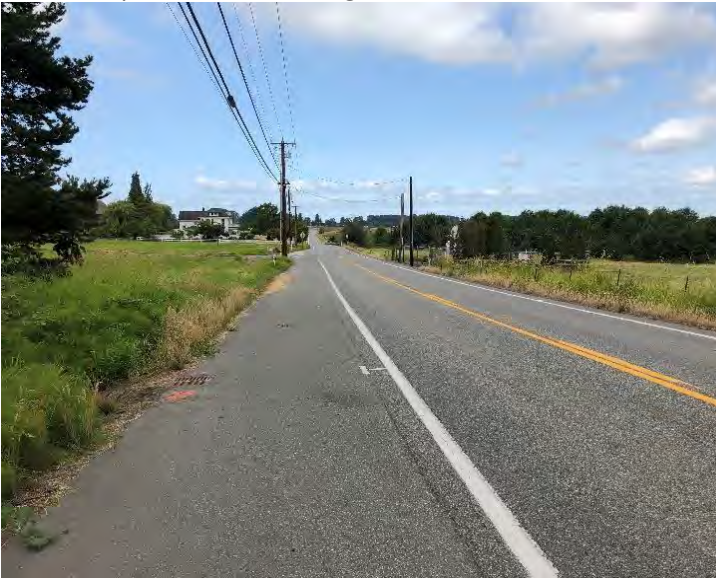
Photo 1 – Downstream of Culvert WDFW ID 995265/Upstream of Crossing WDFW ID CR2

meters	feet	Notes
0	0	30" ϕ culvert (Photo 1- Roadway looking downstream)
3	10	BFW 9.0'
		Constructed channel along road (Photo 2)
15.2	50	BFW 7.6'
18.3	60	Angular/ Rounded boulders (at telephone poles) (Photo 3)
76.2	250	Inlet of culvert crossing SR 534 (WDFW ID CR2) - 3.0' ϕ (Photo 4)

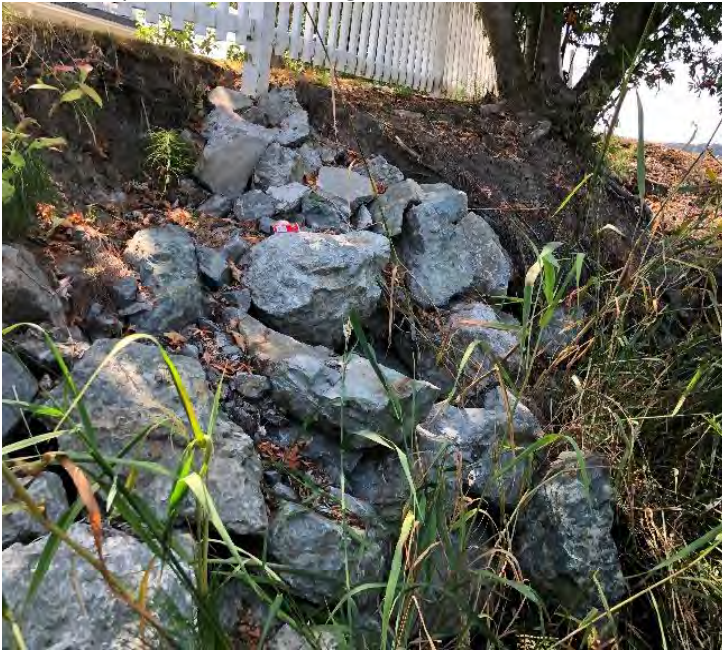
Photo 5 – Downstream of Culvert WDFW ID 995265/Upstream of Crossing WDFW ID CR2

Evidence of scour, large riprap (Photo 5)
Distance Downstream from Culvert WDFW ID CR2		
meters	feet	Notes
0	0	Outlet of culvert crossing SR 534 (WDFW ID CR2)
		Steep channel gradient below culvert outlet
14.3	47	BFW 5.8' (main channel width)
		Cobbles/ boulders in stream channel (Photo 6)
21	69	BFW 7.2'
		End of stream, confluence with Carpenter Creek (Photo 7)
53.5	176	High vegetation mat of canary grass and blackberries over stream from end of culvert to start of levee (Photo 8)
