**REPORT OF
SURVEY FOR HAZARDOUS MATERIALS**

**HALL OF JUSTICE
LOS ANGELES, CALIFORNIA**

April 20, 2005

MACTEC Project 4952-04-2862

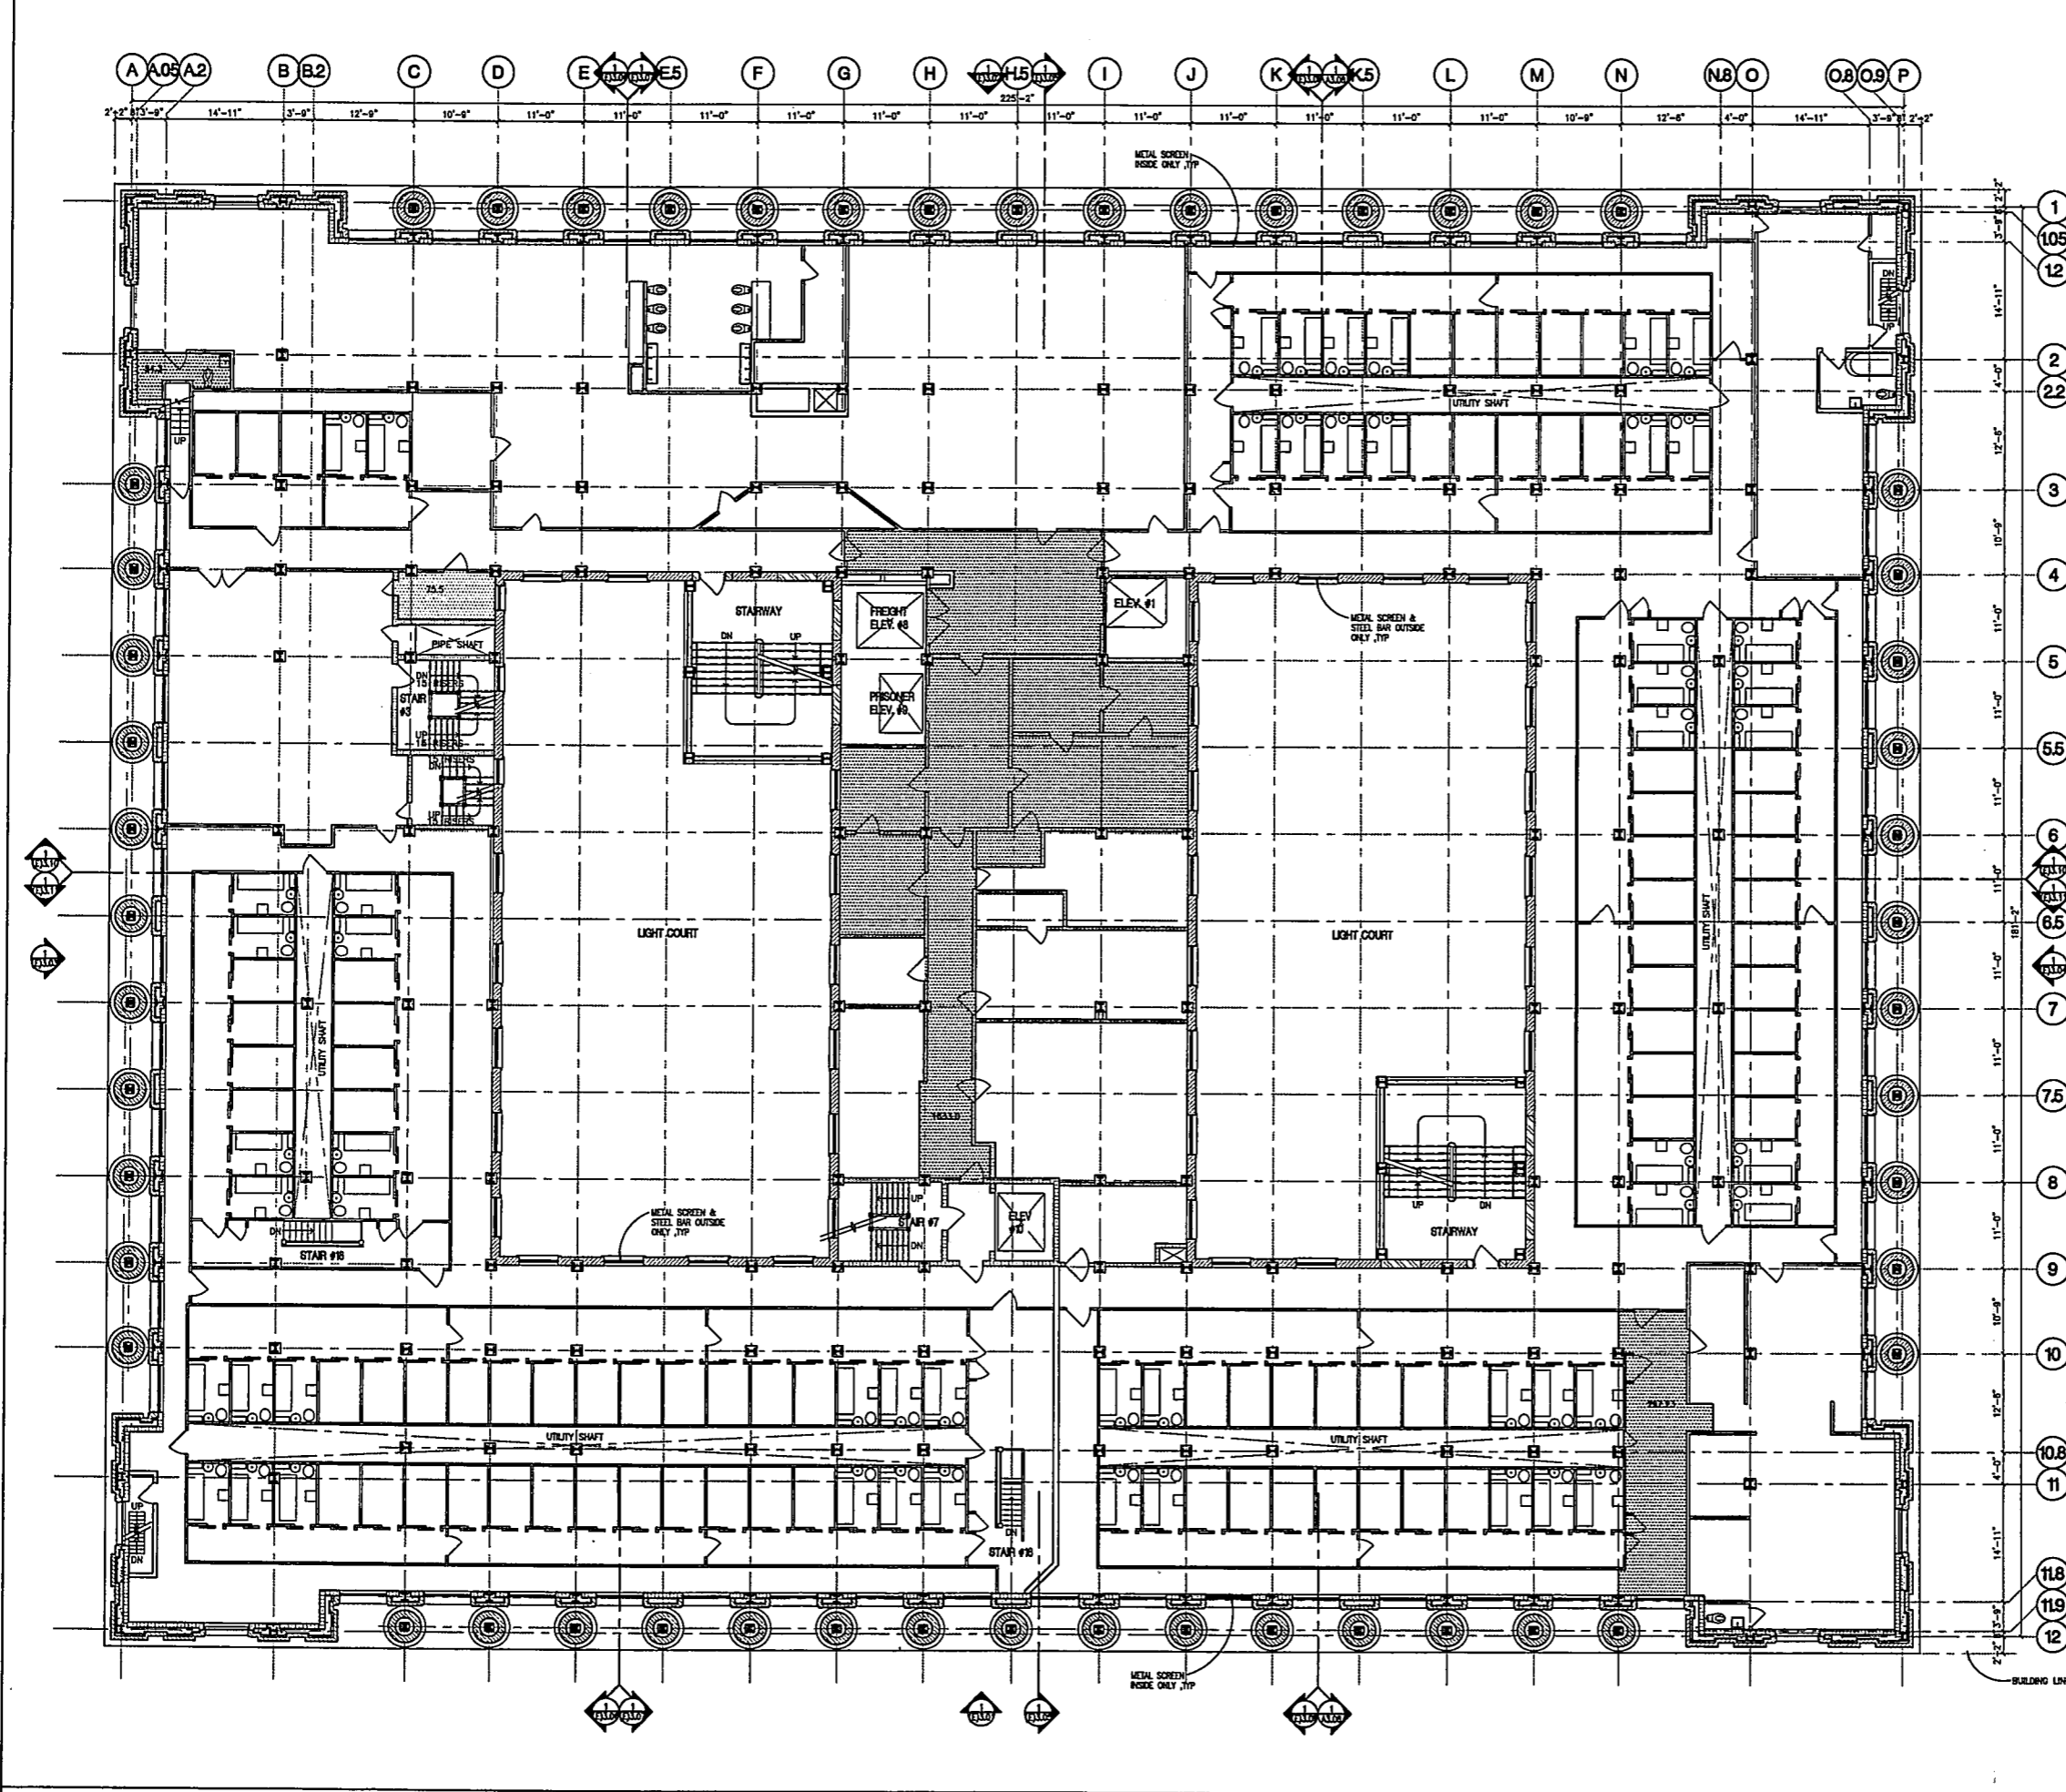
- 105 EXISTING EXTERIOR STONE, TERRAZZOTA / UNREINFORCED MASONRY WITH PLASTER FINISH
- 12 EXISTING CONCRETE WALL / COLUMN
- 2 EXISTING HOLLOW CLAY TILE PARTITION WITH FULL HEIGHT STONE
- 22 CONCRETE BLOCK WALL WITH PLASTER FINISH
- 3 PLASTER AND/OR CERAMIC TILE ON HOLLOW CLAY TILE (HCT) FLOORING OR PARTITION
- 4 HOLLOW CLAY TILE PARTITION WITH PLASTER AND STONE WANSICOT OR BASE
- 5 UNREINFORCED MASONRY WITH STONE WANSICOT OR BASE AND PLASTER FINISH ABOVE
- 6 PLASTER / GYPSUM BOARD ON METAL STUD PARTITION OR FLOORING
- 6.5 HOLLOW CLAY TILE / UNREINFORCED MASONRY / CONCRETE WITH NO FINISH
- 7 ASBESTOS-CONTAINING FLOORING MATERIALS

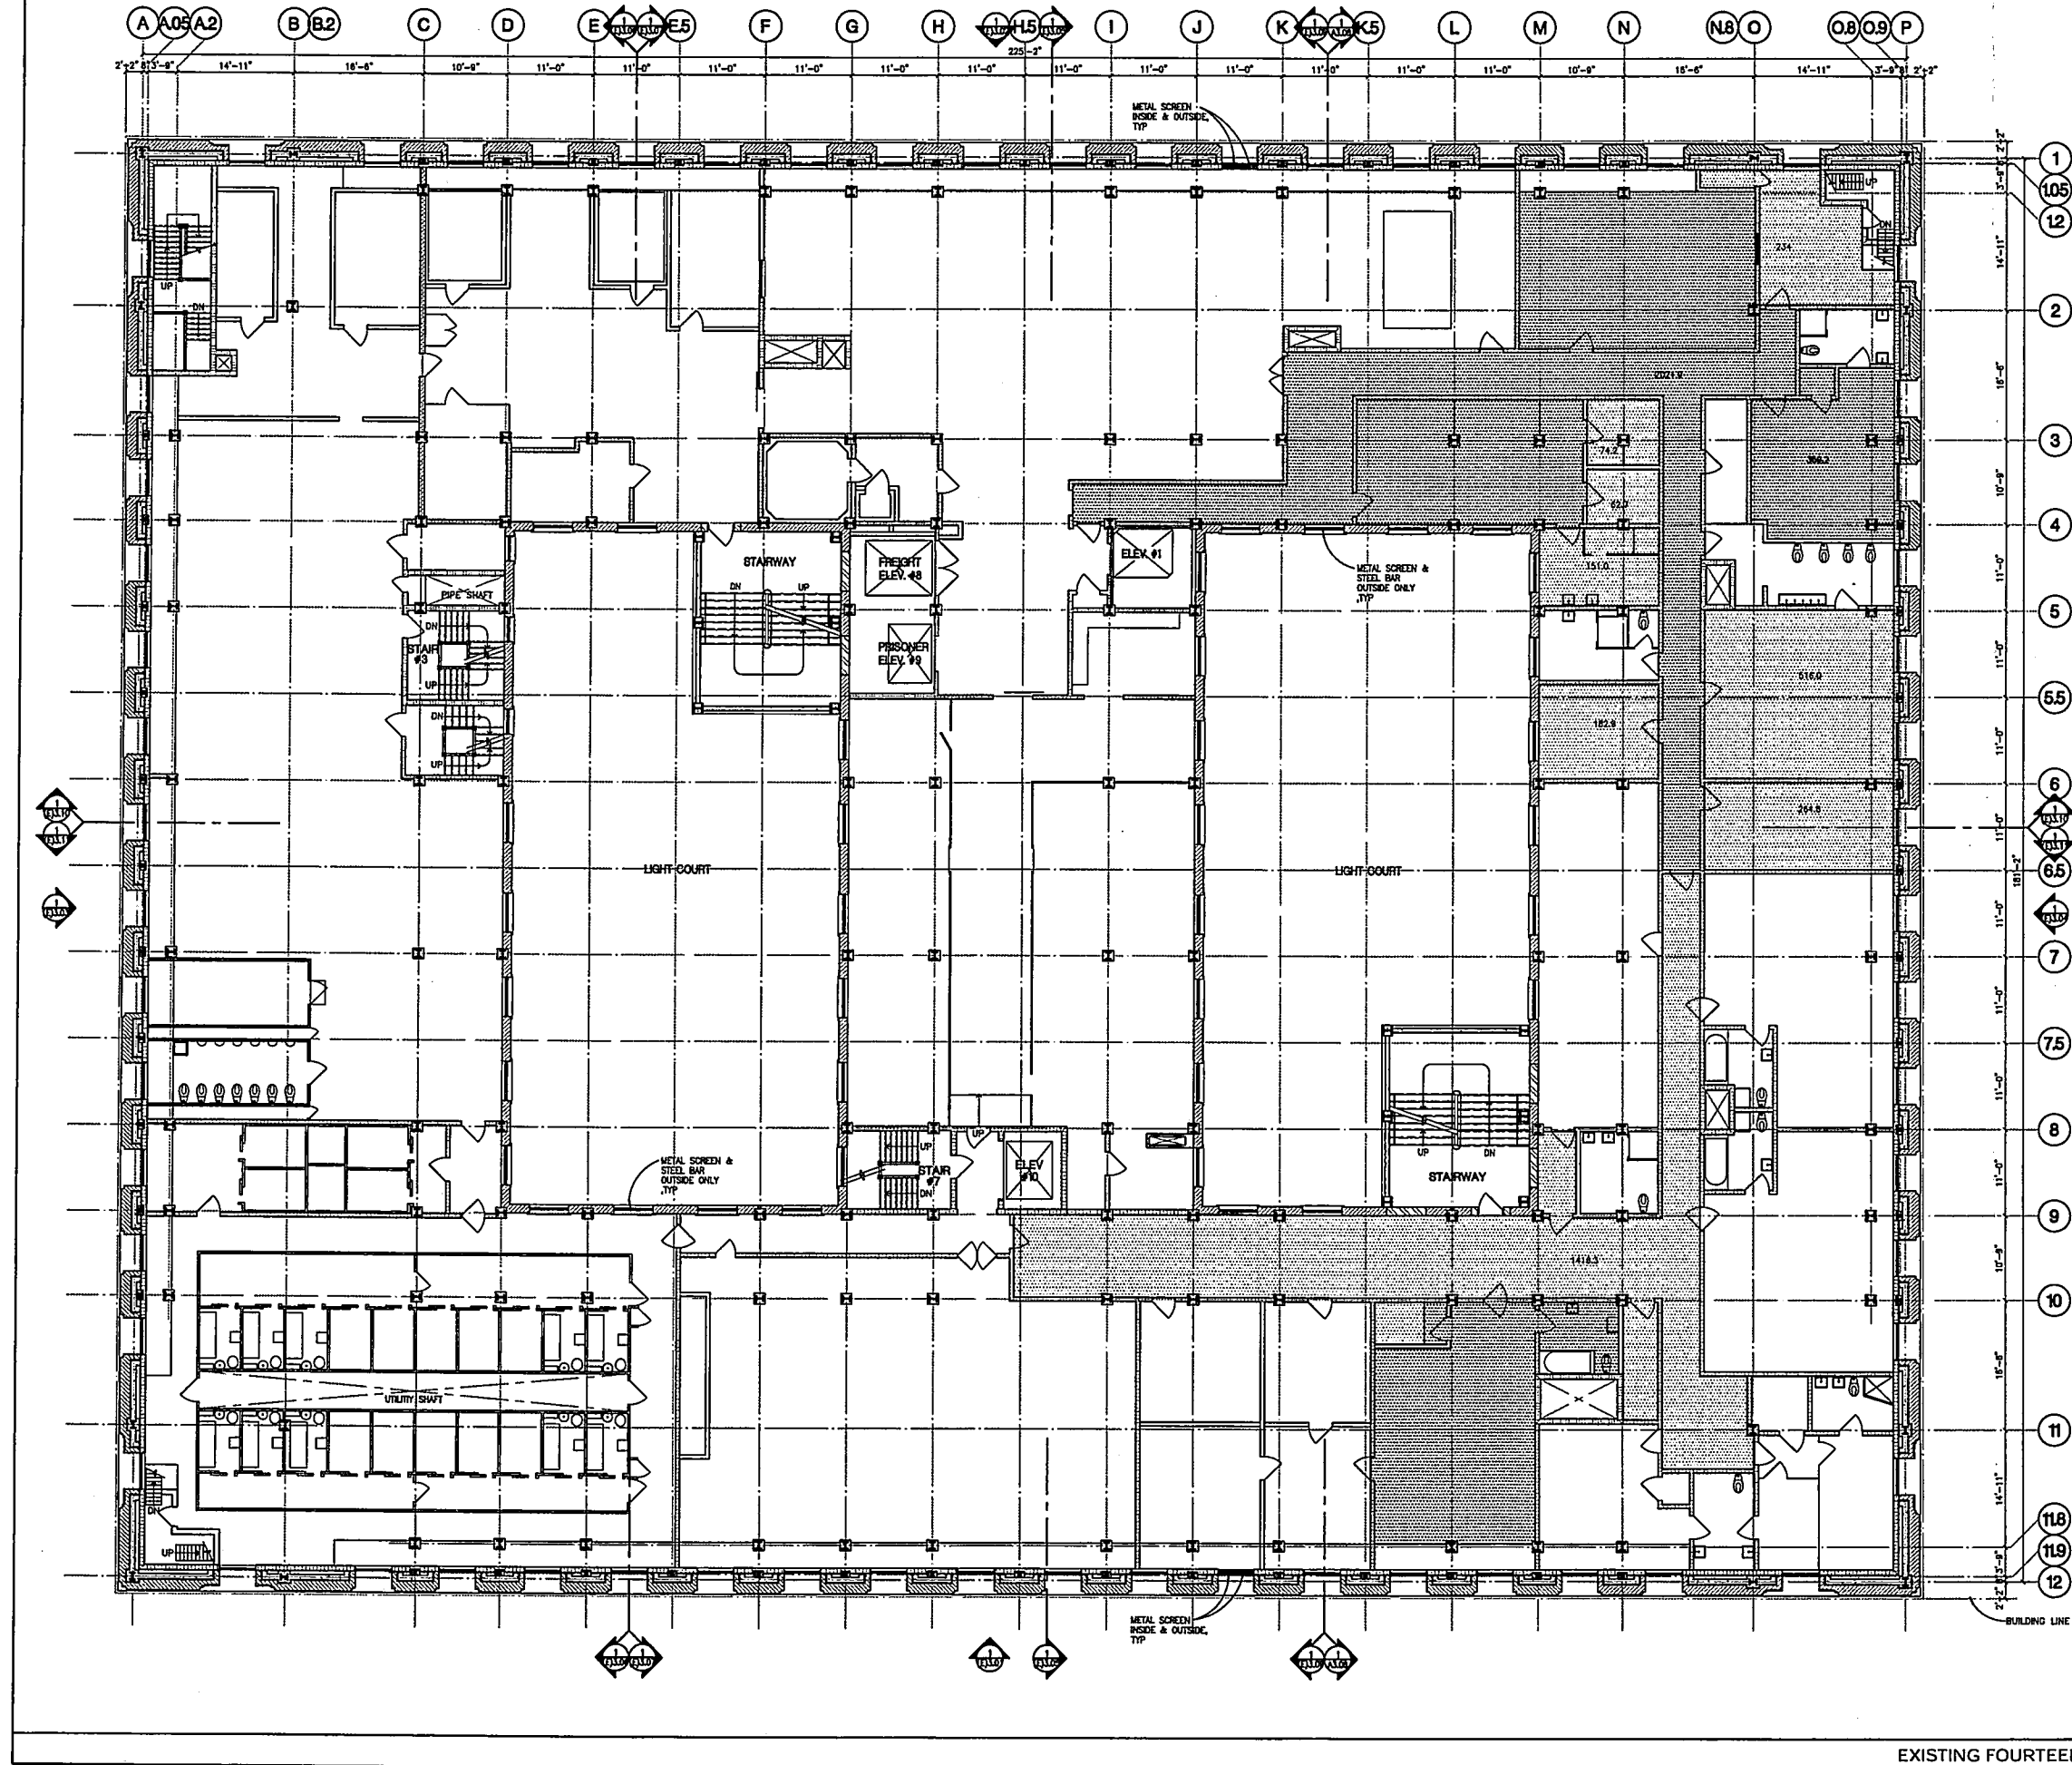
(E)A2.14

- NOTES / EXISTING WALL MATERIALS LEGEND
1. VERIFY ALL EXISTING MATERIALS, DIMENSIONS, FLOOR ELEVATIONS, AND BUILDING CONDITIONS.
- 1. EXISTING EXTERIOR STONE, TERRAZZOTA / UNREINFORCED MASONRY WITH PLASTER FINISH
 - 2. EXISTING CONCRETE WALL / COLIUM
 - 3. EXISTING HOLLOW CLAY TILE PARTITION WITH FULL HEIGHT STONE
 - 4. CONCRETE BLOCK WALL WITH PLASTER FINISH
 - 5. PLASTER AND/OR CERAMIC TILE ON HOLLOW CLAY TILE (4CT) FURRING OR PARTITION
 - 6. HOLLOW CLAY TILE PARTITION WITH PLASTER AND STONE WANSICOT OR BASE
 - 7. UNREINFORCED MASONRY WITH STONE WANSICOT OR BASE AND PLASTER FINISH ABOVE
 - 8. PLASTER / GYPSUM BOARD ON METAL STUD PARTITION OR FURRING
 - 9. HOLLOW CLAY TILE / UNREINFORCED MASONRY / CONCRETE WITH NO FINISH
 - 10. ASBESTOS-CONTAINING FLOORING MATERIALS

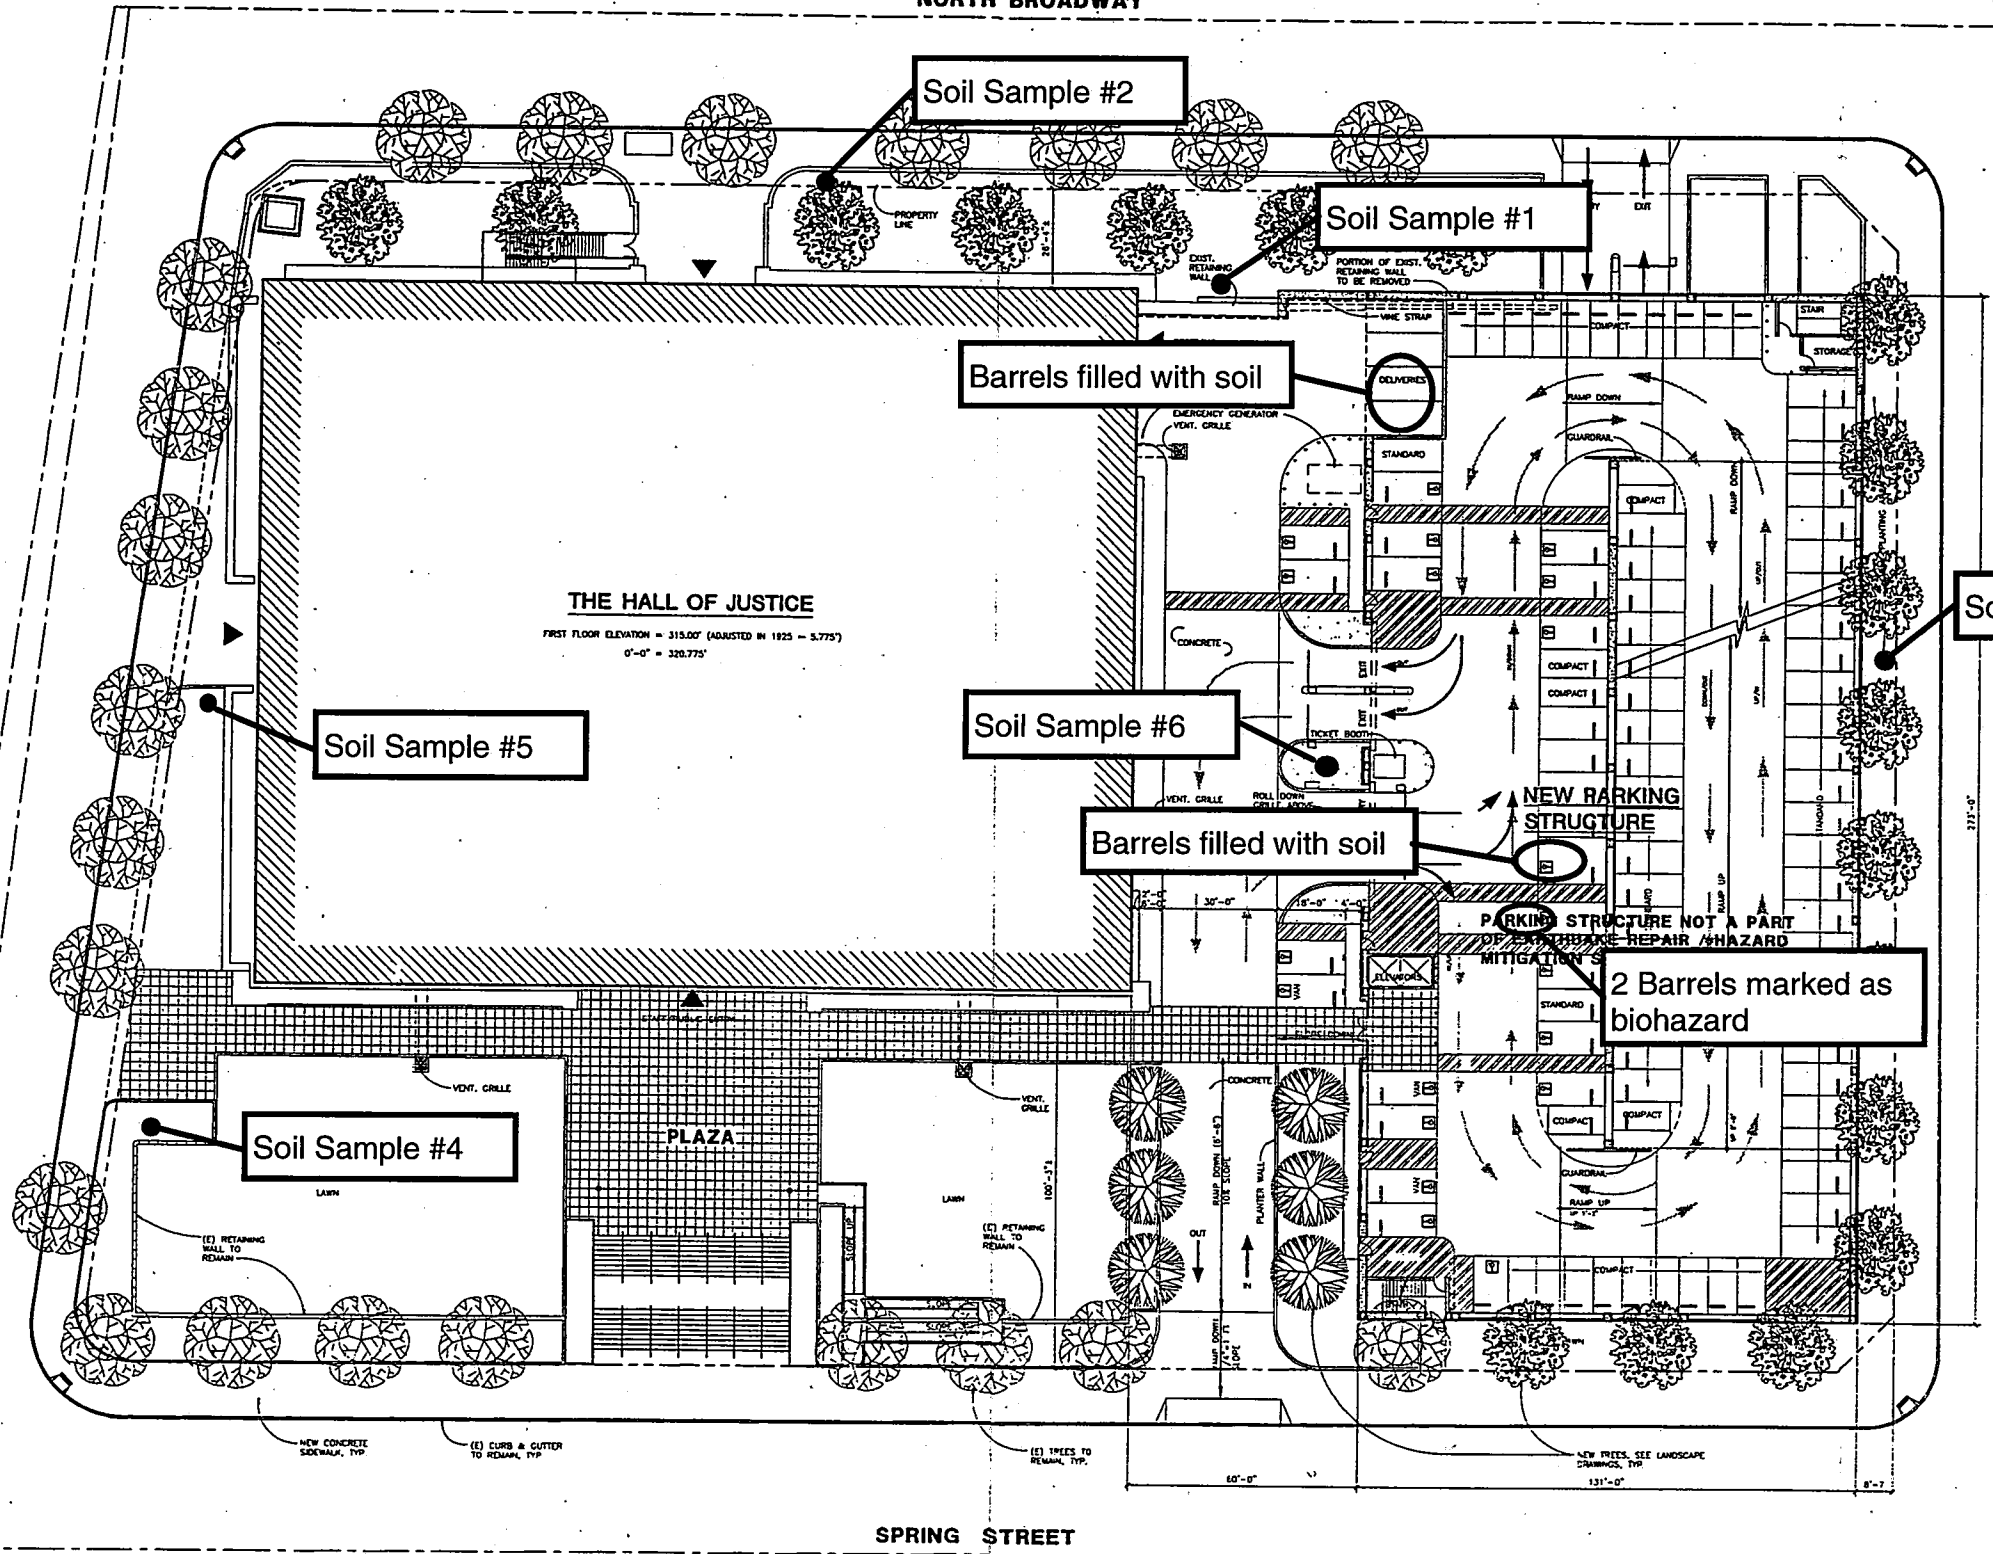
Soil Sample #4
