**Devils Creek at Kodiak,
Hydrology and Hydraulic Study,
HDR, March, 2014**

Devils Creek at Kodiak Airport

Hydrology and Hydraulic Study

FINAL REPORT

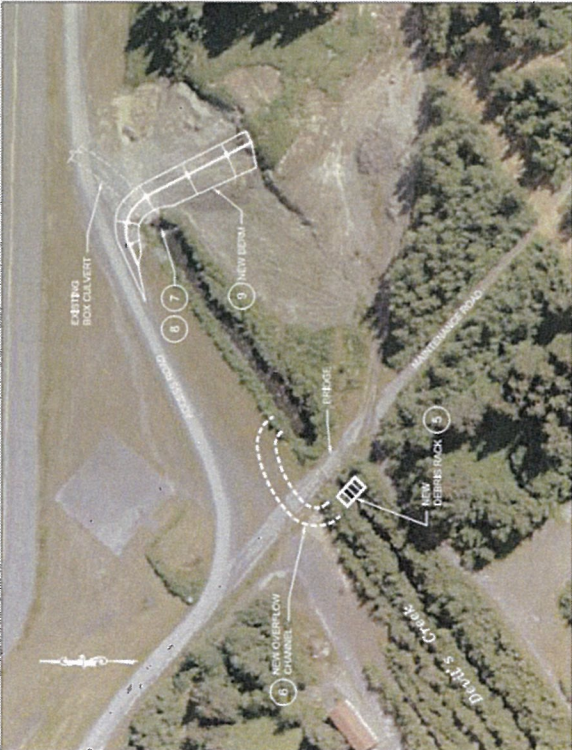
<p style="text-align: center;">PROPOSED IMPROVEMENTS DETAIL NOT TO SCALE</p>

The original 500 foot long portion of the east culvert has an 8" concrete encased pressure sewer line along its bottom on its east (right side). The dimensions of this concrete encasement are approximately 2-foot-wide x 1.5-foot-tall. The protrusion of this concrete into the culvert may be causing a slight backwater, potentially causing deposition in the upstream section of the culvert. Relocation of this sewer would provide a consistent culvert section but would require open cut replacement of approximately 500 feet of pressure sewer line; a portion of this across the primary runway. From a culvert hydraulics perspective, removal of this sewer is not justified. However, since the bottom of the box culvert is to be resurfaced and this pipe is over 39 years old (it is shown as existing on a 1974 Apron and Taxiway Plan), DOT&PF may want to evaluate the replacement of this pipe along with the structural rehabilitation of the culvert.

Bob Butera, P.E. of HDR Alaska, Inc. completed a reconnaissance of the project on October 19, 2012. Ray Gamradt, also of HDR Alaska, Inc., performed a previous structural reconnaissance on August 27, 2012. Photographs taken during the site reconnaissance are included in Appendix A. The structural reconnaissance is documented in a separate report and recommends resurfacing of the eroded invert of the twin box concrete culvert.
