GEO TECHNICAL INVESTIGATION

**MOXY HOTEL
835 SIXTH AVENUE
SAN DIEGO, CALIFORNIA**

GEOCON
INCORPORATED

**JUNE 26, 2015
PROJECT NO. G1863-52-01**

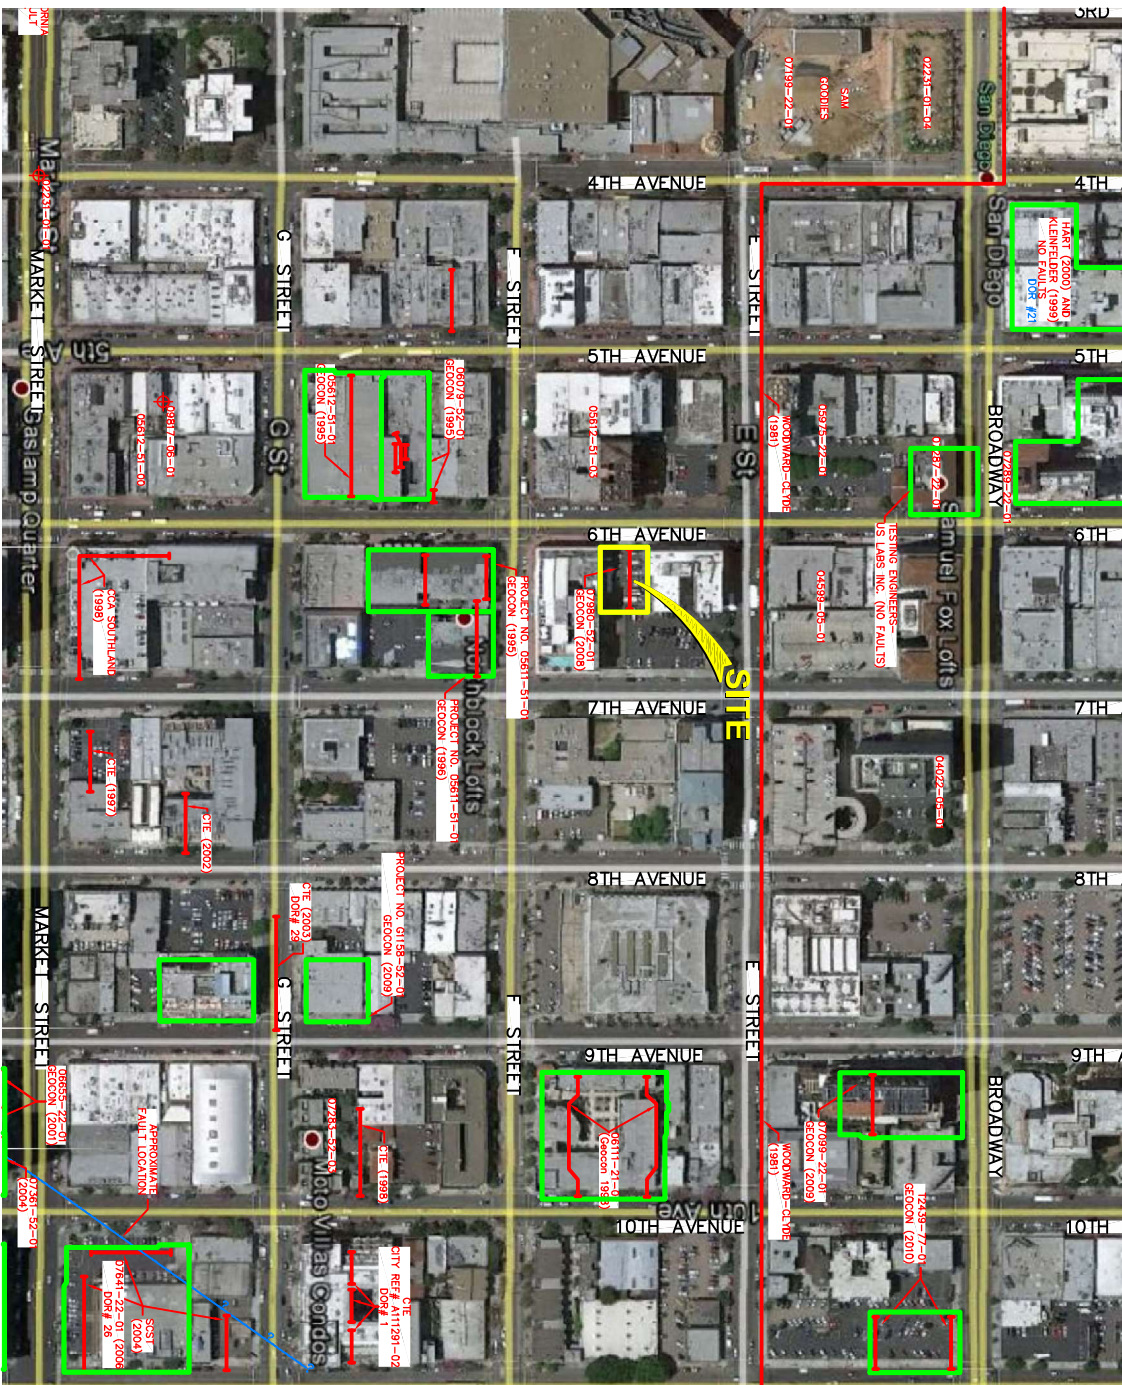
- GEOCON LEGEND**
- APPROX. LOCATION OF FAULT TRENCH, COMPANY THAT PERFORMED THE TRENCH (Year Reported)
 - APPROX. LOCATION OF PREVIOUS PROJECT BOUNDARY
 - APPROX. LOCATION OF ENCOUNTERED FAULT (Quoted Where Uncertain)

FAULT LOCATION MAP DATE 06-26-2015

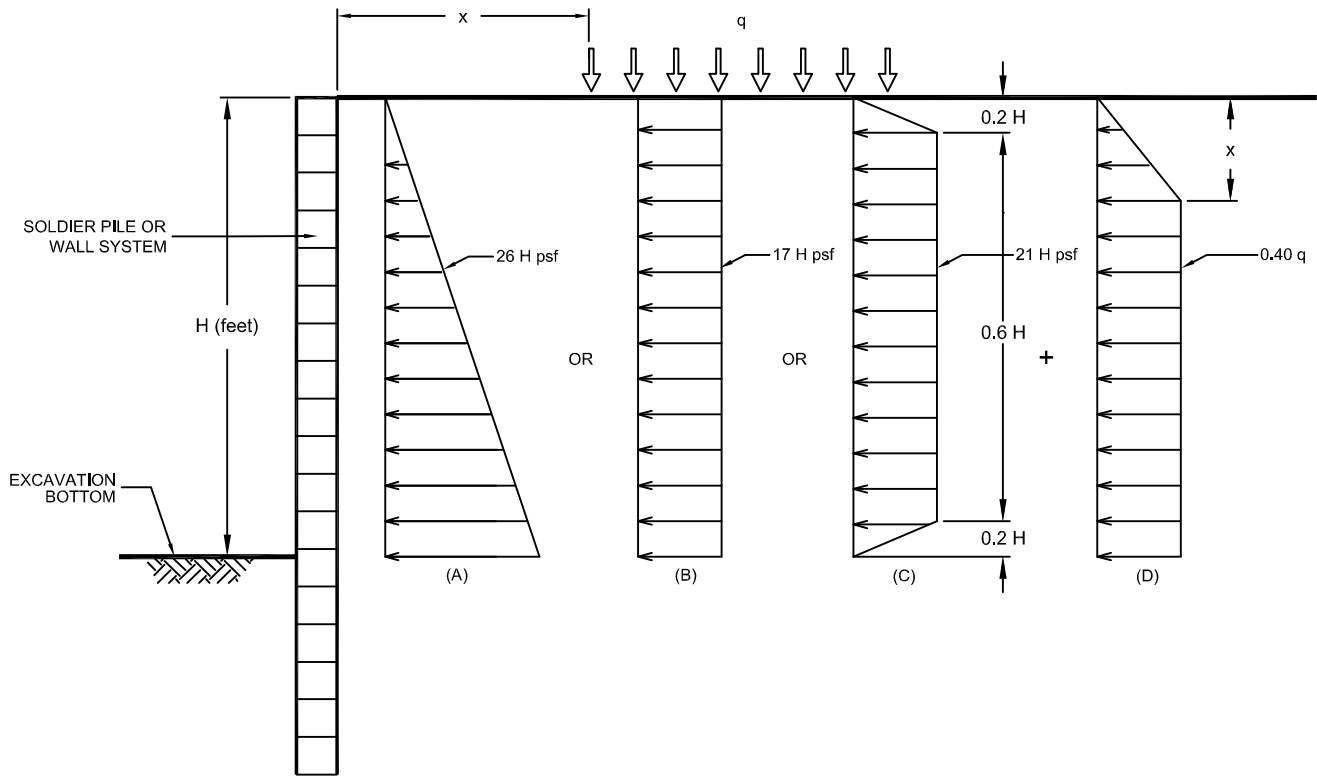
FIG.6

- (A).....TRIANGULAR DISTRIBUTION - CANTILEVERED SHORING
- (B).....RECTANGULAR DISTRIBUTION - MULTI-BRACED SHORING
- (C).....TRAPEZOIDAL DISTRIBUTION - MULTI BRACED SHORING

- 8.5.5 Temporary shoring with a level backfill should be designed using a lateral pressure envelope acting on the back of the shoring and applying a pressure equal to $26H$, $17H$, or $21H$, for a triangular, rectangular, or trapezoidal distribution, respectively, where H is the height of the shoring in feet (resulting pressure in pounds per square foot) as shown in Figure 6. These values are based on a retaining wall height of 25 feet and we should be contacted if higher retaining wall are planned. Triangular distribution should be used for cantilevered shoring and, the trapezoidal and rectangular distribution should be used for multi-braced systems such as tieback anchors and rakers. The project shoring engineer should determine the applicable soil distribution for the design of the temporary shoring system. Additional lateral earth pressure due to the surcharging effects of adjacent structures or traffic loads should be considered, where appropriate, during design of the shoring system.

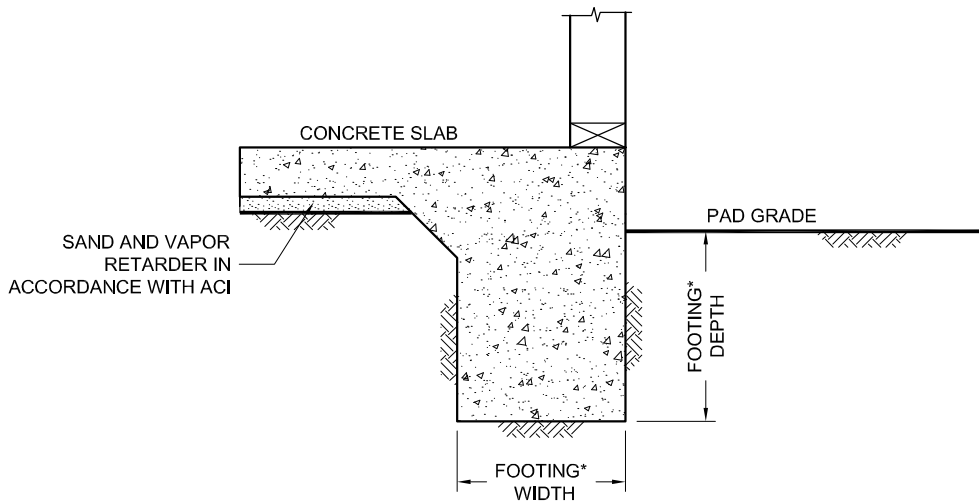
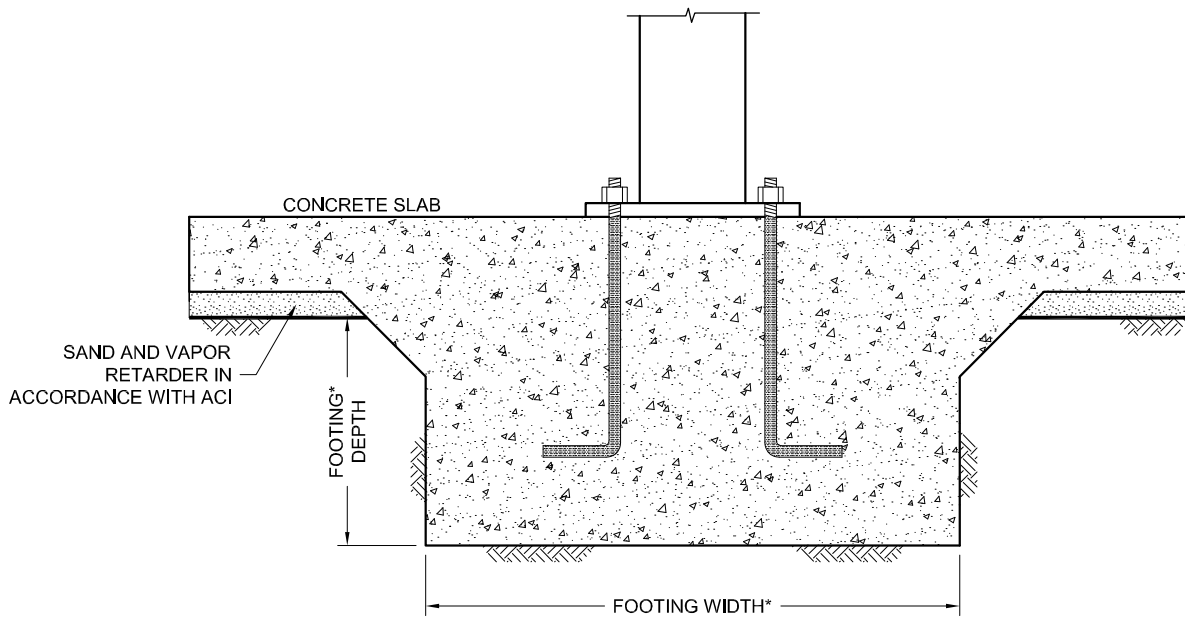
FIG. 9

*...SEE REPORT FOR FOUNDATION WIDTH AND DEPTH RECOMMENDATION

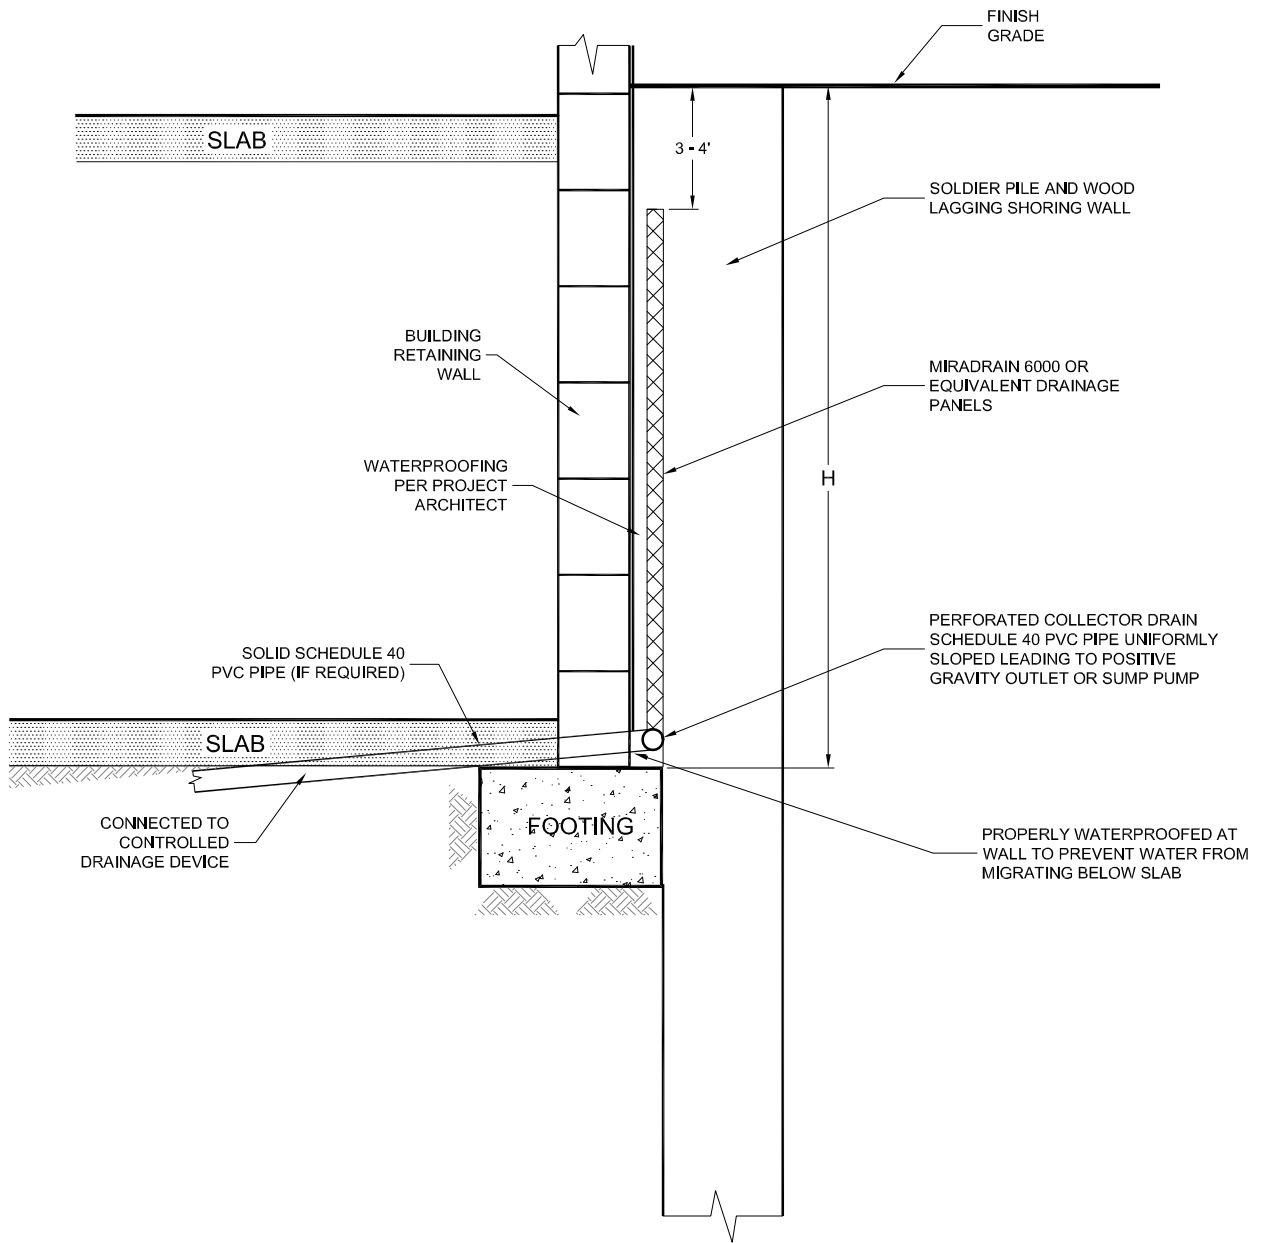
FIG. 10

SOLDIER PILE WALL DRAINAGE DETAIL

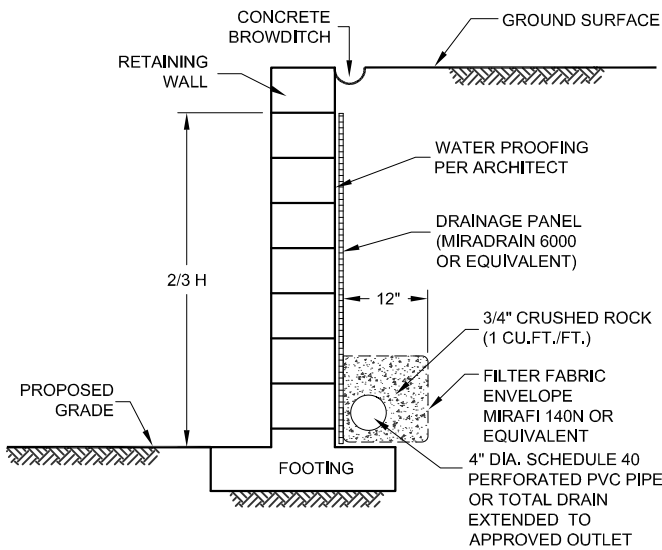
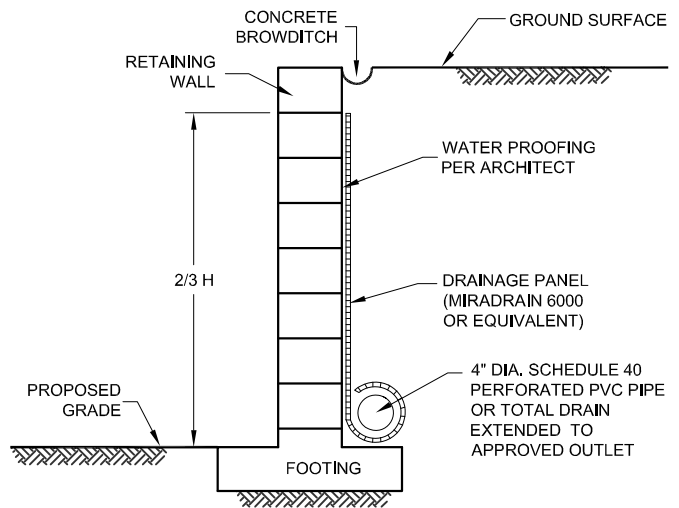
DRAIN SHOULD BE UNIFORMLY SLOPED TO GRAVITY OUTLET
OR TO A SUMP WHERE WATER CAN BE REMOVED BY PUMPING

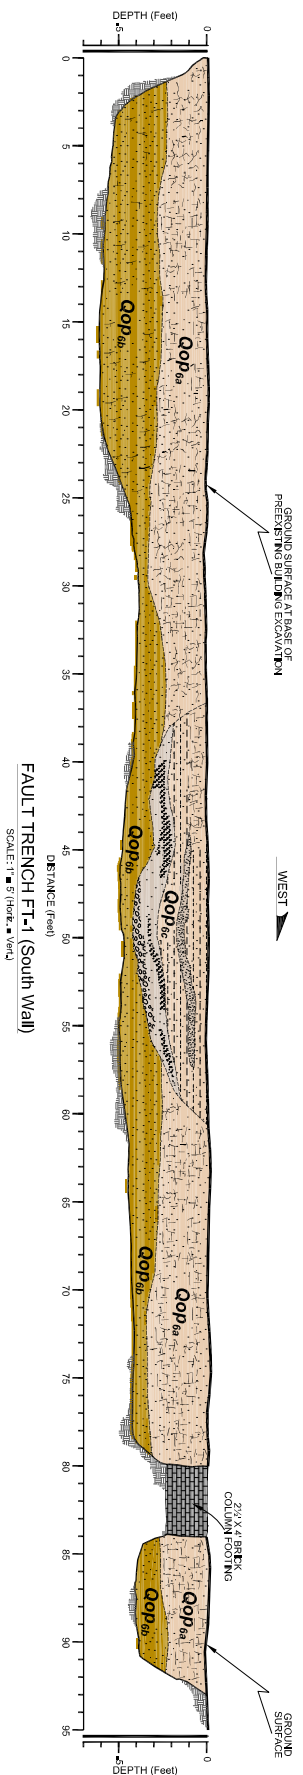
FAULT TRENCH FT-1 (South Wall)
SCALE: 1" = 5' (Horizontal) 1" = 1' (Vertical)

We logged the trench walls at a scale of 1 inch equals 5 feet (1" = 5'). Stationing along the trench surfaces was established during logging for accurate location of features and for ease of description. Also, a horizontal string line was established within the trenches for use as an internal reference. The entire surface of the geologic units exposed along the north and south sides of each trench was cleaned and examined for indications of faulting. These indications could include offset units, contacts, or laminations, tectonically disturbed or deformed clay layers, clay gouge, fissures, or slickensides.

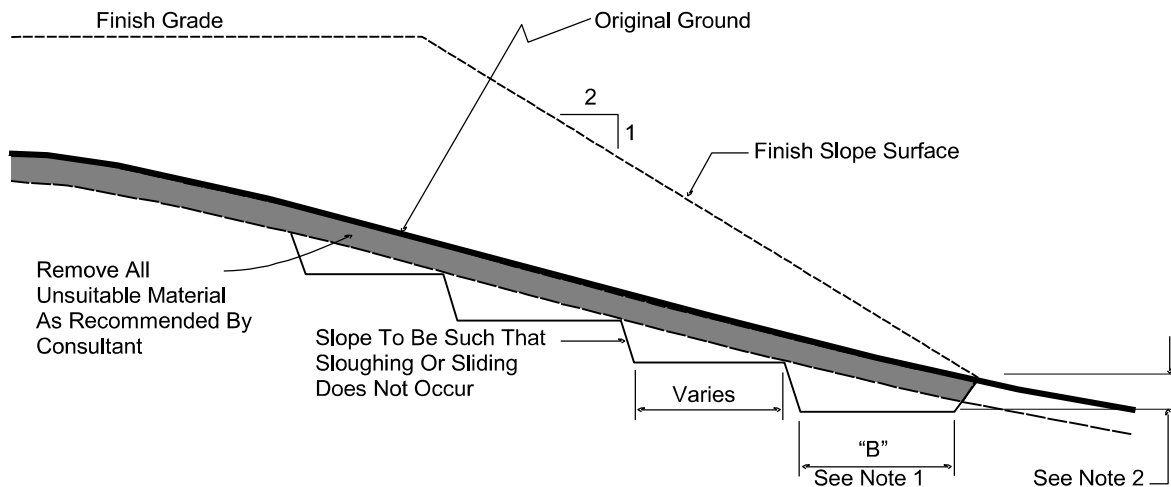
TYPICAL BENCHING DETAIL

- DETAIL NOTES:
- (1) Key width "B" should be a minimum of 10 feet, or sufficiently wide to permit complete coverage with the compaction equipment used. The base of the key should be graded horizontal, or inclined slightly into the natural slope.
 - (2) The outside of the key should be below the topsoil or unsuitable surficial material and at least 2 feet into dense formational material. Where hard rock is exposed in the bottom of the key, the depth and configuration of the key may be modified as approved by the Consultant.

- 4.4 Where the slope ratio of the original ground is steeper than 5:1 (horizontal:vertical), or where recommended by the Consultant, the original ground should be benched in accordance with the following illustration.
