## CULTURAL RESOURCES TECHNICAL REPORT

# Proposed Renovation of Hall of Justice Los Angeles, California

HISTORIC RESOURCES GROUP, LLC 1728 Whitley Avenue Los Angeles, CA 90028-4809

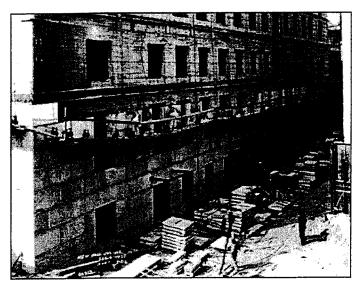
Figure 2: Installing the exterior granite veneer, 1925. (Los Angeles Public Library Photo Database)

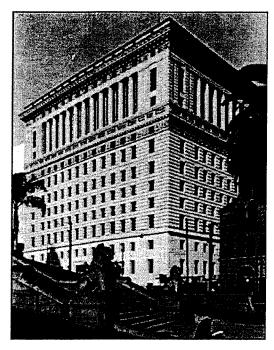
Figure 6: The Hall of Justice in 1934. The tripartite division of the each façade is a distinct visual characteristic of the building. (Los Angeles Public Library Photo Database)

Perhaps the most notable of these characteristics in the Hall of Justice is the tripartite division of each façade. This division suggests the three parts of a classical column—base, shaft, and capital. The first three floors of the Hall of Justice, distinguished by granite veneer stacked as rectangular blocks, form a visual base. The fourth through ninth floors, with an exterior of cut granite, act as the building's shaft. The uppermost floors, ten through fourteen, and the roof line serve as an ornamental capital. This symmetrical division of facades creates a distinct sense of unity and massiveness that defines the building's presence.

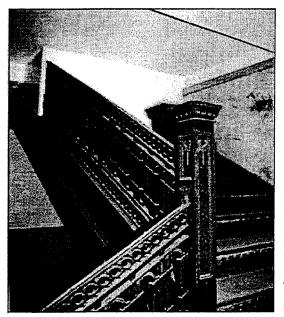
Figure 9: Original staircase. (Historic Resources Group, 2001)

The means of circulation, namely the stairways and elevators, are also character-defining features of the building's interior. The main stairways are located at the northwestern side of the south light court and at the northeastern side of the north light court. Significant characteristics of the original staircases include marble wainscots, iron treads and risers, decorative iron and hardwood railings, and decorative iron newel posts. The staircases in the detention areas have plain iron railings and posts. In addition to the stairways, circulation is provided by a central bank of elevators. The elevators run from the first floor up to the eighth floor and are accessed through a central elevator lobby. The configuration of the elevator lobby space is the same on floors one through eight, and these spaces retain such original material as marble walls and a plaster cornice. The elevator cabs retain the original Llewellen cast iron housing, hardwood interior paneling, and control hardware.

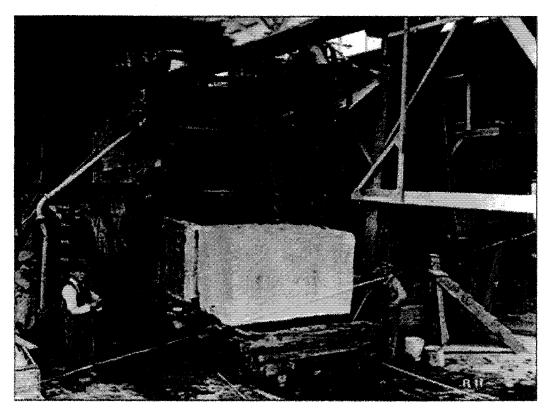
Photo 1: A large piece of granite from the Raymond Granite Company is prepared to be installed in the Hall of Justice. (Los Angeles Public Library Photo Database)

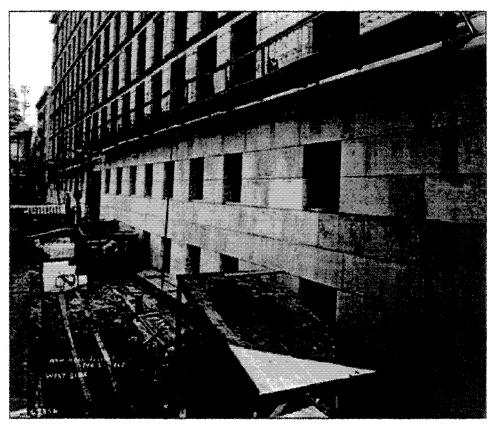
Photo 2: The Hall of Justice under construction, 1925. (Los Angeles Public Library Photo Database)

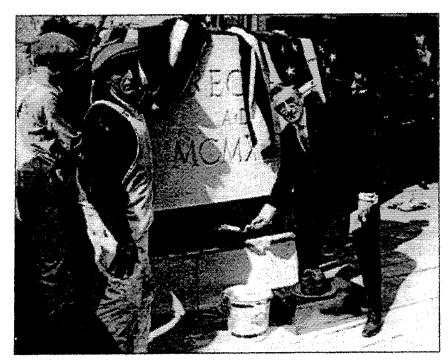
Photo 3: Securing the Hall of Justice cornerstone, 1925. (Los Angeles Public Library Photo Database)
