US Army Corps
of Engineers
Portland District

COLUMBIA RIVER MOUTH OF THE COLUMBIA RIVER JETTY A REHABILITATION

**COLUMBIA RIVER
 MCR JETTY A REHABILITATION**

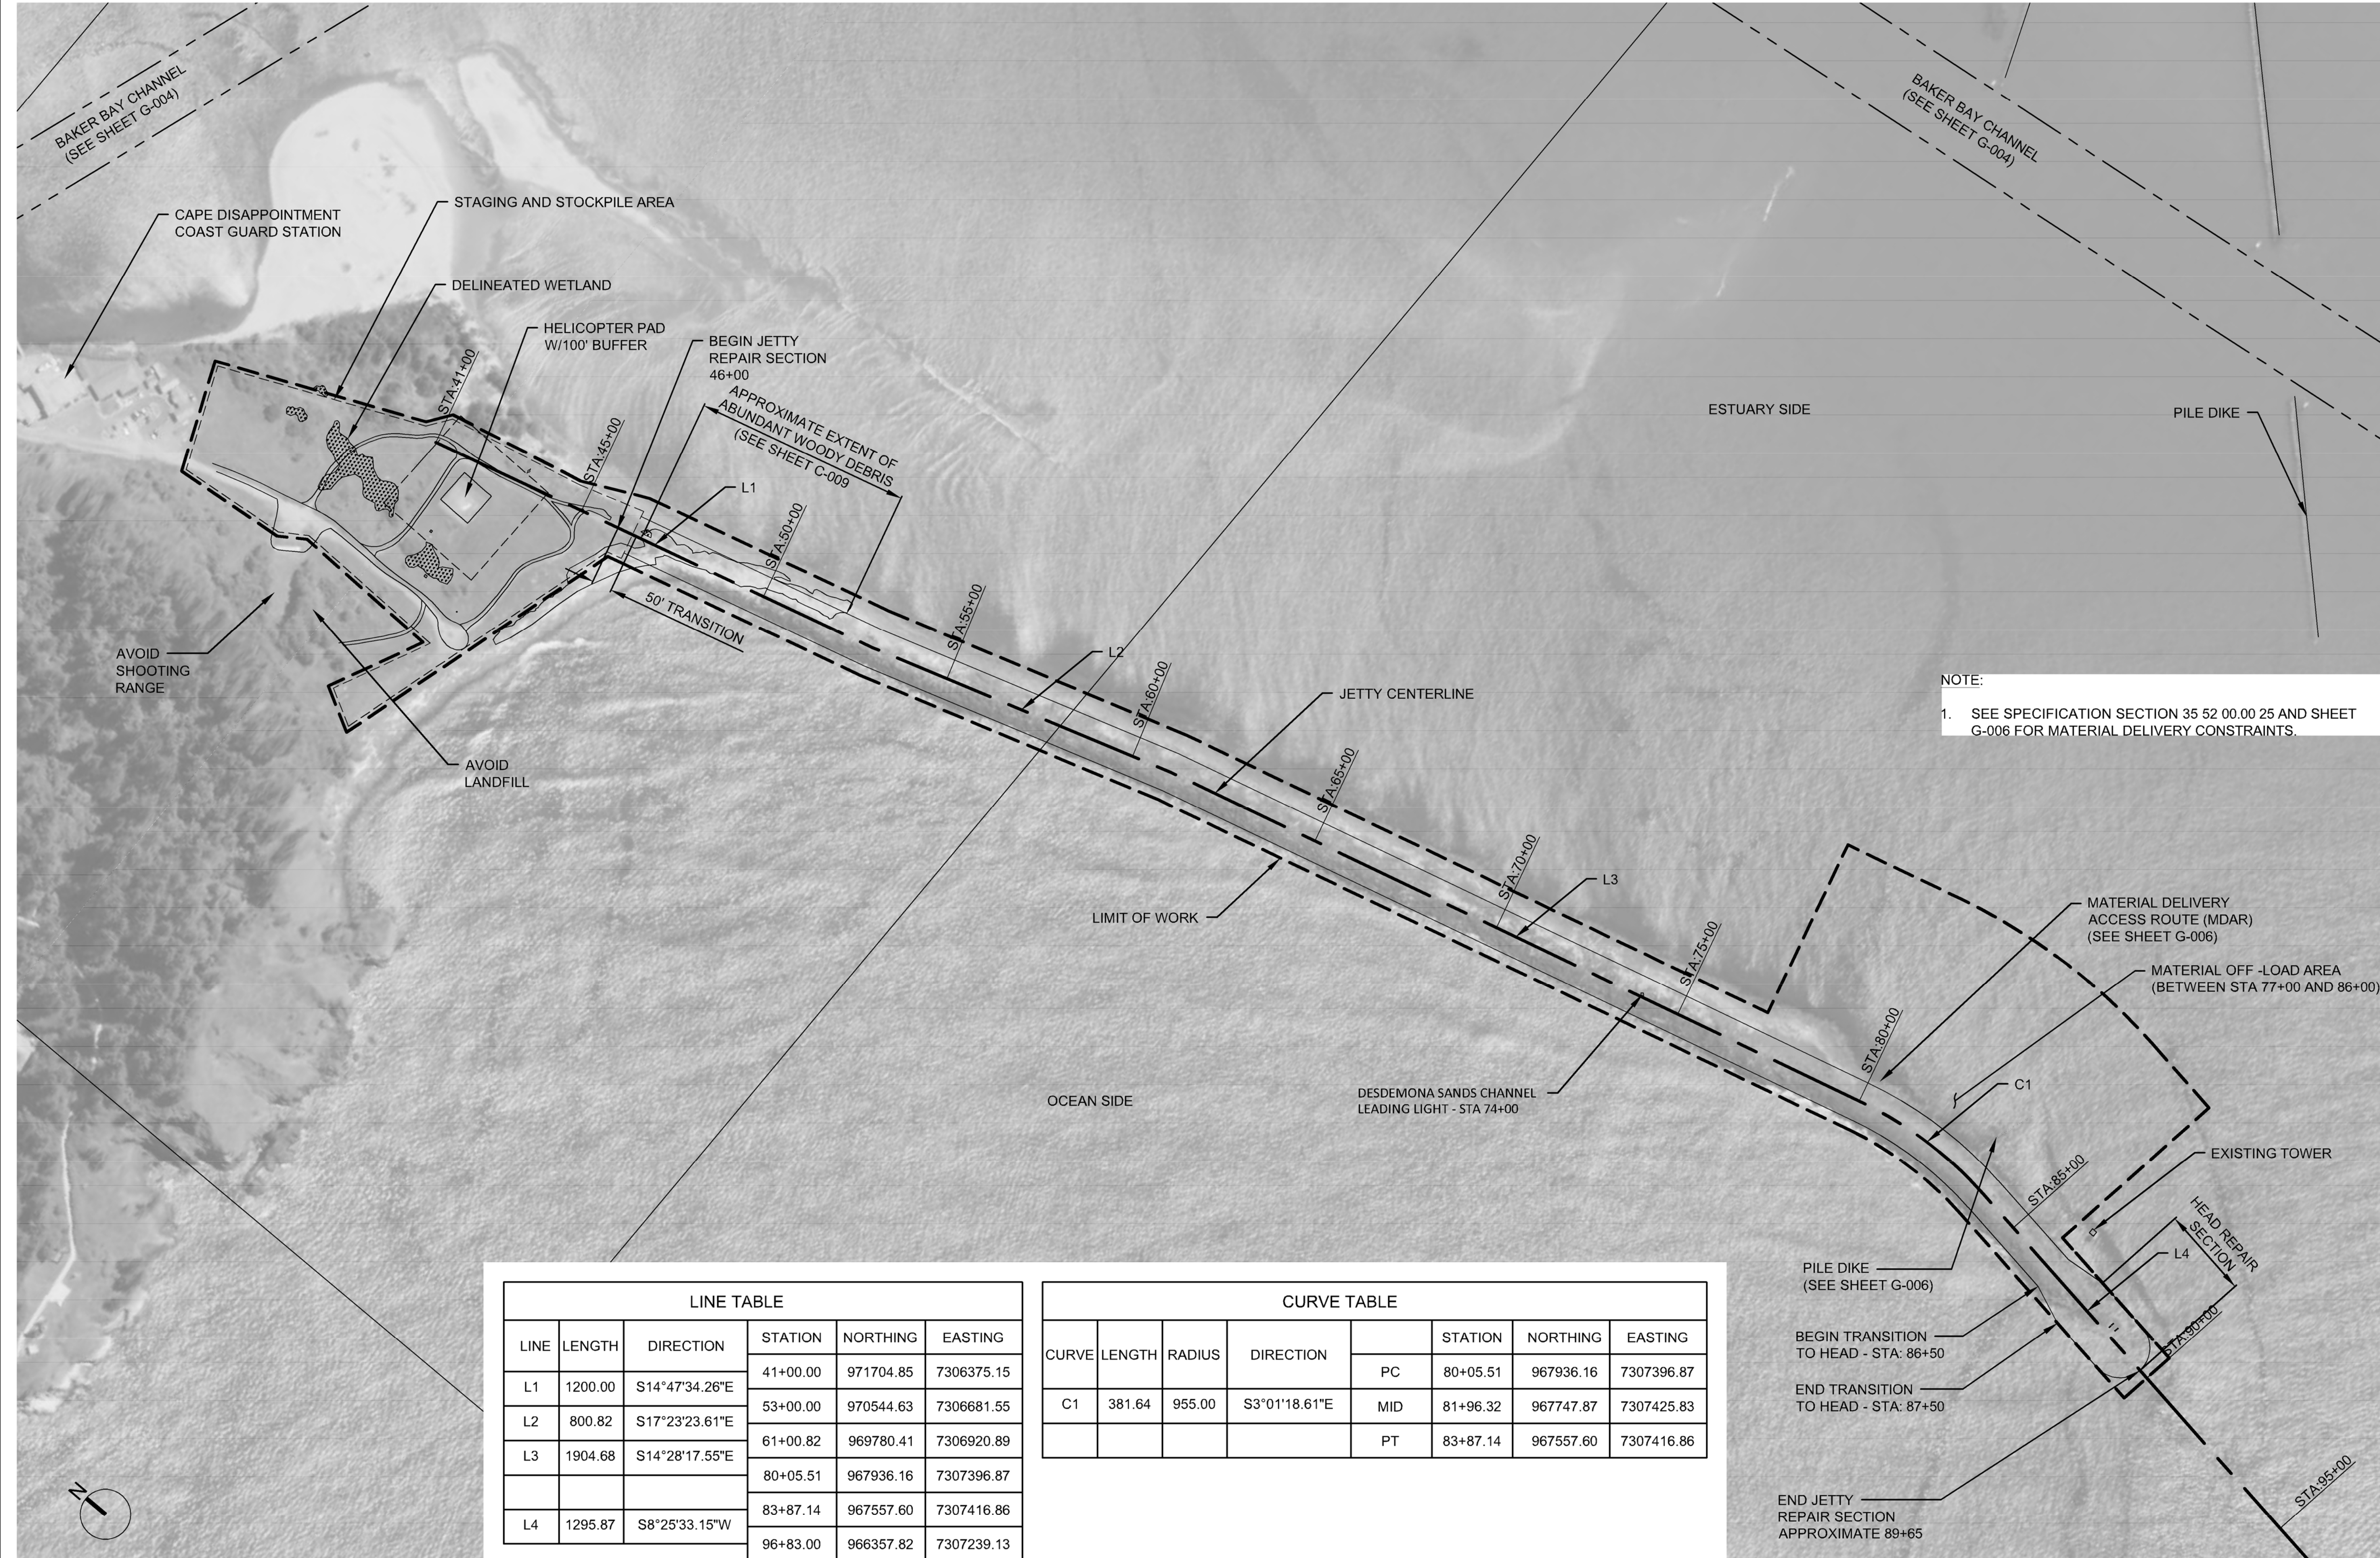
SITE PLAN
SCALE: 1" = 200'

LINE TABLE					
LINE	LENGTH	DIRECTION	STATION	NORTHING	EASTING
L1	1200.00	S14°47'34.26"E	41+00.00	971704.85	7306375.15
			53+00.00	970544.63	7306681.55
L2	800.82	S17°23'23.61"E	61+00.82	969780.41	7306920.89
			80+05.51	967936.16	7307396.87
L3	1904.68	S14°28'17.55"E	83+87.14	967557.60	7307416.86
			96+83.00	966357.82	7307239.13

CURVE TABLE							
CURVE	LENGTH	RADIUS	DIRECTION		STATION	NORTHING	EASTING
				PC	80+05.51	967936.16	7307396.87
C1	381.64	955.00	S3°01'18.61"E	MID	81+96.32	967747.87	7307425.83
				PT	83+87.14	967557.60	7307416.86

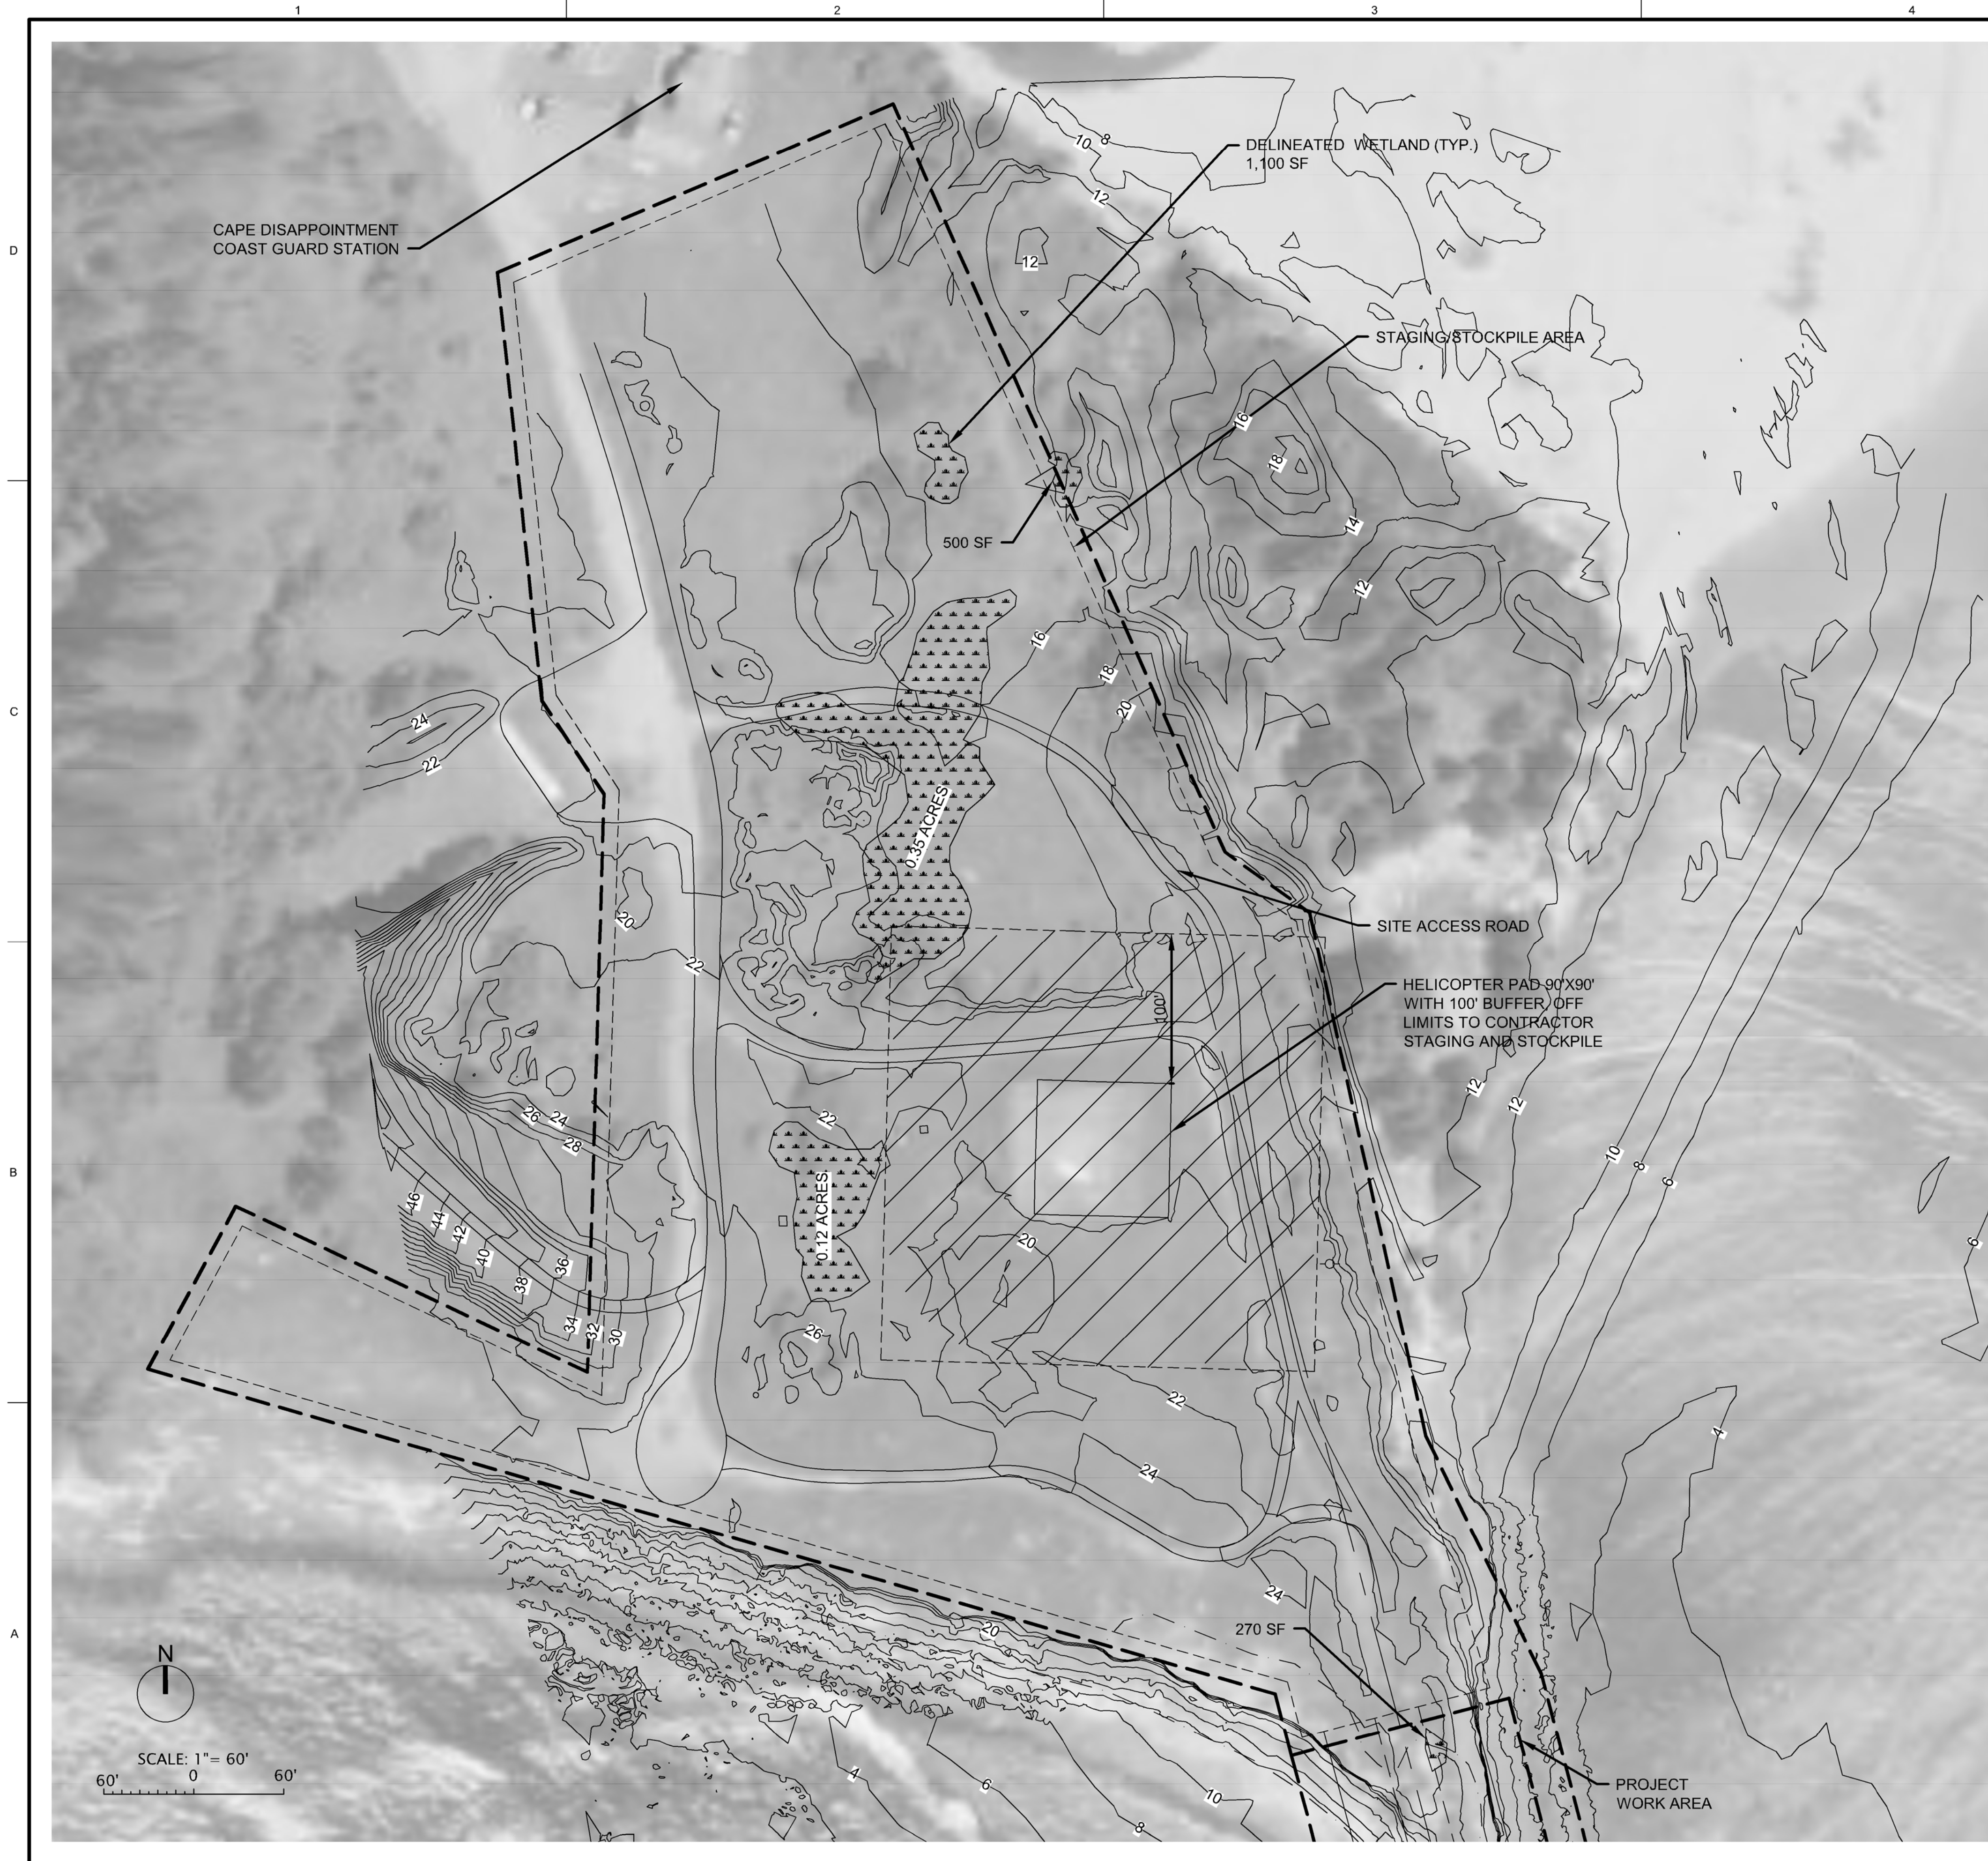
STAGING AND STOCKPILE AREA PLAN

- NOTE:
1. STAGING/STOCKPILE AREA IS APPROXIMATELY 7 ACRES.
 2. CONTOURS ARE 2' INTERVALS.
 3. VERTICAL DATUM: IS NAVD88
 4. DELINEATED WETLANDS SHOWN MAY BE FILLED AND MITIGATED.

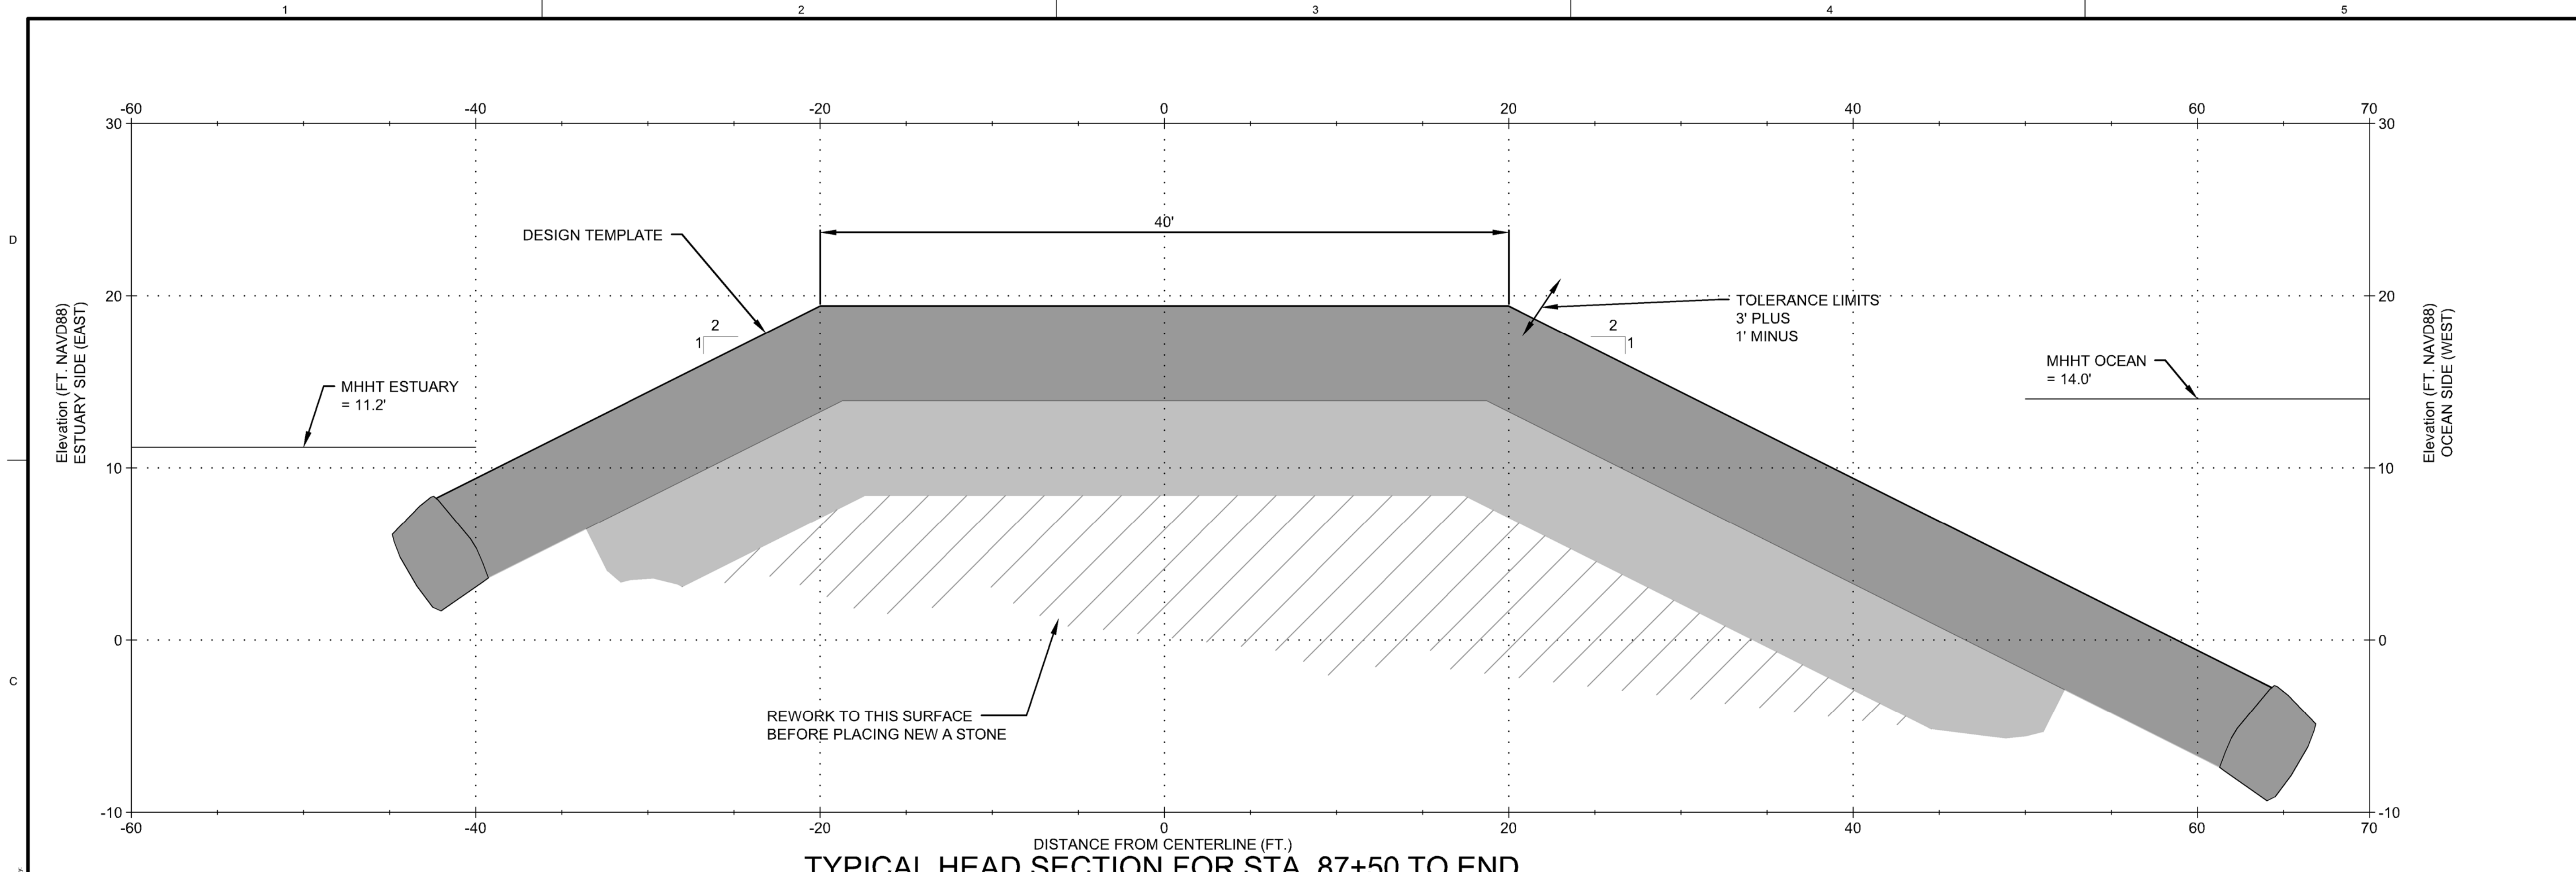
TYPICAL HEAD SECTION FOR STA. 87+50 TO END

- LEGEND**
- A-STONE
 - DESIGN TEMPLATE - WORK IS REQUIRED
 - DESIGN TEMPLATE - BELOW EXISTING GRADE
NO WORK IS REQUIRED
 - TOE STONE
 - A-STONE OR RELICT STONE
 - A-SELECT STONE

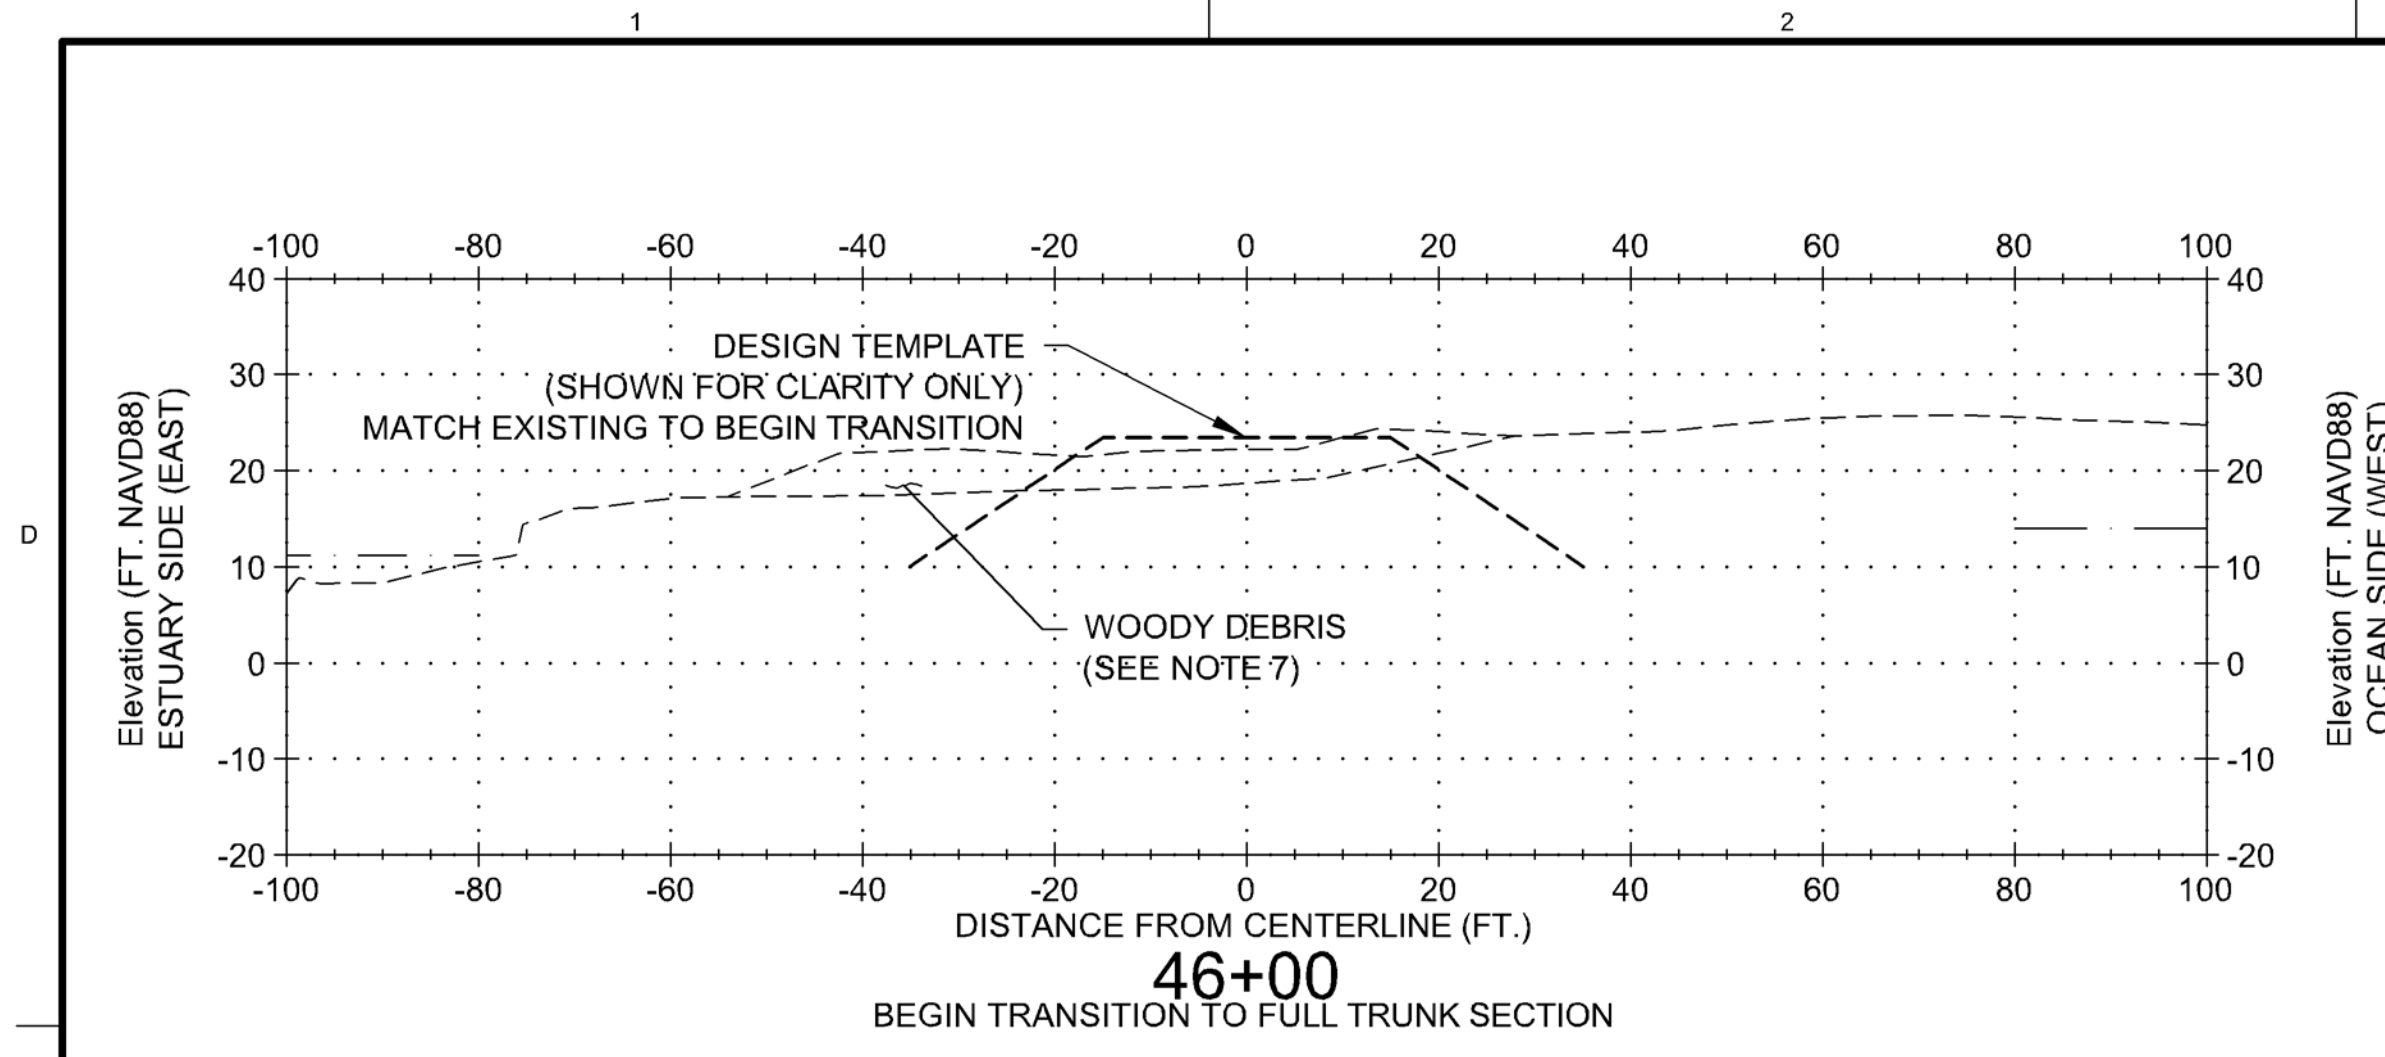
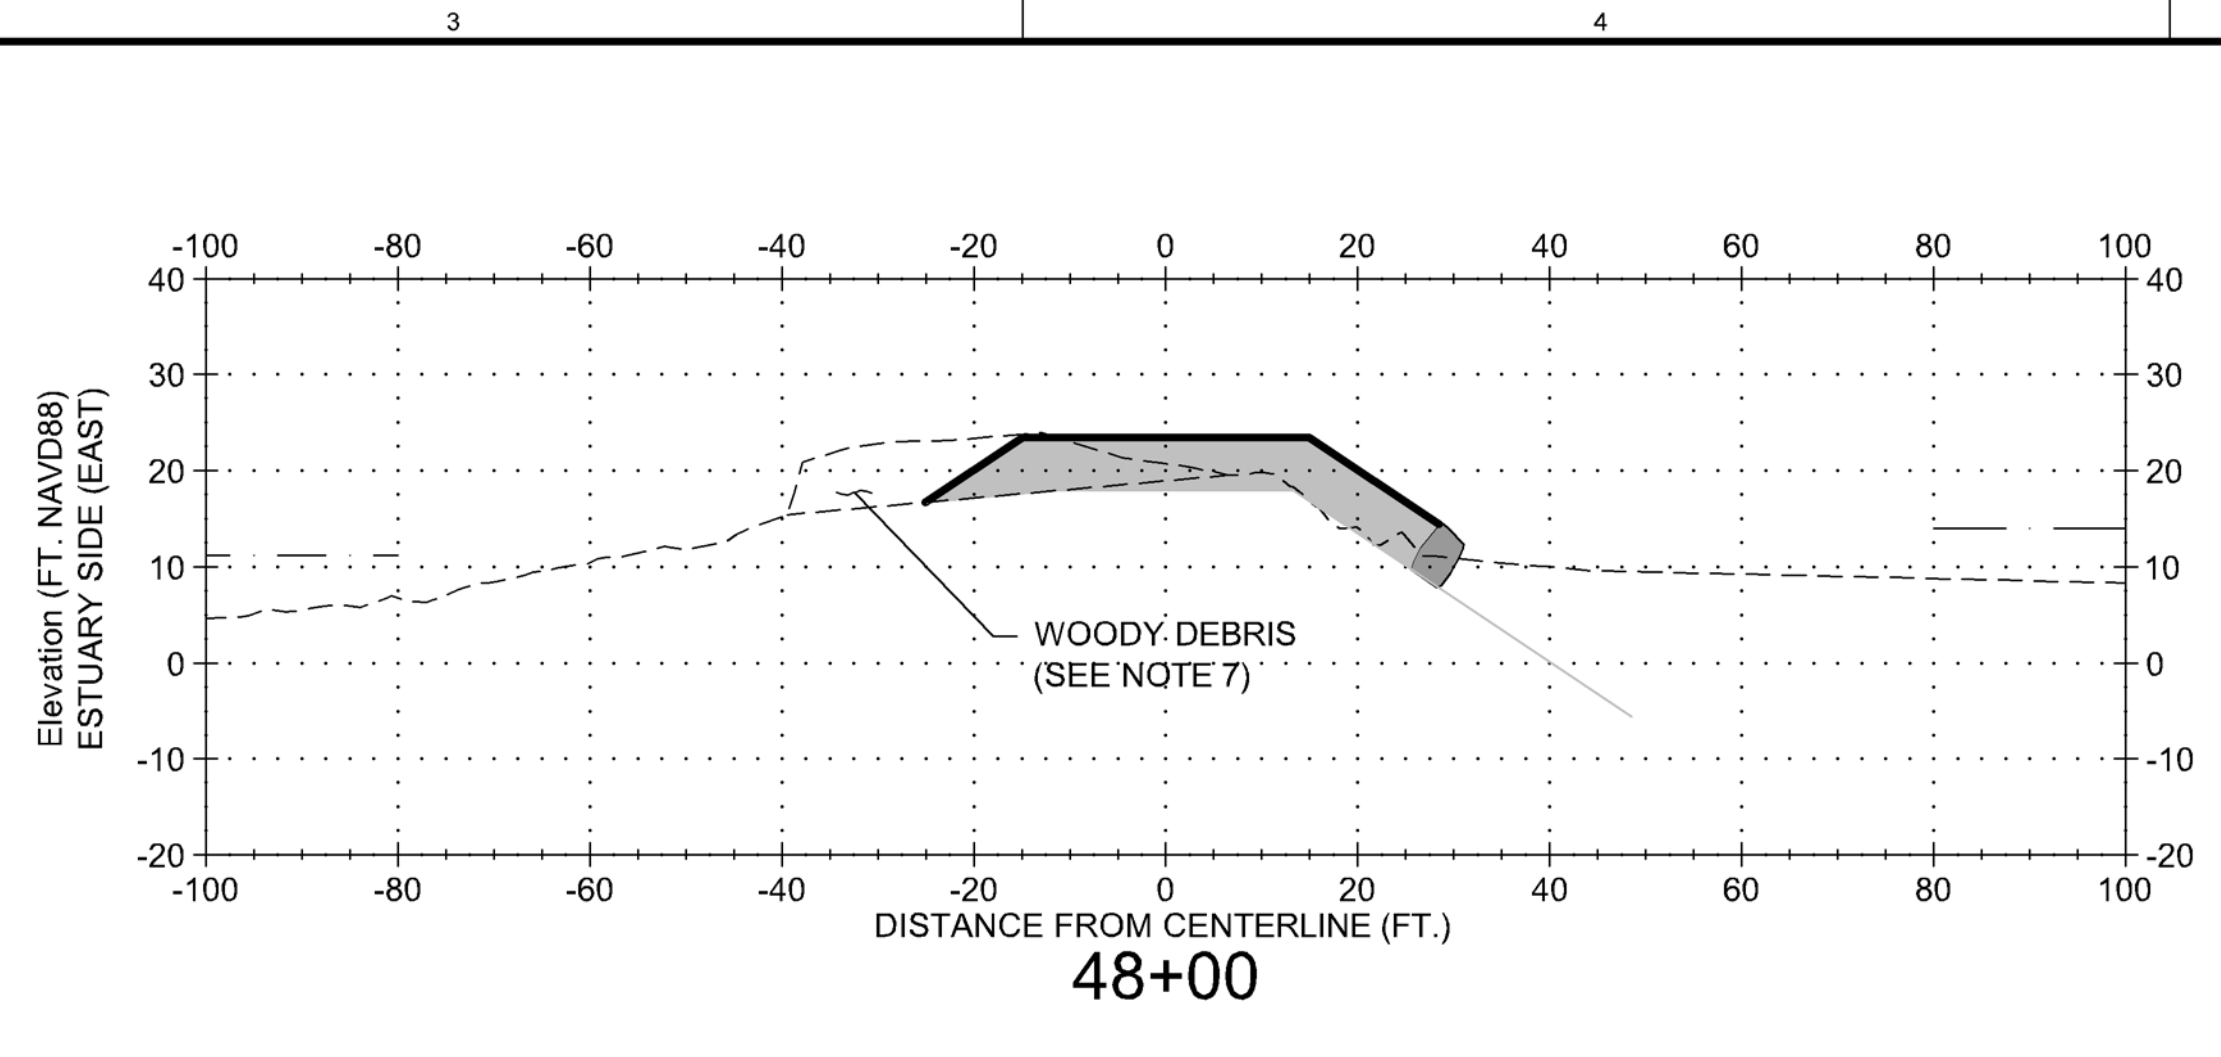
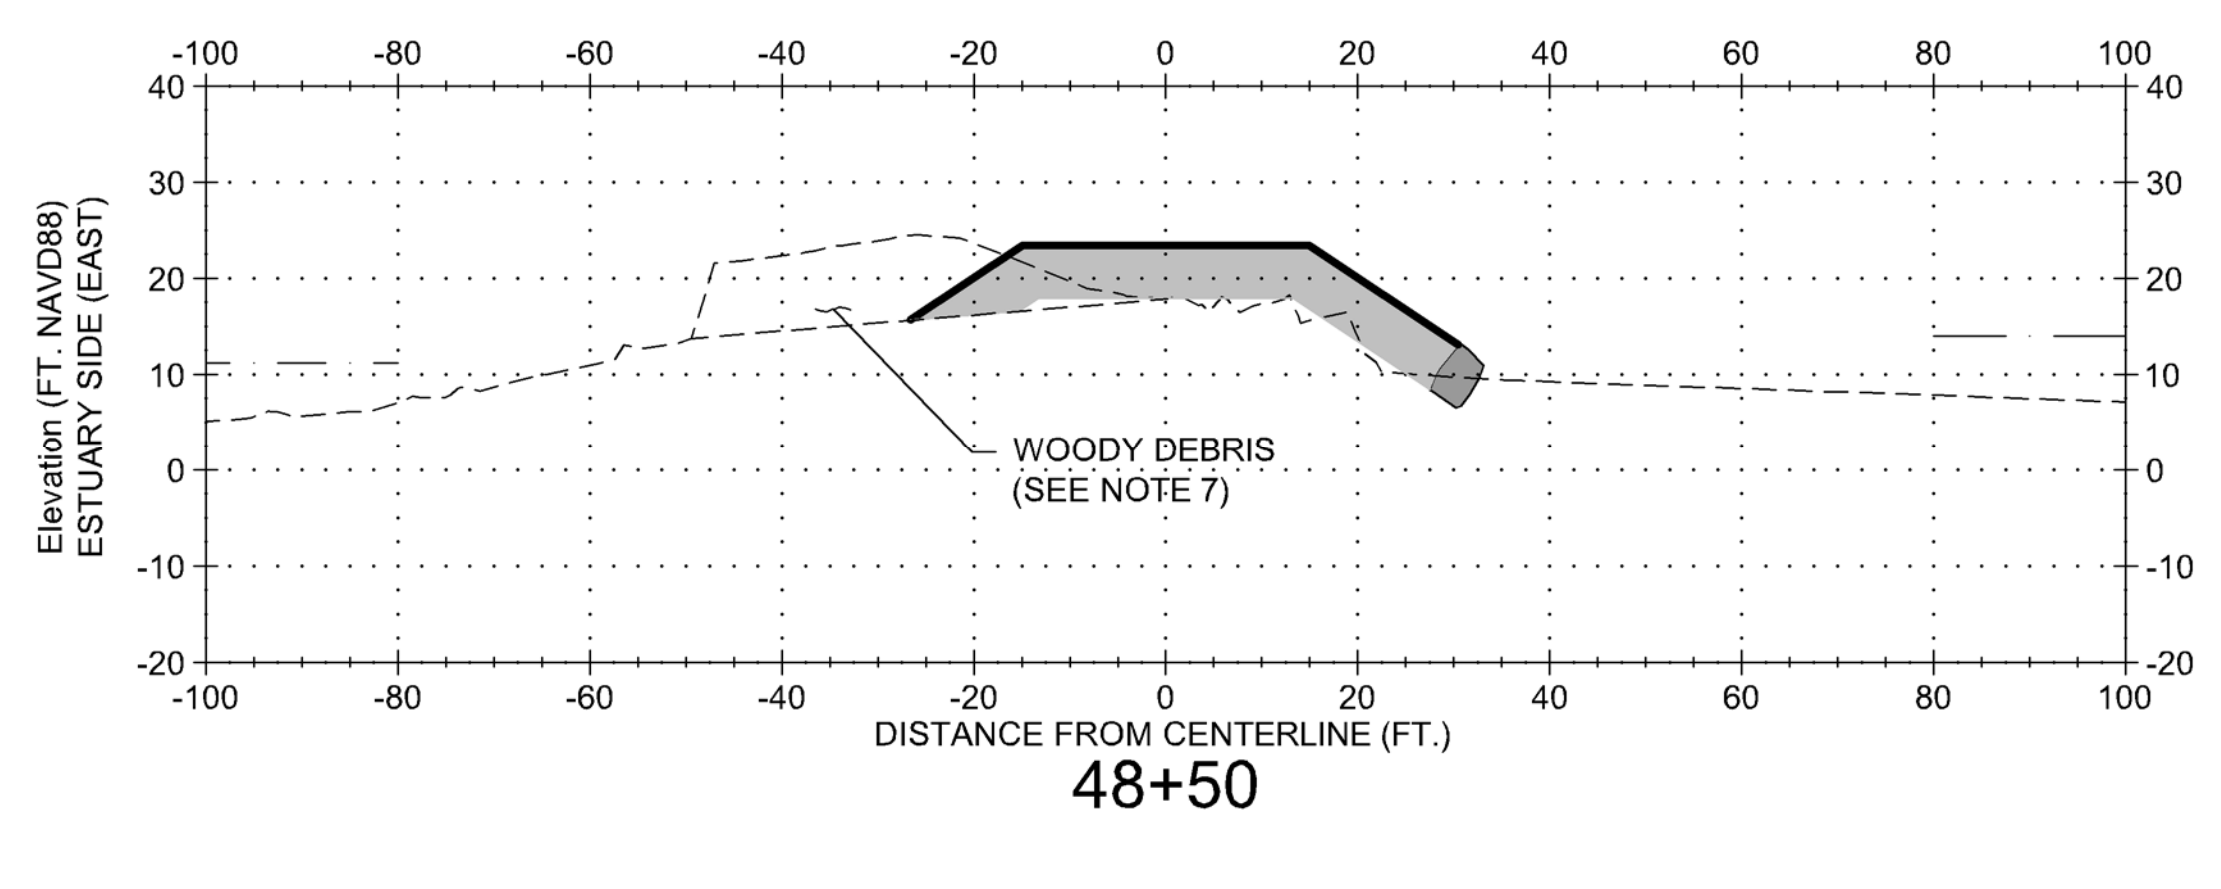
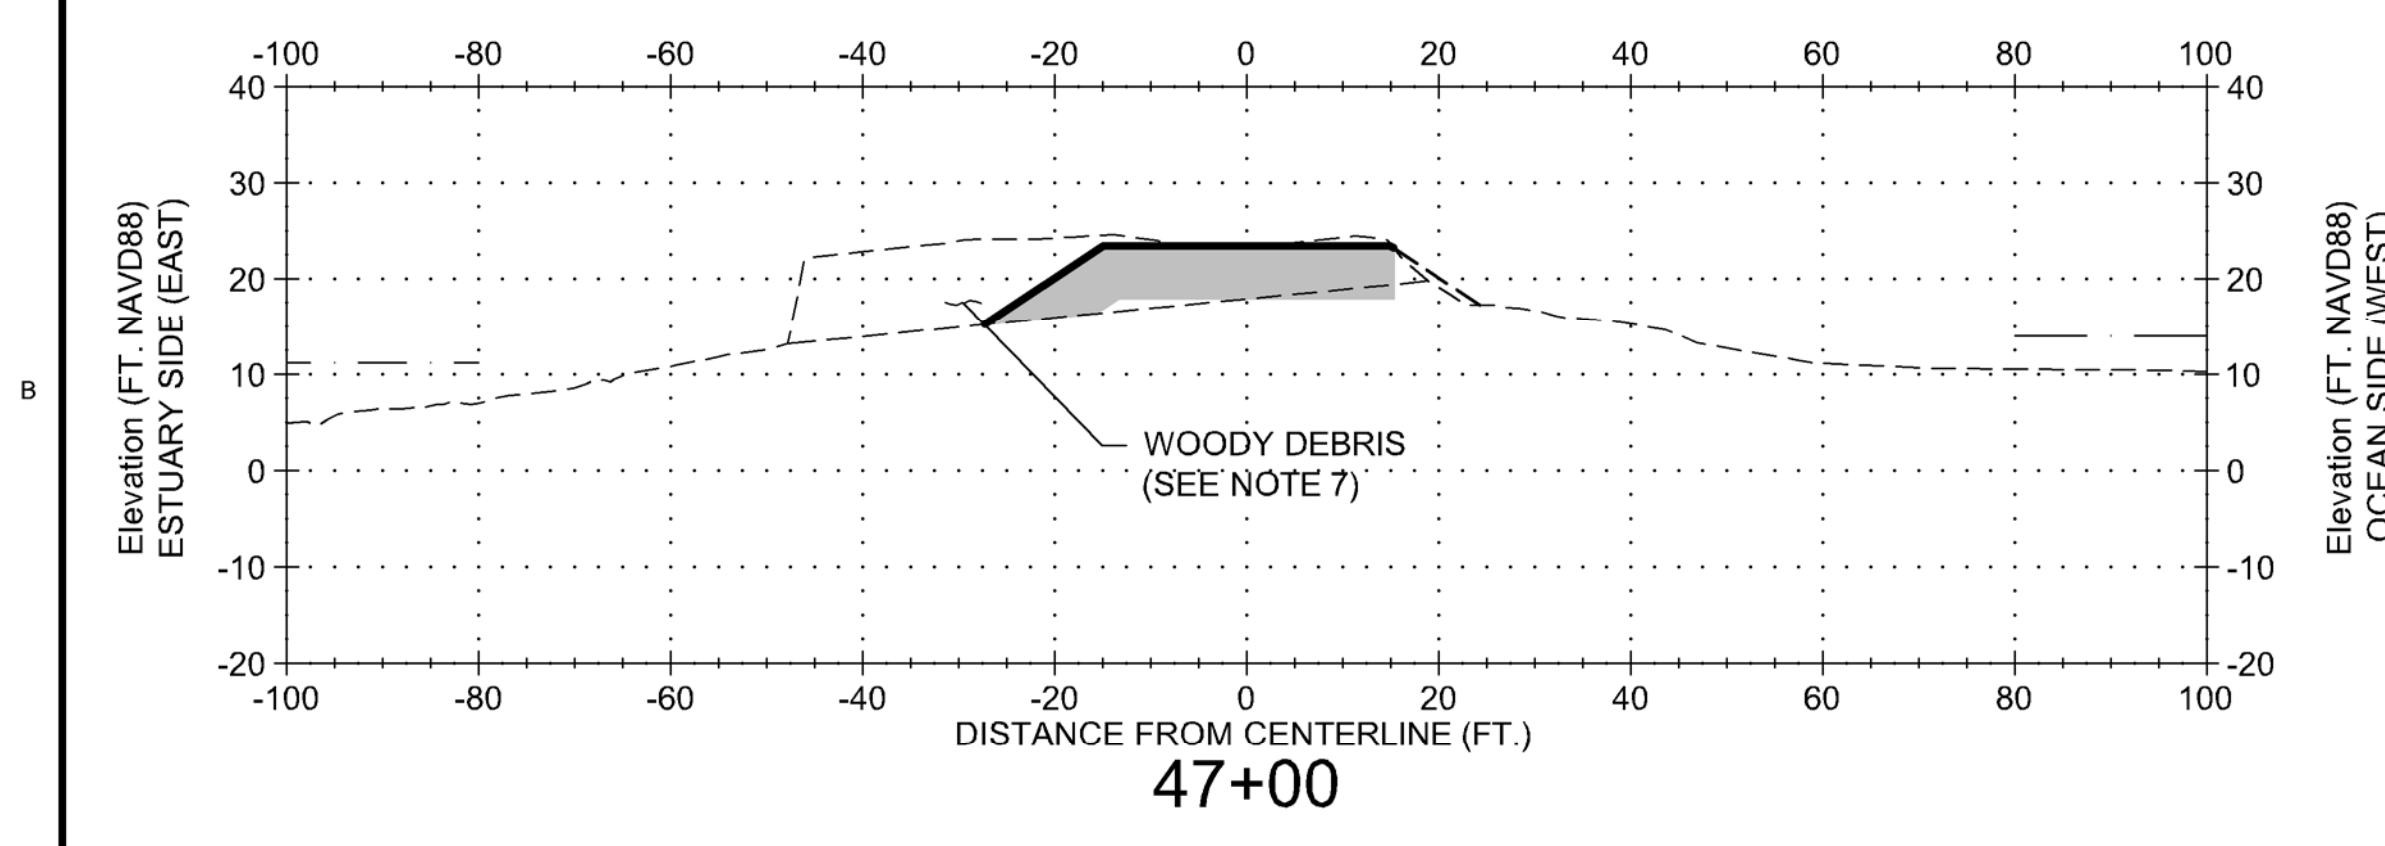
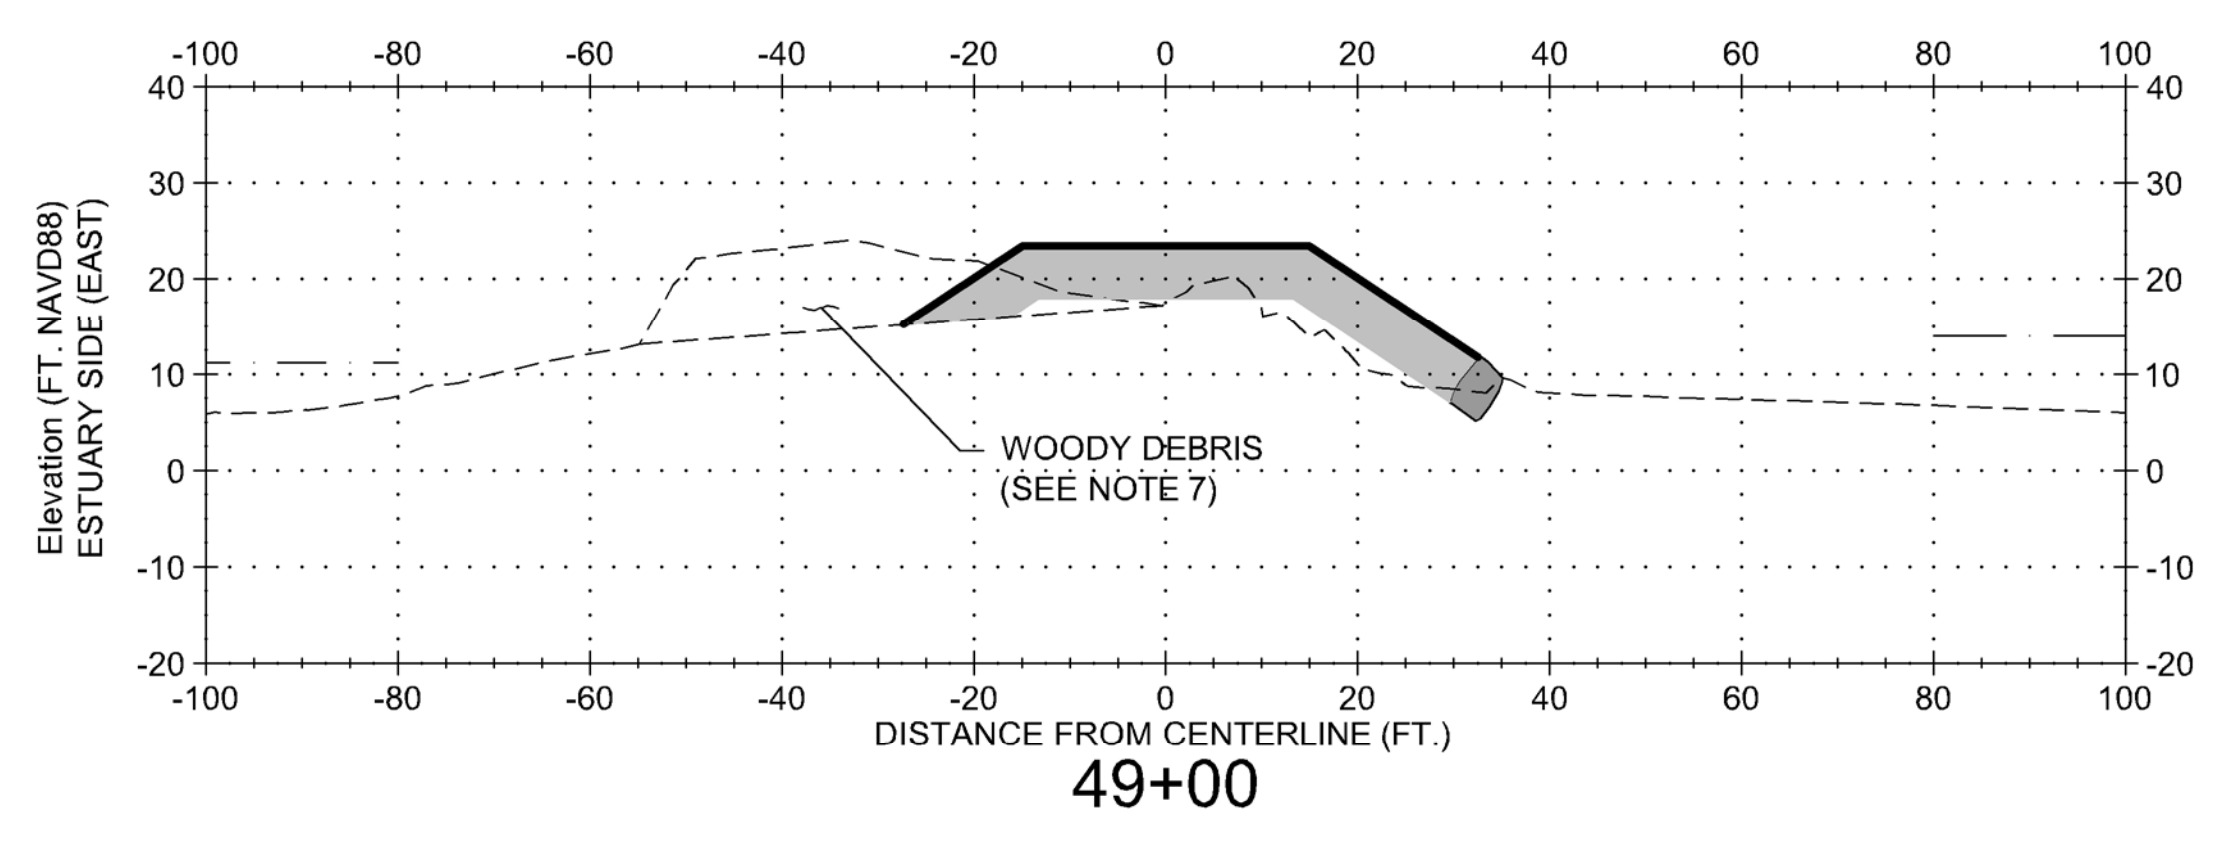
SHEET
IDENTIFICATION
CS003

- NOTES:
1. SHOWN CONDITIONS APPLY TO THE SPECIFIC CROSS SECTION AT THE TIME OF SURVEY: AUGUST 2014, UNLESS WHERE NOTED OTHERWISE.
 2. TOE ELEVATION OF REPAIR TEMPLATE VARIES BASED ON POINT OF INTERSECTION BETWEEN:

1) RELICT ARMOR STONE MASS OF EXISTING CROSS SECTION, AND
2) FALL LINE(GRADE) OF REPAIR TEMPLATE
 3. THE AMOUNT AND LOCATION FOR WHERE EXISTING RELICT STONE WOULD NEED TO BE REPOSITIONED (TO ACCOMMODATE INTERLOCKING WITH NEW ARMOR STONE) IS VARIABLE. THERE MAY BE INSTANCES WHEN EXISTING RELICT STONE NEEDS TO BE MOVED, AND OTHER INSTANCES WHEN IT DOES NOT.

4. NO REPAIRS ARE REQUIRED FOR AREAS ABOVE THE DESIGN TEMPLATE LIMITS. THE JETTY IS TO BE REPAIRED IF A MINIMUM OF 1 LAYER OF NEW JETTY STONE CAN BE ACCOMMODATED WITHIN THE CROSS-SECTION TEMPLATE AND ITS TOLERANCES. SEE SPECIFICATION 35 31 26.40 25 3.3.1 e. DASHED LINE SHOWN REPRESENTS AREAS WHERE DESIGN TEMPLATE IS BELOW EXISTING GRADE.

6. NOMINAL THICKNESS OF 1 LAYER OF NEW A-STONE IS 5.5 FT., BASED ON 171 PCF. STONE DENSITY OF EXISTING ARMOR STONE.
 7. WOODY DEBRIS NOTE - AREA SHOWN IS KNOWN TO HAVE WOODY DEBRIS, WHICH WHEN REMOVED MAY EXPOSE DEFICIENT JETTY SECTIONS WHICH SHALL BE REPAIRED, AS NEEDED TO PROVIDE FULL CROSS-SECTION TEMPLATE ACCORDING TO CONTRACT PLAN NEAT LINE.

10. VERTICAL DATUM: NAVD88
 11. TOE STONE IS REQUIRED FOR REPAIR AREAS WHERE SIDE SLOPES EXTEND BELOW CREST 1 OR MORE STONE DIMENSIONS.
