US Army Corps
of Engineers
Portland District

COLUMBIA RIVER MOUTH OF THE COLUMBIA RIVER JETTY A REHABILITATION

**COLUMBIA RIVER
 MCR JETTY A REHABILITATION**

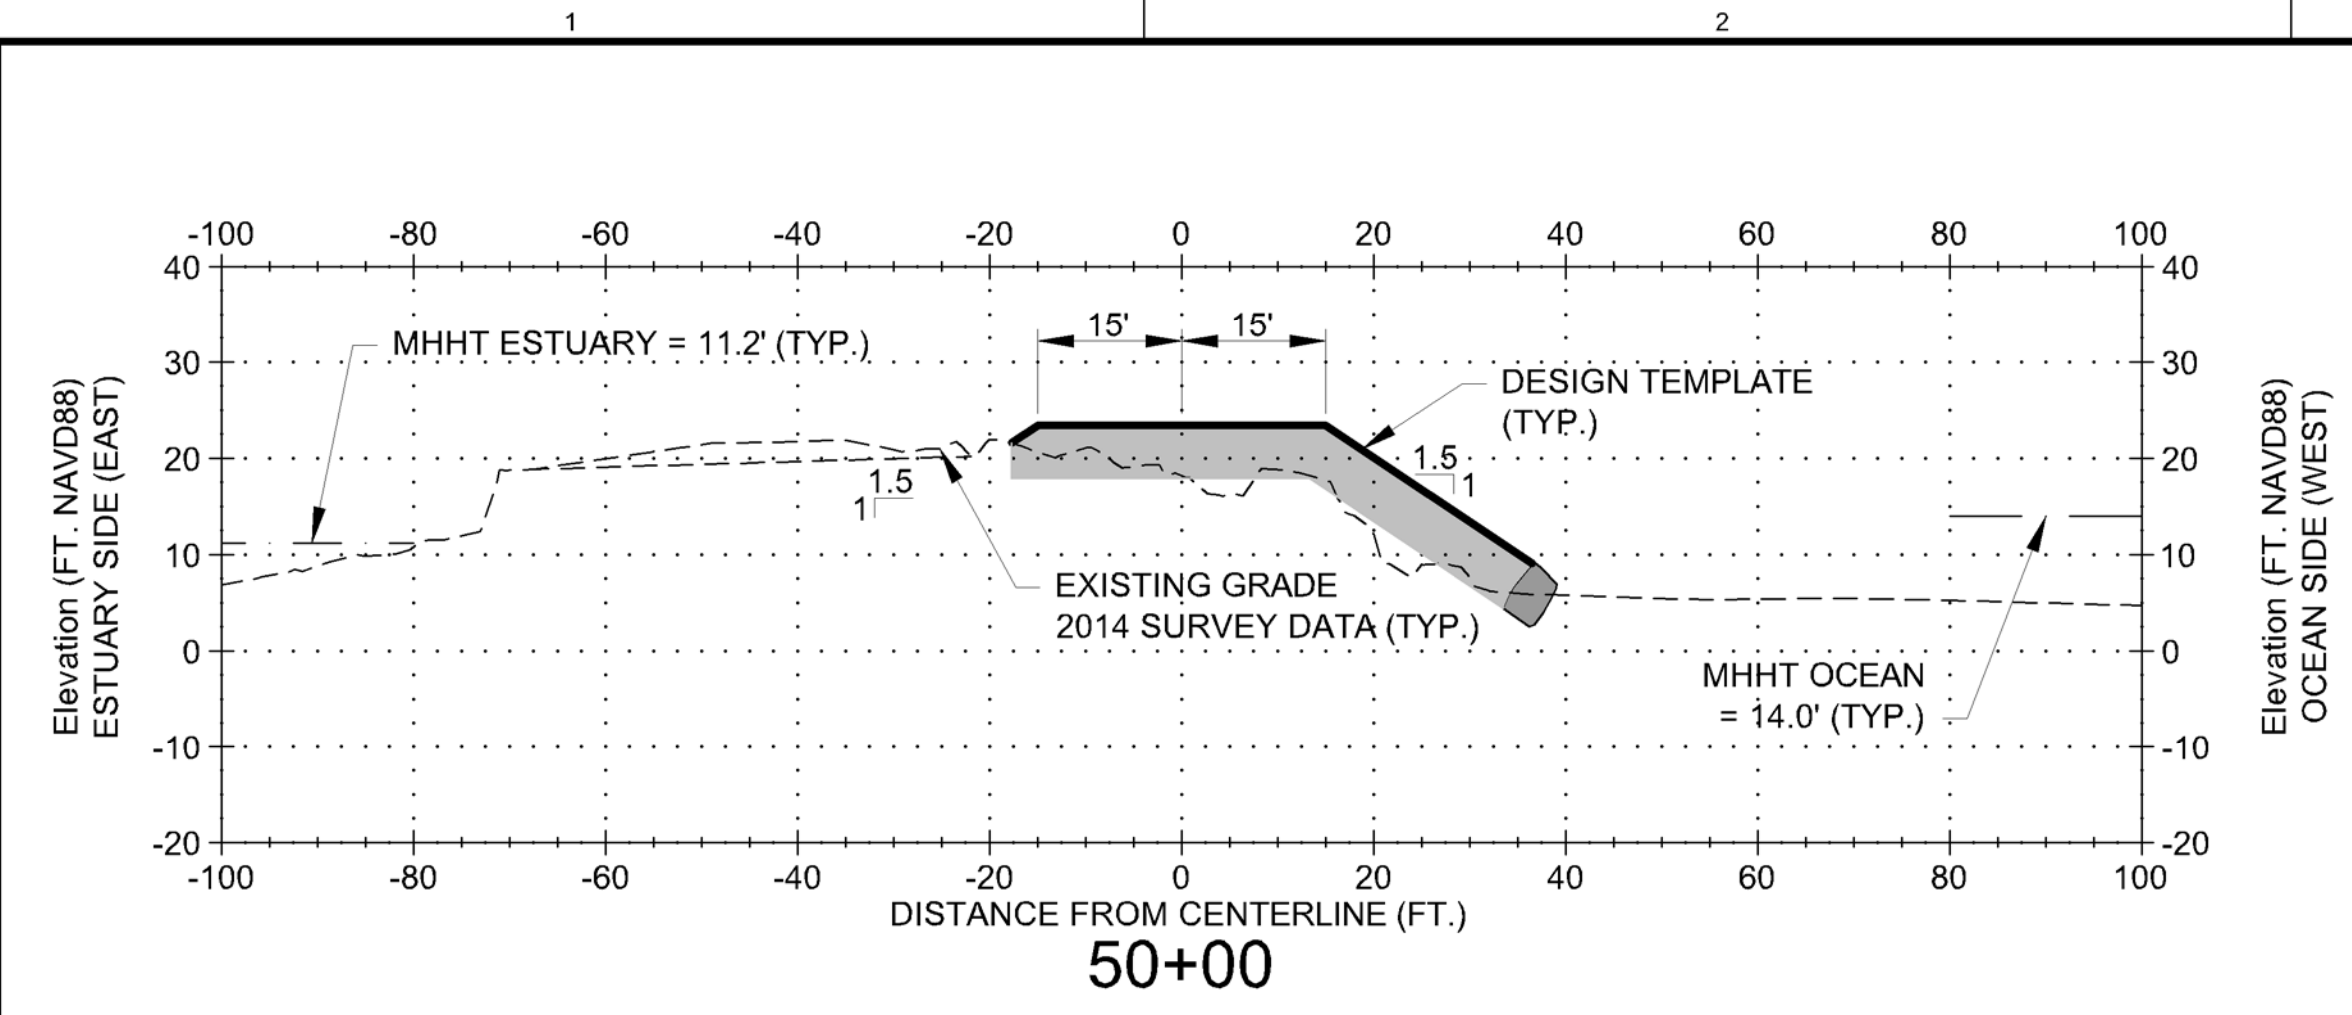
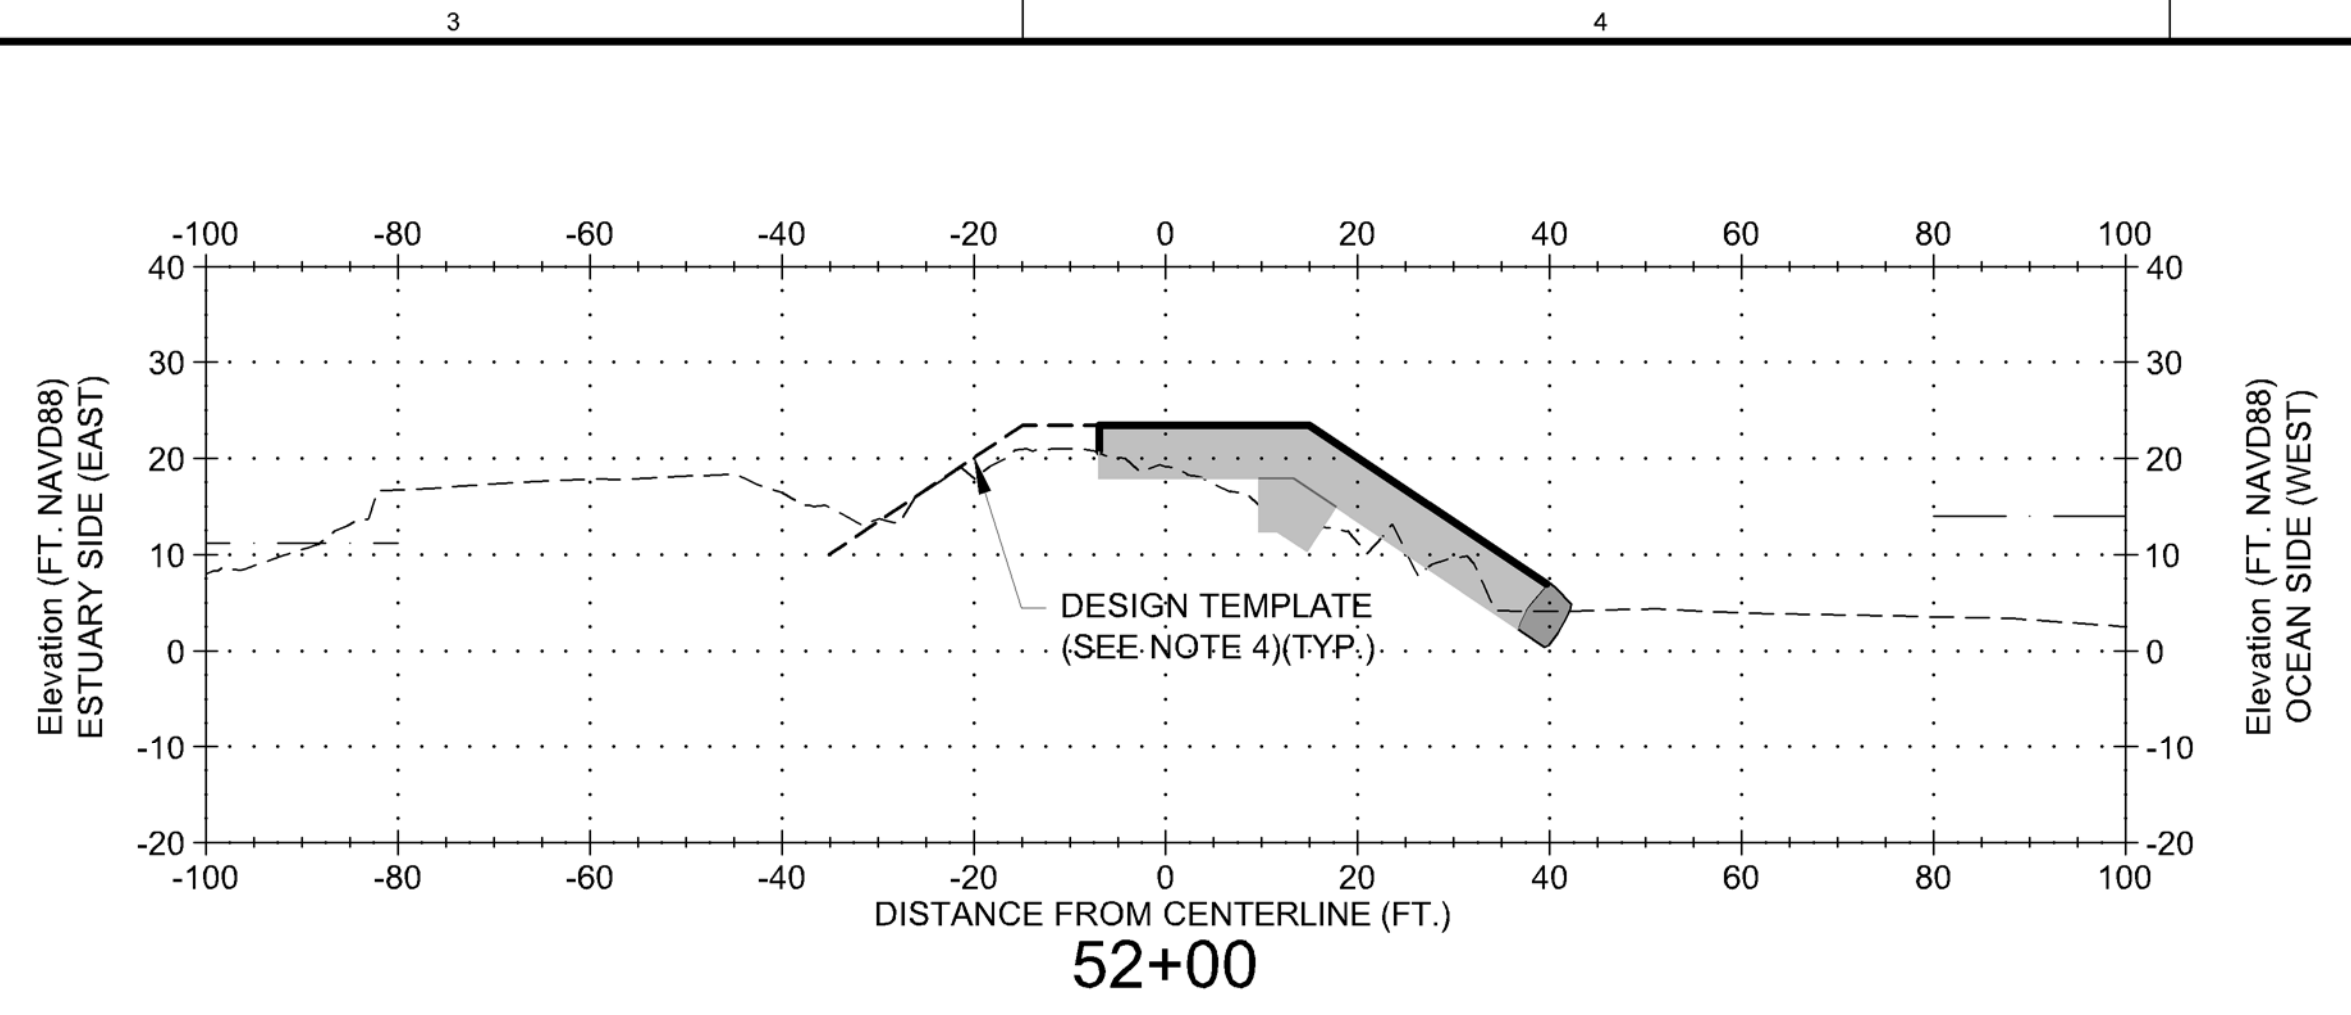
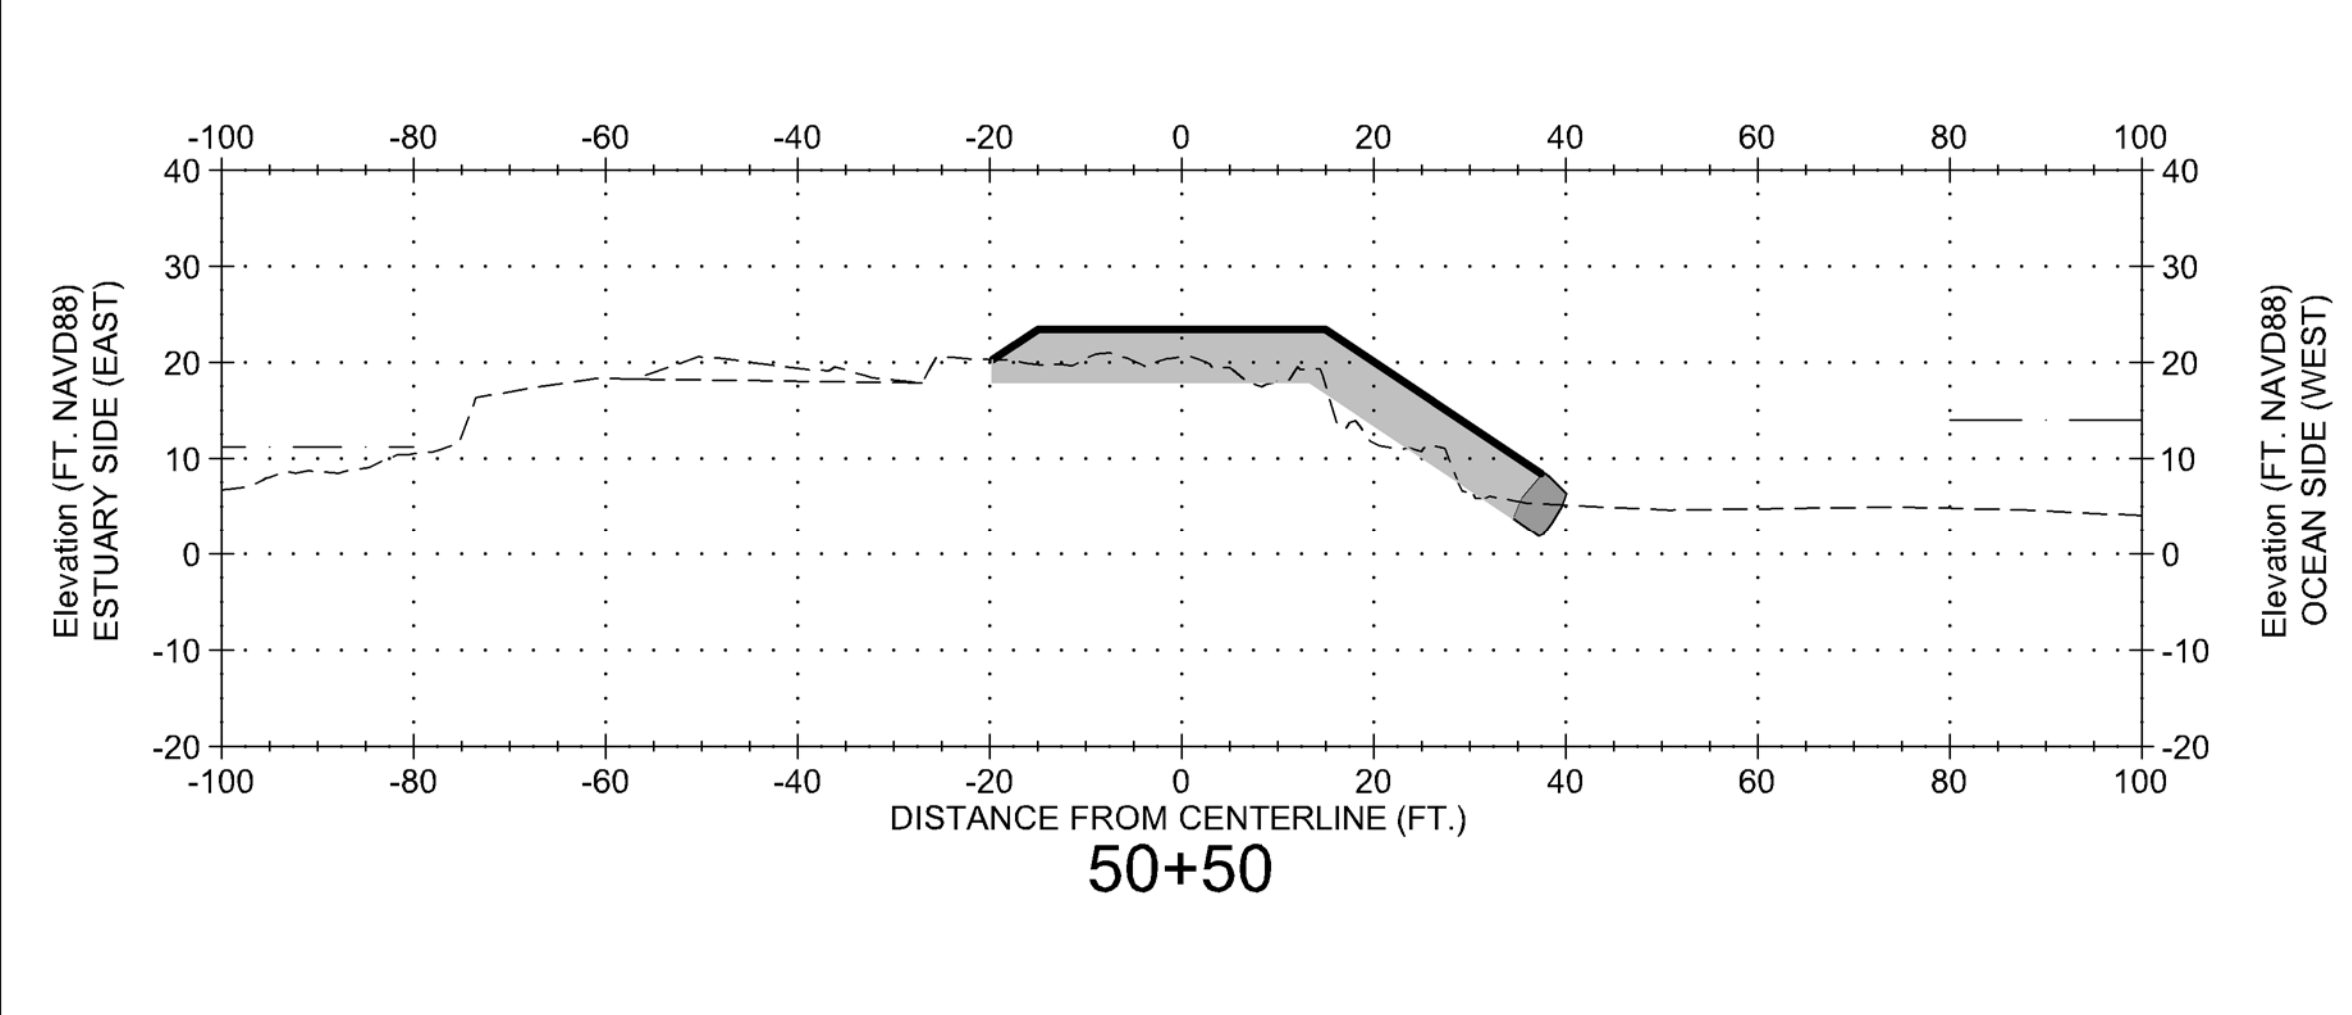
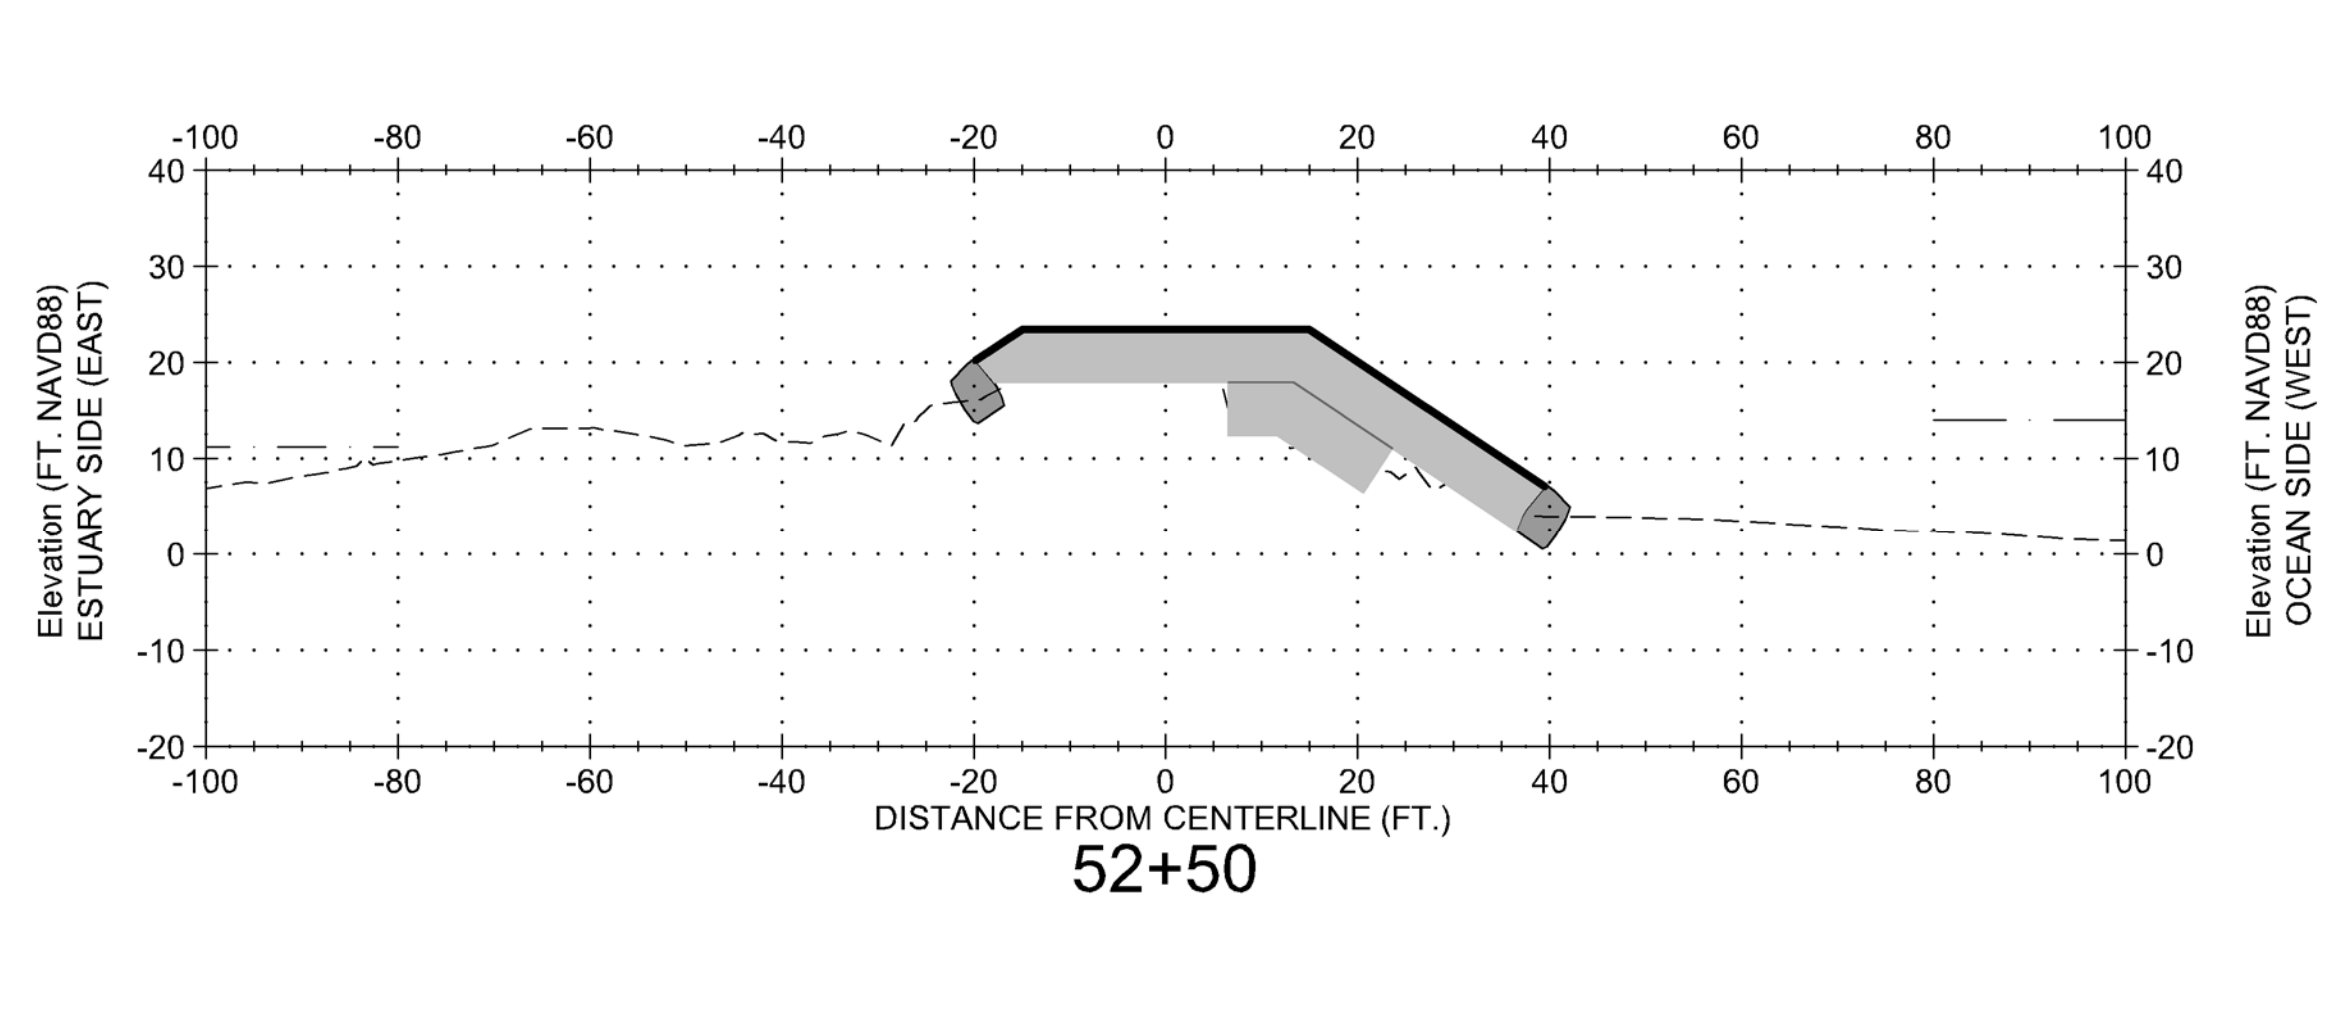
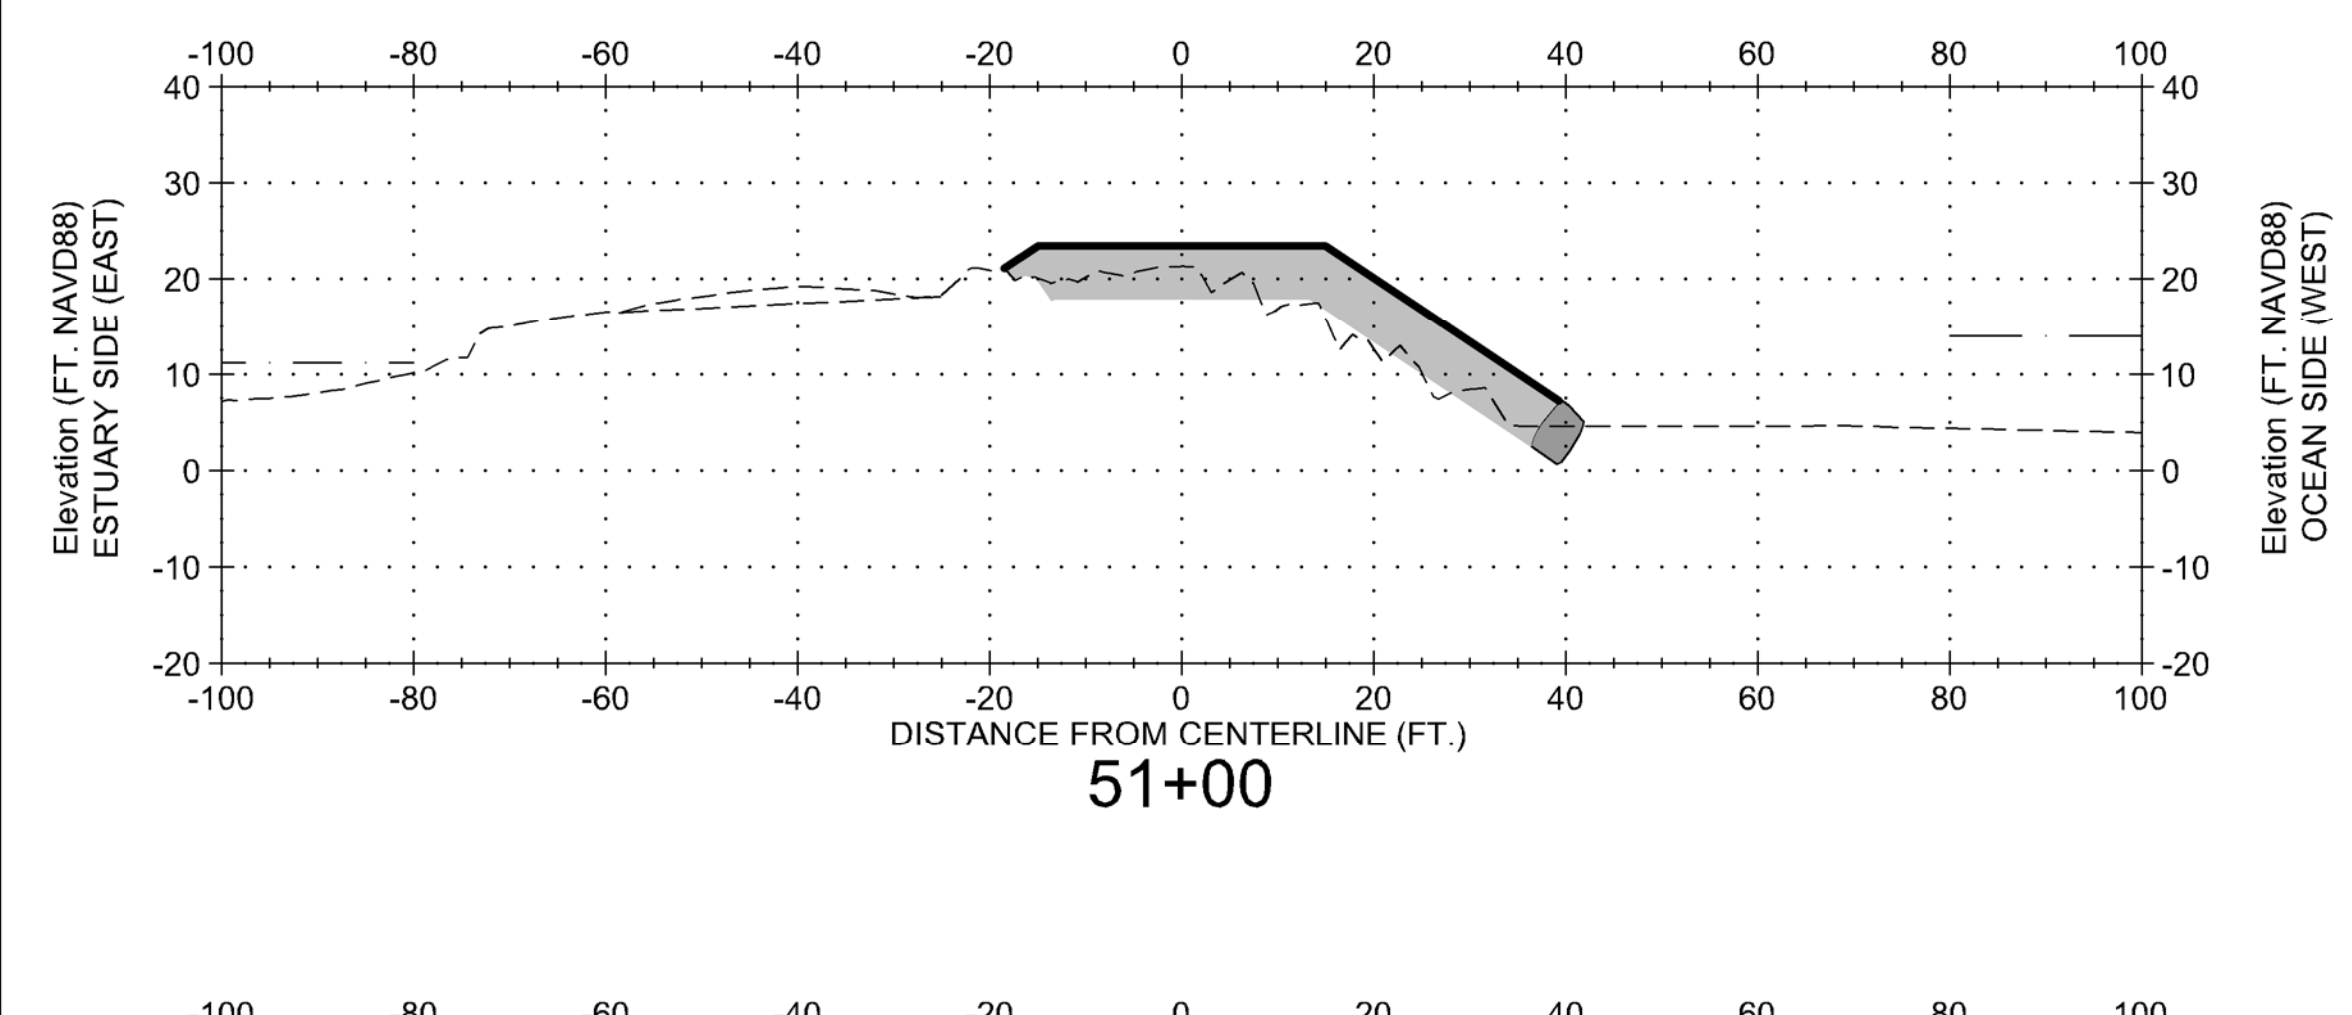
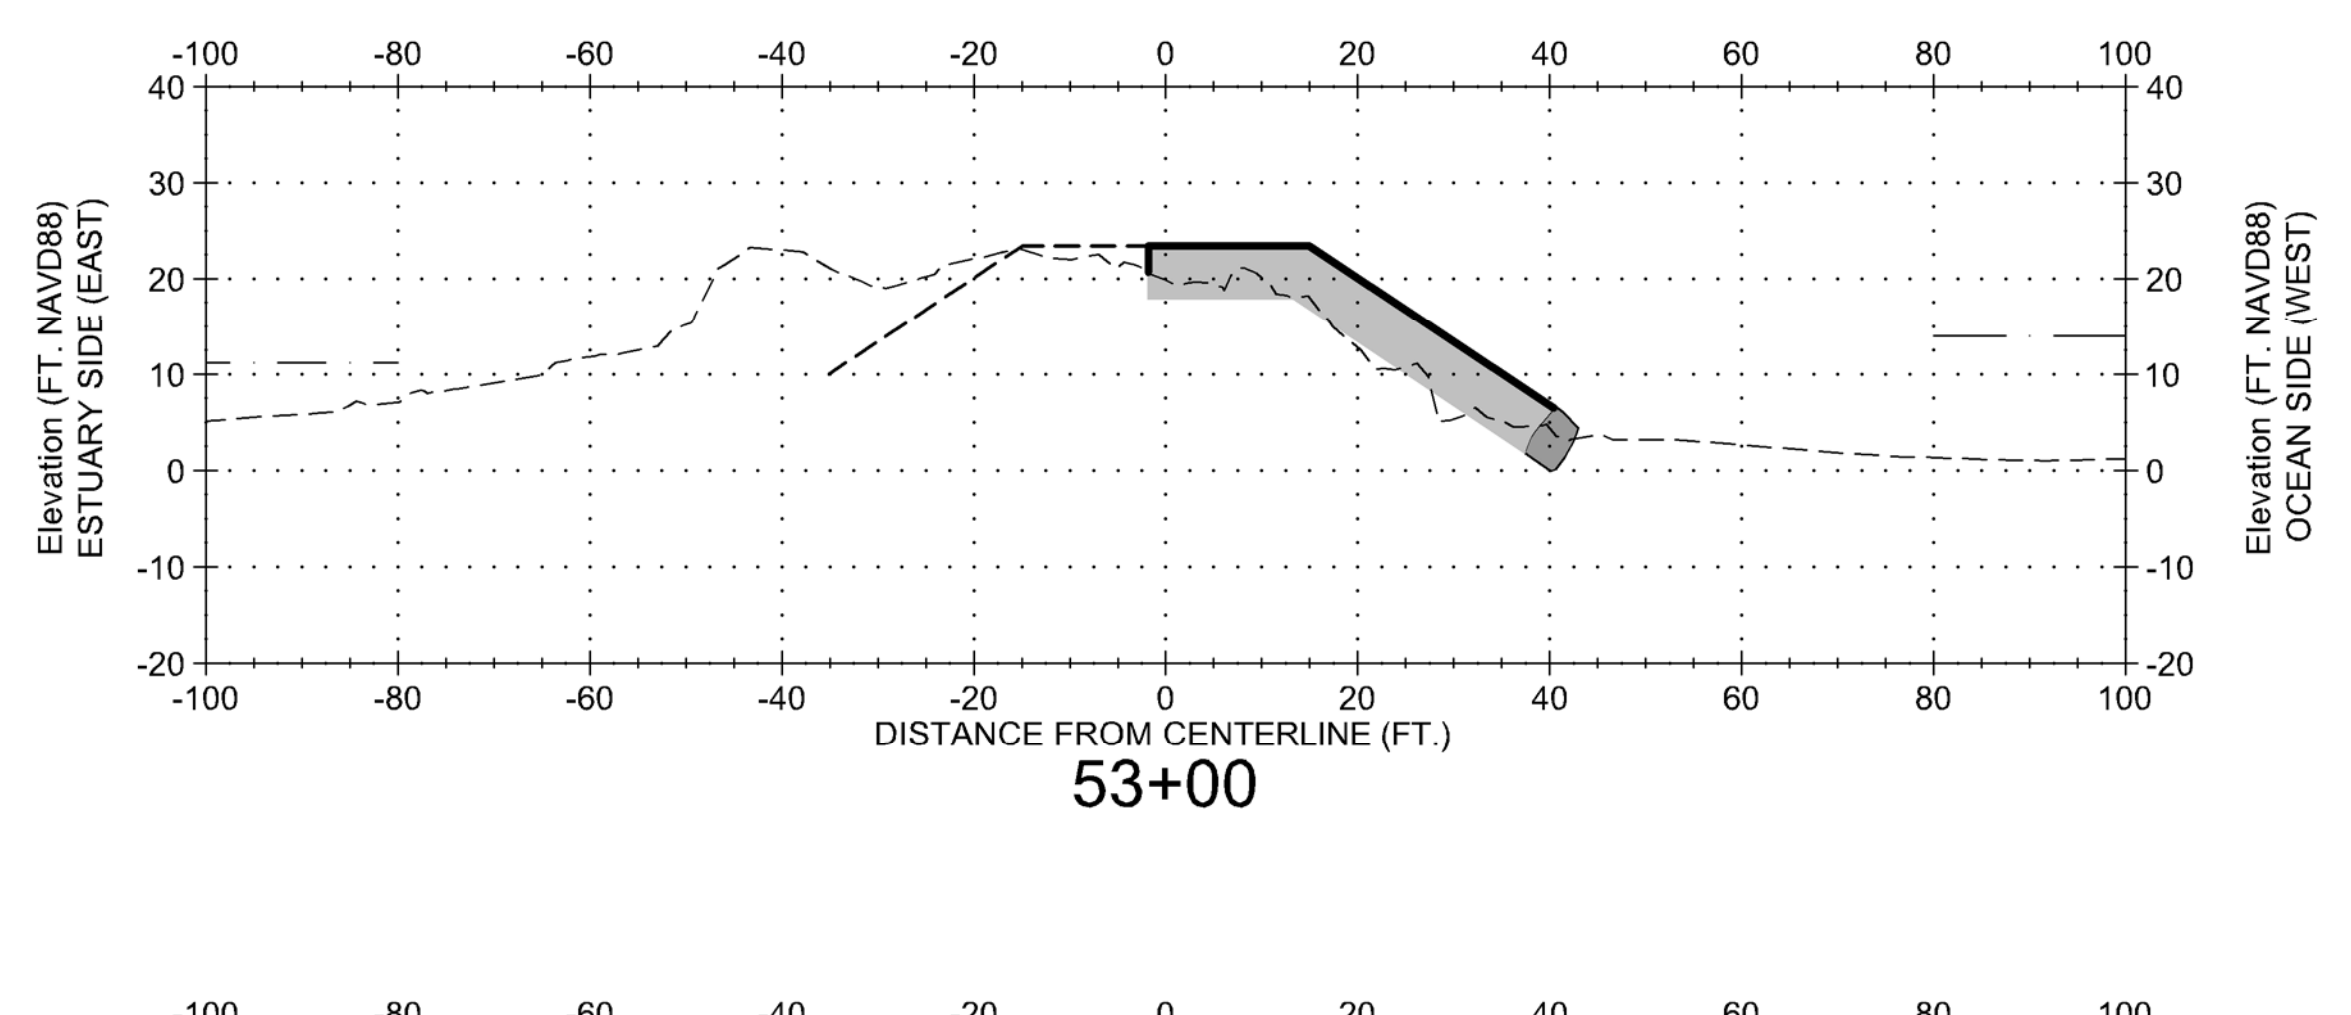
SHEET IDENTIFICATION
CS004

- NOTES:
1. SHOWN CONDITIONS APPLY TO THE SPECIFIC CROSS SECTION AT THE TIME OF SURVEY: AUGUST 2014, UNLESS WHERE NOTED OTHERWISE.
 2. TOE ELEVATION OF REPAIR TEMPLATE VARIES BASED ON POINT OF INTERSECTION BETWEEN:

- 1) RELICT ARMOR STONE MASS OF EXISTING CROSS SECTION, AND
 - 2) FALL LINE (GRADE) OF REPAIR TEMPLATE
 3. THE AMOUNT AND LOCATION FOR WHERE EXISTING RELICT STONE WOULD NEED TO BE REPOSITIONED (TO ACCOMMODATE INTERLOCKING WITH NEW ARMOR STONE) IS VARIABLE. THERE MAY BE INSTANCES WHEN EXISTING RELICT STONE NEEDS TO BE MOVED, AND OTHER INSTANCES WHEN IT DOES NOT.

4. NO REPAIRS ARE REQUIRED FOR AREAS ABOVE THE DESIGN TEMPLATE LIMITS. THE JETTY IS TO BE REPAIRED IF A MINIMUM OF 1 LAYER OF NEW JETTY STONE CAN BE ACCOMMODATED WITHIN THE CROSS-SECTION TEMPLATE AND ITS TOLERANCES. SEE SPECIFICATION 35 31 26.40 25 3.3.1 e. DASHED LINE SHOWN REPRESENTS AREAS WHERE DESIGN TEMPLATE IS BELOW EXISTING GRADE.

6. NOMINAL THICKNESS OF 1 LAYER OF NEW A-STONE IS 5.5 FT., BASED ON 171 PCF. STONE DENSITY OF EXISTING ARMOR STONE.
 7. WOODY DEBRIS NOTE - AREA SHOWN IS KNOWN TO HAVE WOODY DEBRIS, WHICH WHEN REMOVED MAY EXPOSE DEFICIENT JETTY SECTIONS WHICH SHALL BE REPAIRED, AS NEEDED TO PROVIDE FULL CROSS-SECTION TEMPLATE ACCORDING TO CONTRACT PLAN NEAT LINE.

10. VERTICAL DATUM: NAVD88
 11. TOE STONE IS REQUIRED FOR REPAIR AREAS WHERE SIDE SLOPES EXTEND BELOW CREST 1 OR MORE STONE DIMENSIONS.
