US Army Corps
of Engineers
Portland District

COLUMBIA RIVER MOUTH OF THE COLUMBIA RIVER JETTY A REHABILITATION

**COLUMBIA RIVER
 MCR JETTY A REHABILITATION**

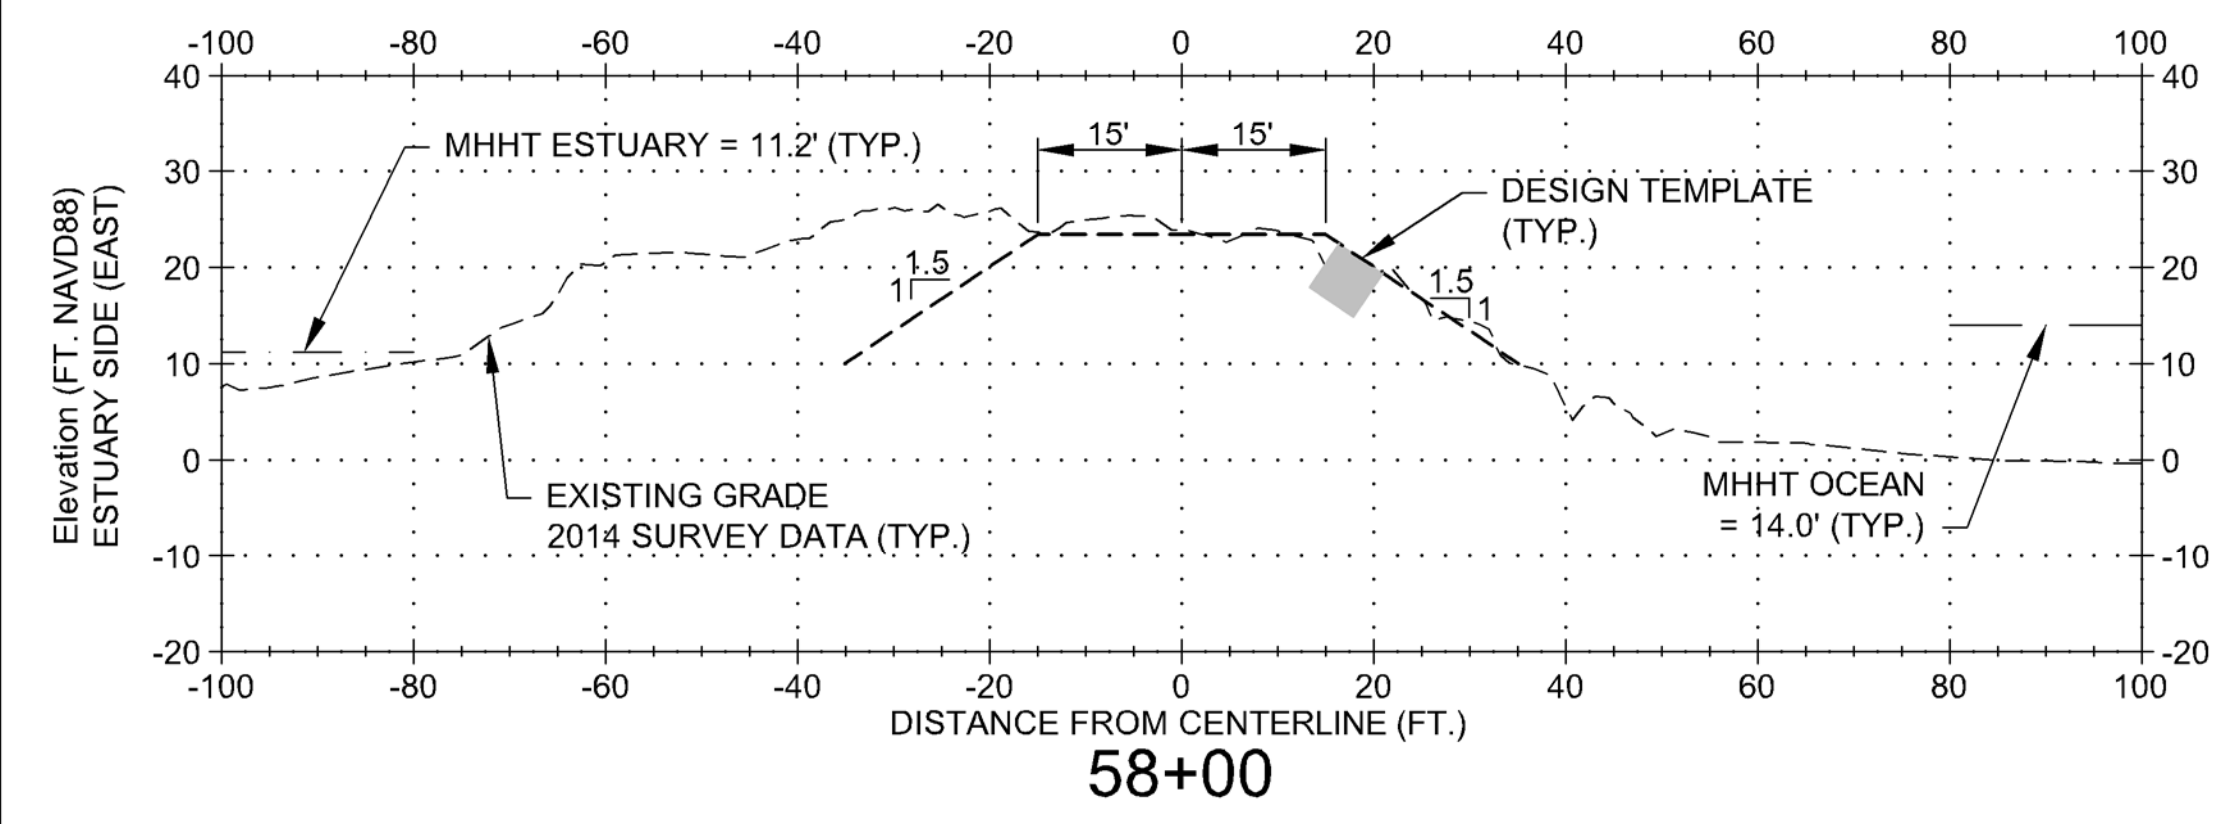
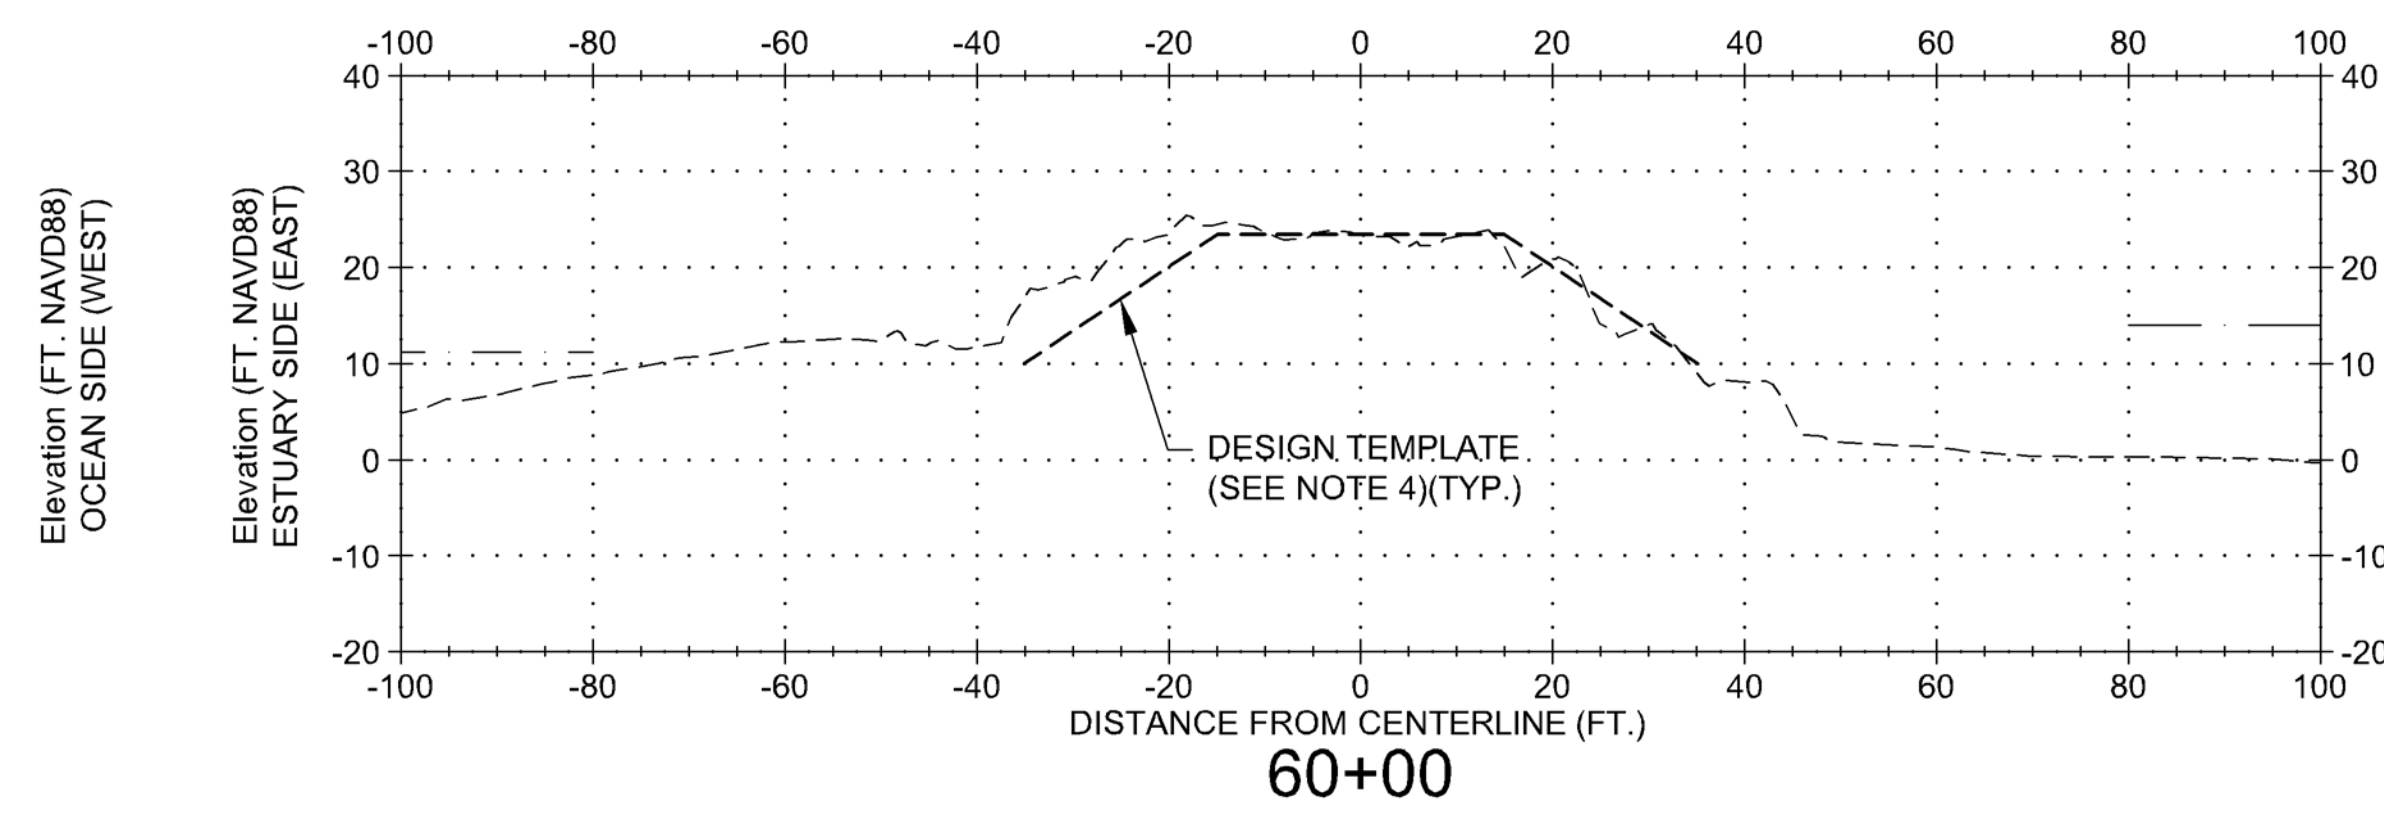
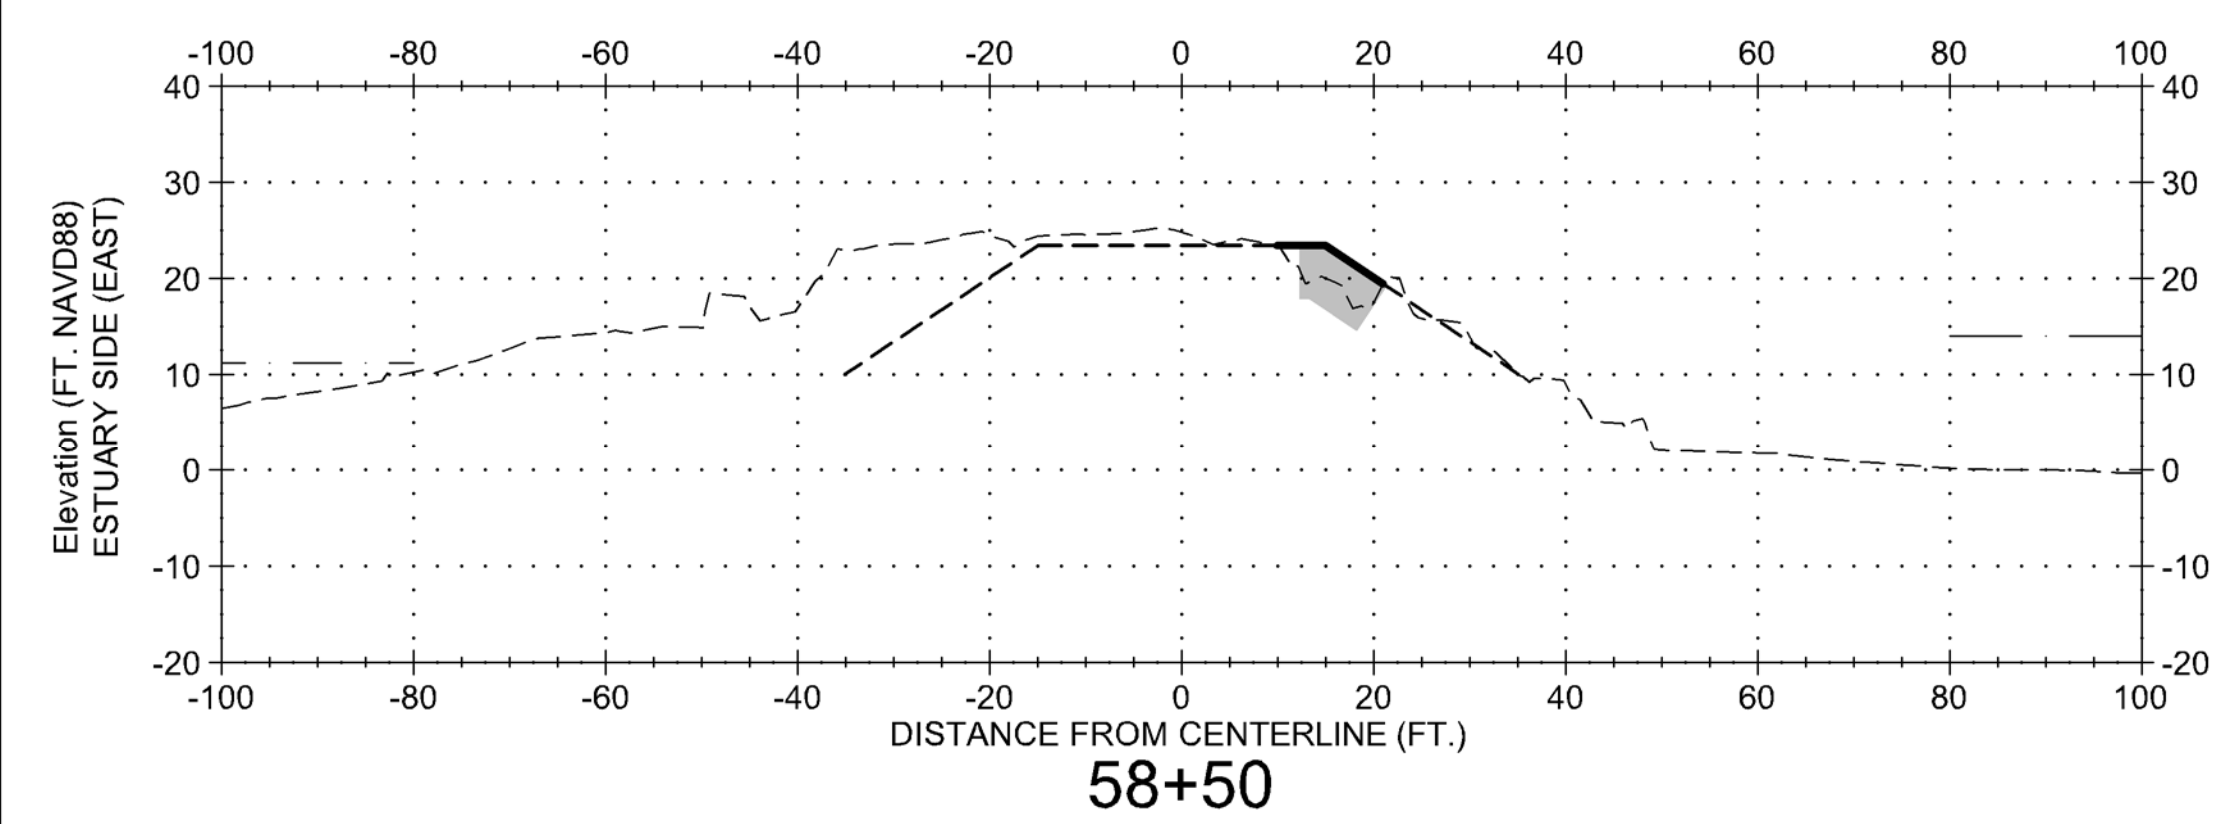
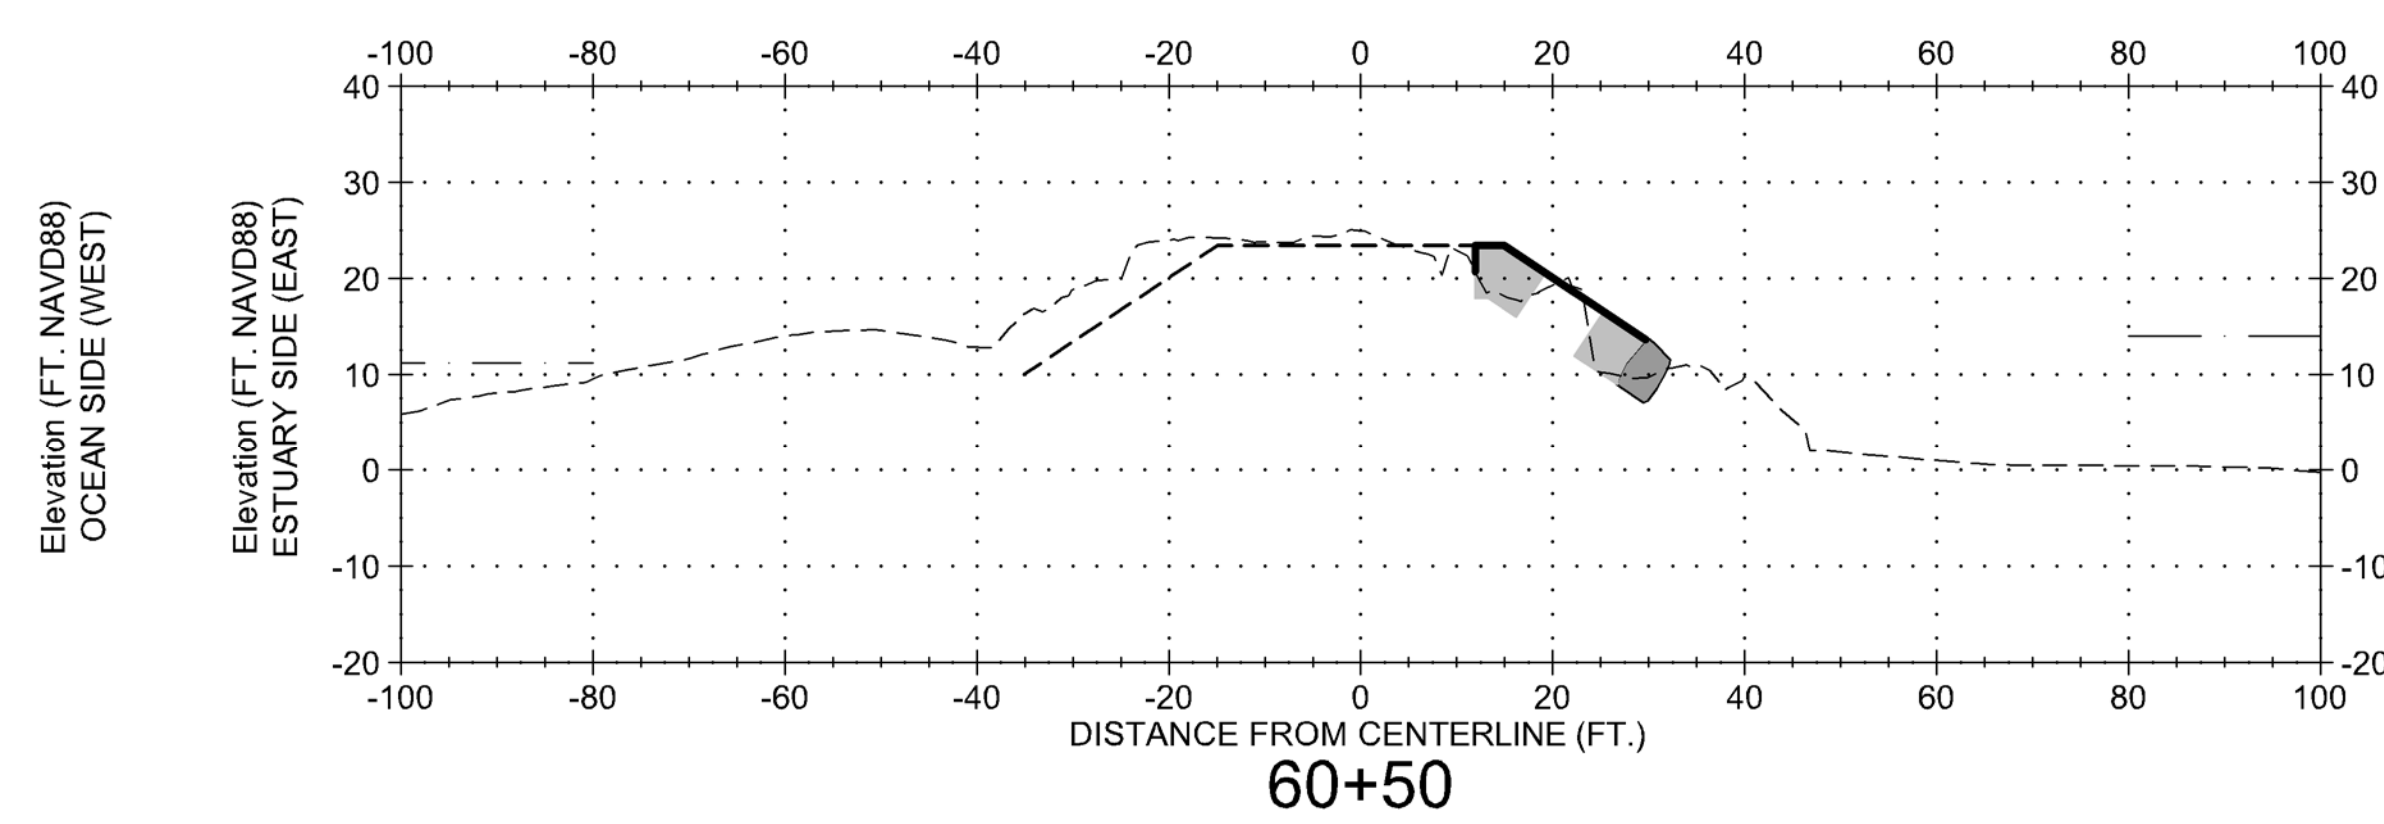
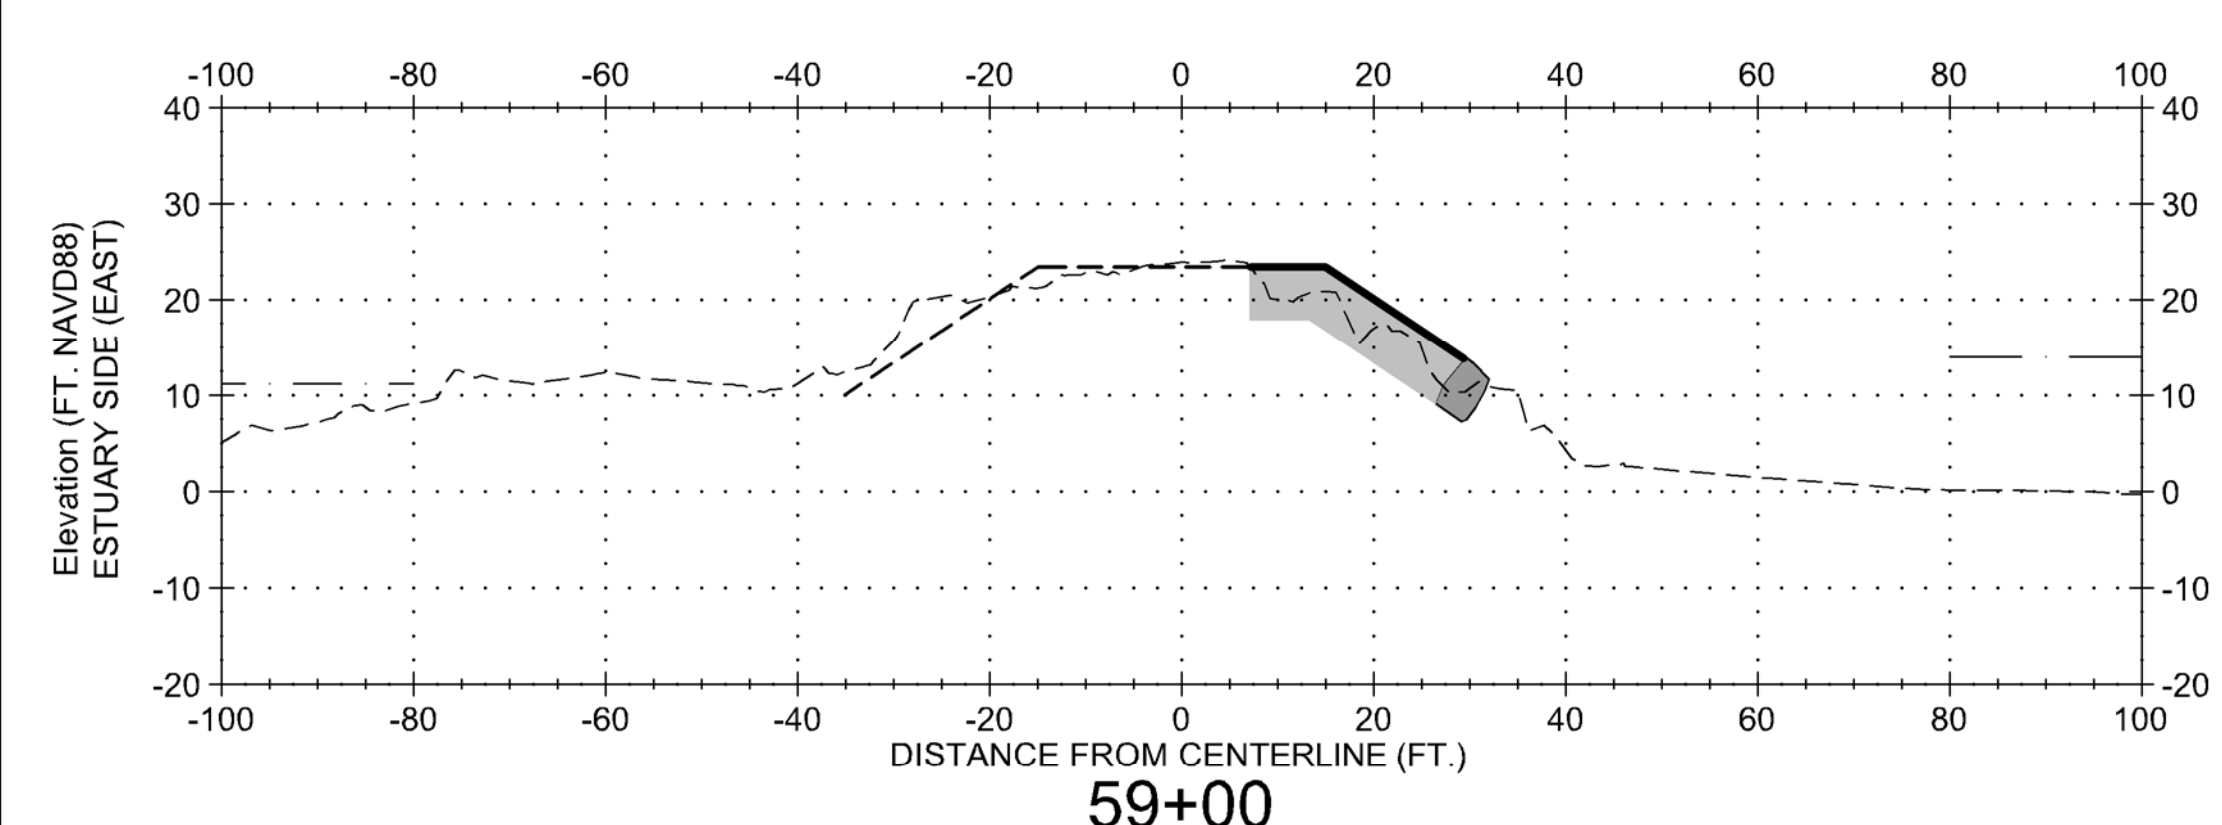
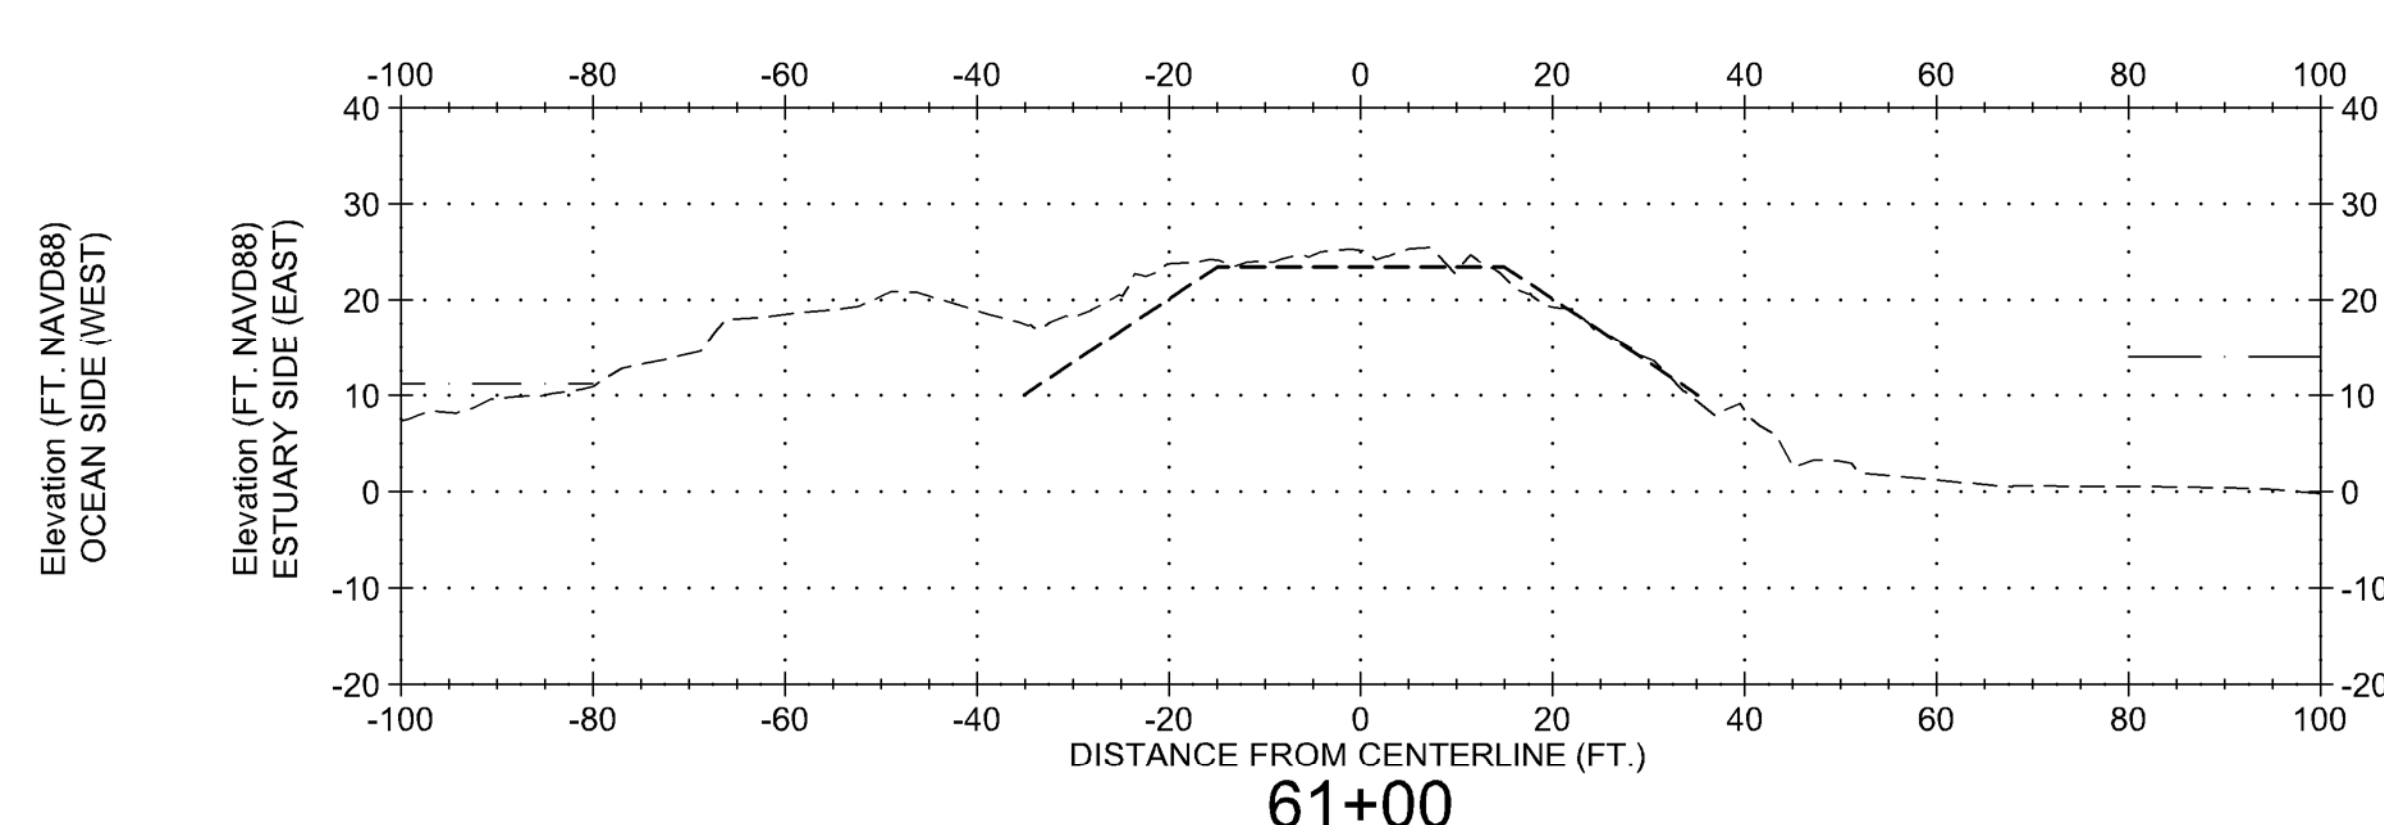
- NOTES:
1. SHOWN CONDITIONS APPLY TO THE SPECIFIC CROSS SECTION AT THE TIME OF SURVEY: AUGUST 2014, UNLESS WHERE NOTED OTHERWISE.
 2. TOE ELEVATION OF REPAIR TEMPLATE VARIES BASED ON POINT OF INTERSECTION BETWEEN:

1) RELICT ARMOR STONE MASS OF EXISTING CROSS SECTION, AND
2) FALL LINE (GRADE) OF REPAIR TEMPLATE
 3. THE AMOUNT AND LOCATION FOR WHERE EXISTING RELICT STONE WOULD NEED TO BE REPOSITIONED (TO ACCOMMODATE INTERLOCKING WITH NEW ARMOR STONE) IS VARIABLE. THERE MAY BE INSTANCES WHEN EXISTING RELICT STONE NEEDS TO BE MOVED, AND OTHER INSTANCES WHEN IT DOES NOT.

4. NO REPAIRS ARE REQUIRED FOR AREAS ABOVE THE DESIGN TEMPLATE LIMITS. THE JETTY IS TO BE REPAIRED IF A MINIMUM OF 1 LAYER OF NEW JETTY STONE CAN BE ACCOMMODATED WITHIN THE CROSS-SECTION TEMPLATE AND ITS TOLERANCES. SEE SPECIFICATION 35 31 26.40 25 3.3.1 e. DASHED LINE SHOWN REPRESENTS AREAS WHERE DESIGN TEMPLATE IS BELOW EXISTING GRADE.

6. NOMINAL THICKNESS OF 1 LAYER OF NEW A-STONE IS 5.5 FT., BASED ON 171 PCF. STONE DENSITY OF EXISTING ARMOR STONE.
 7. WOODY DEBRIS NOTE - AREA SHOWN IS KNOWN TO HAVE WOODY DEBRIS, WHICH WHEN REMOVED MAY EXPOSE DEFICIENT JETTY SECTIONS WHICH SHALL BE REPAIRED, AS NEEDED TO PROVIDE FULL CROSS-SECTION TEMPLATE ACCORDING TO CONTRACT PLAN NEAT LINE.

10. VERTICAL DATUM: NAVD88
 11. TOE STONE IS REQUIRED FOR REPAIR AREAS WHERE SIDE SLOPES EXTEND BELOW CREST 1 OR MORE STONE DIMENSIONS.

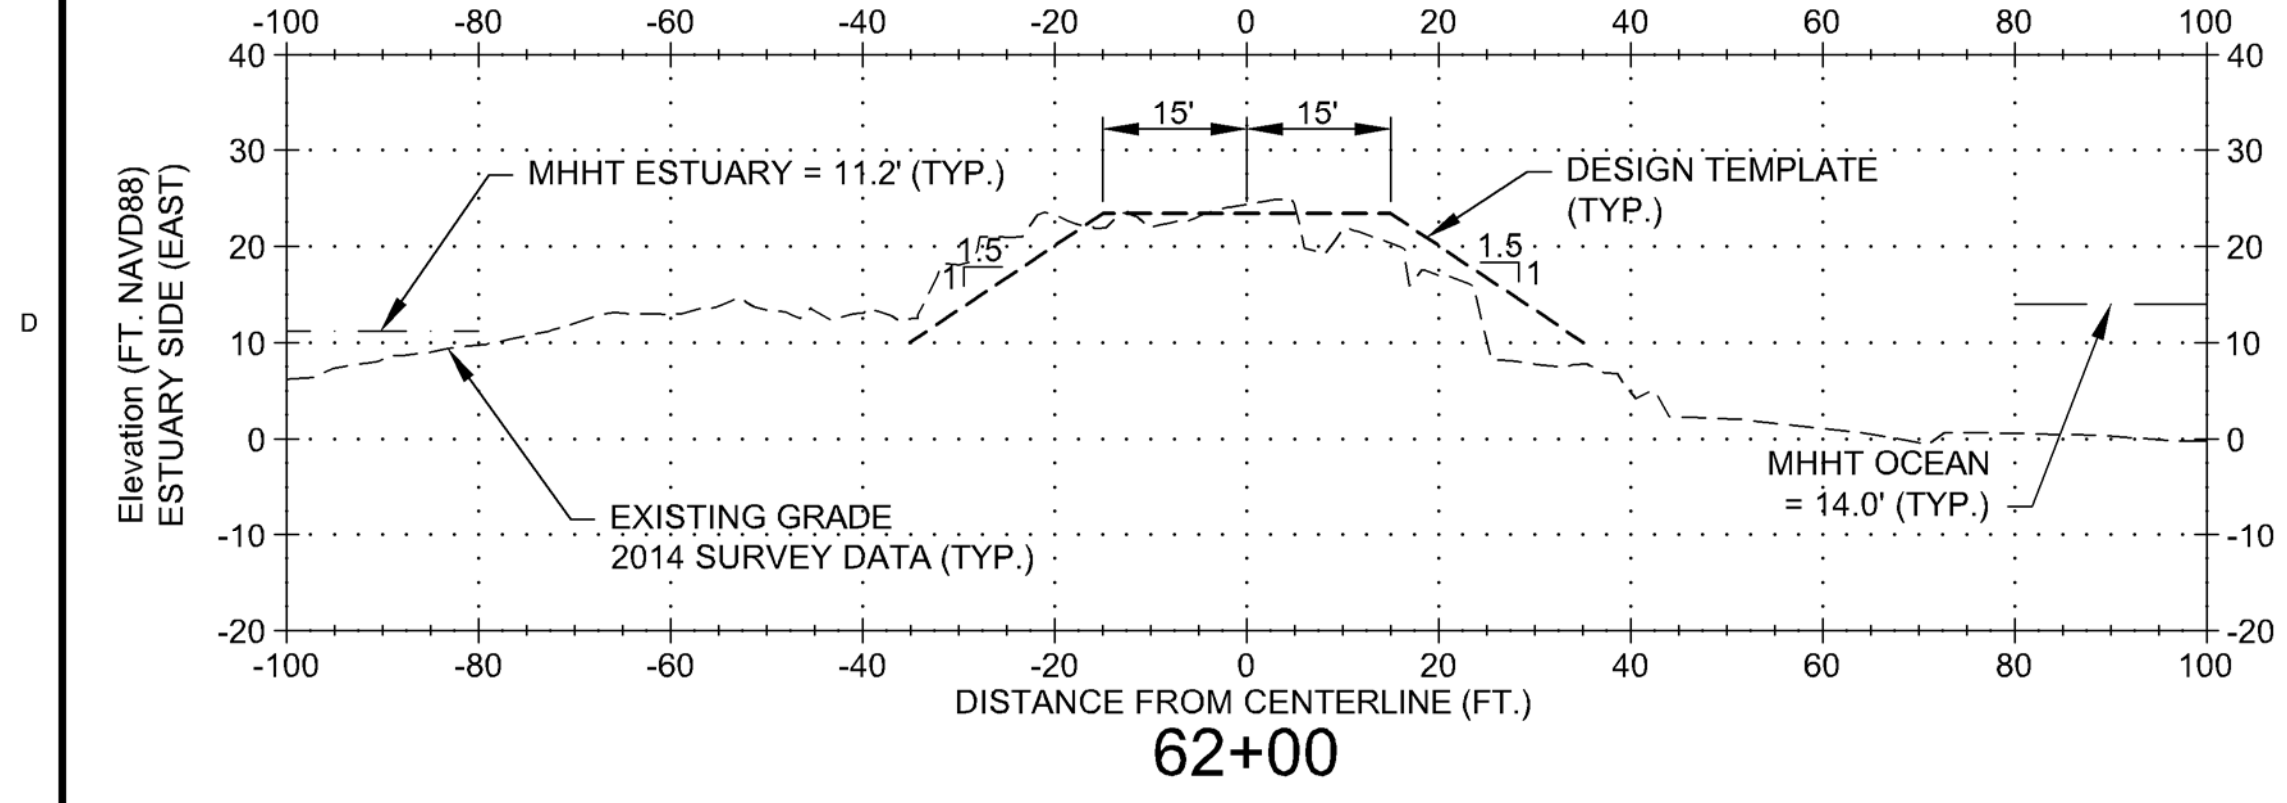
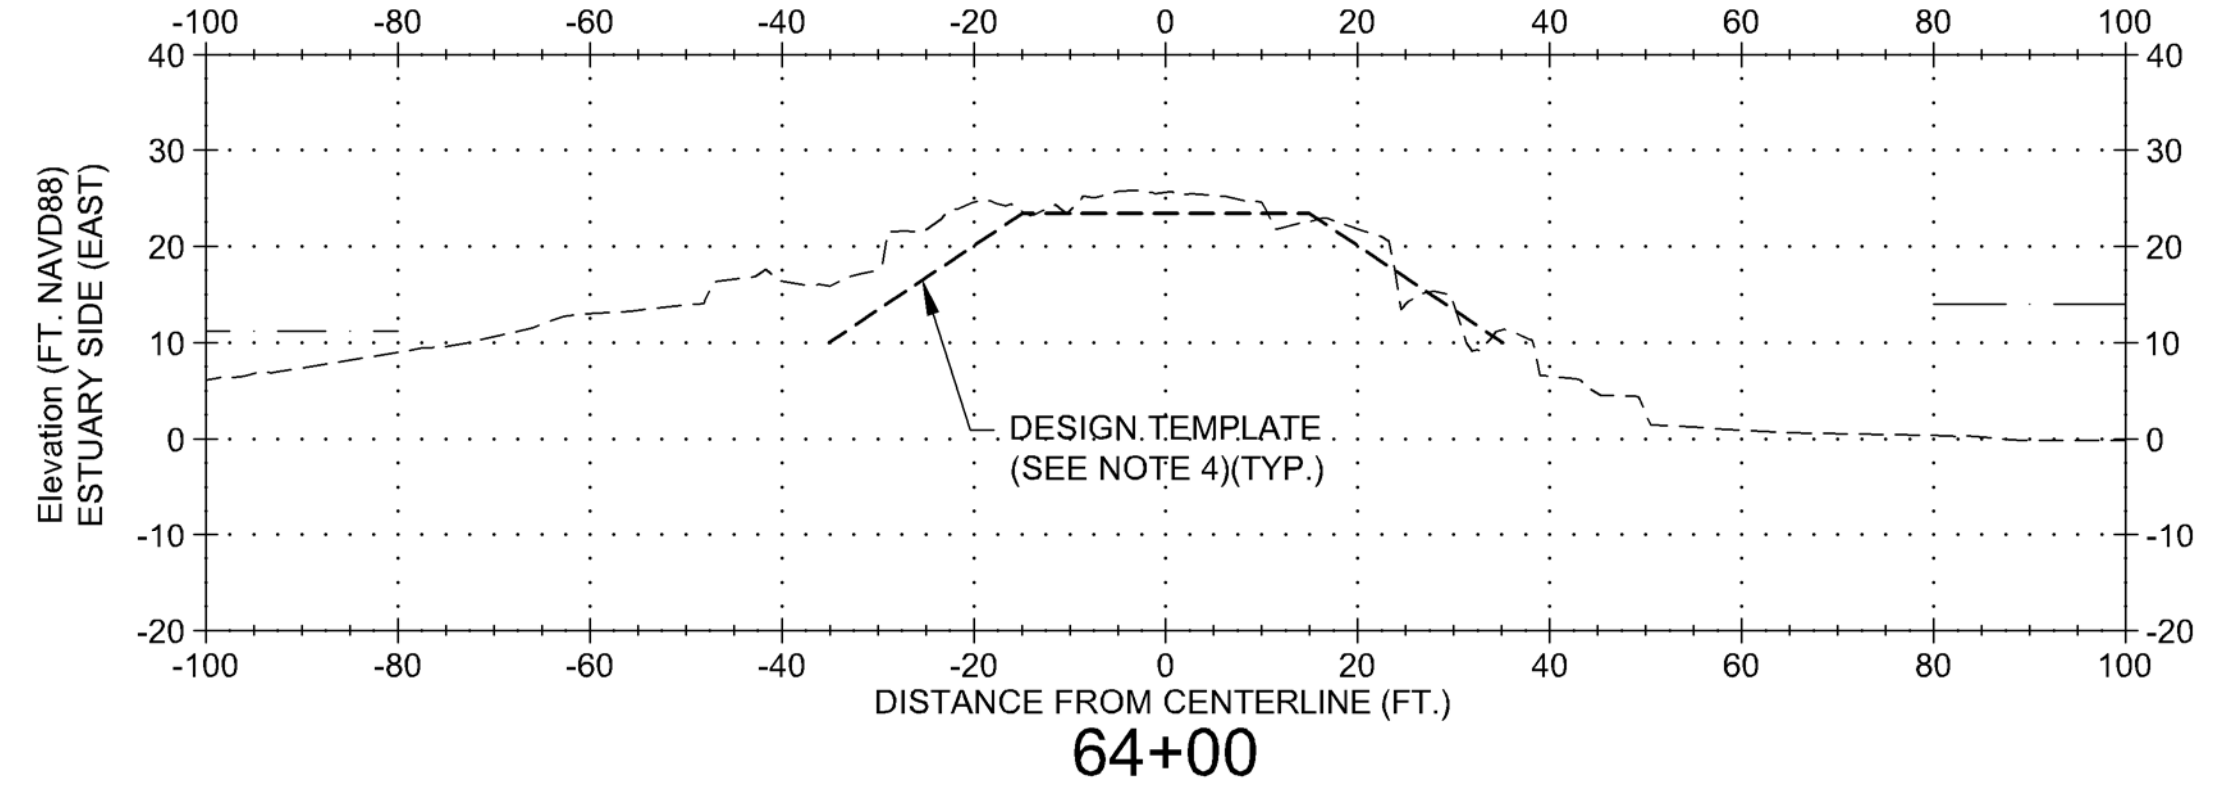
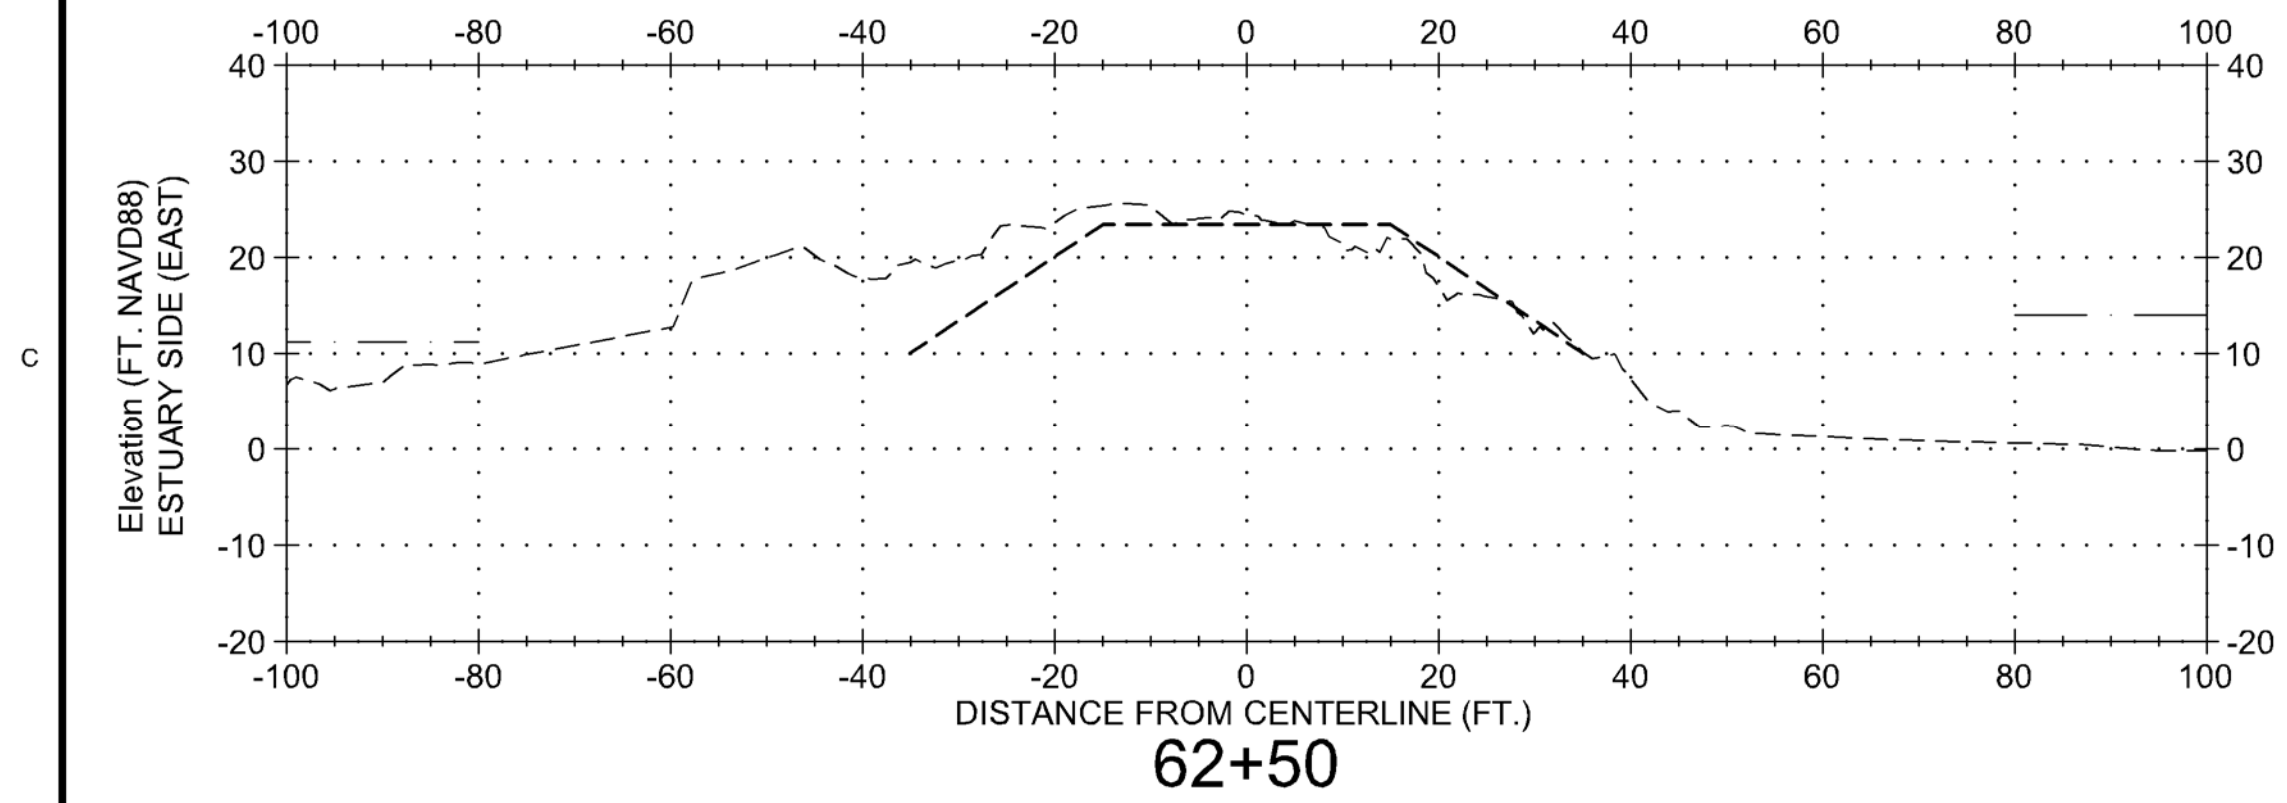
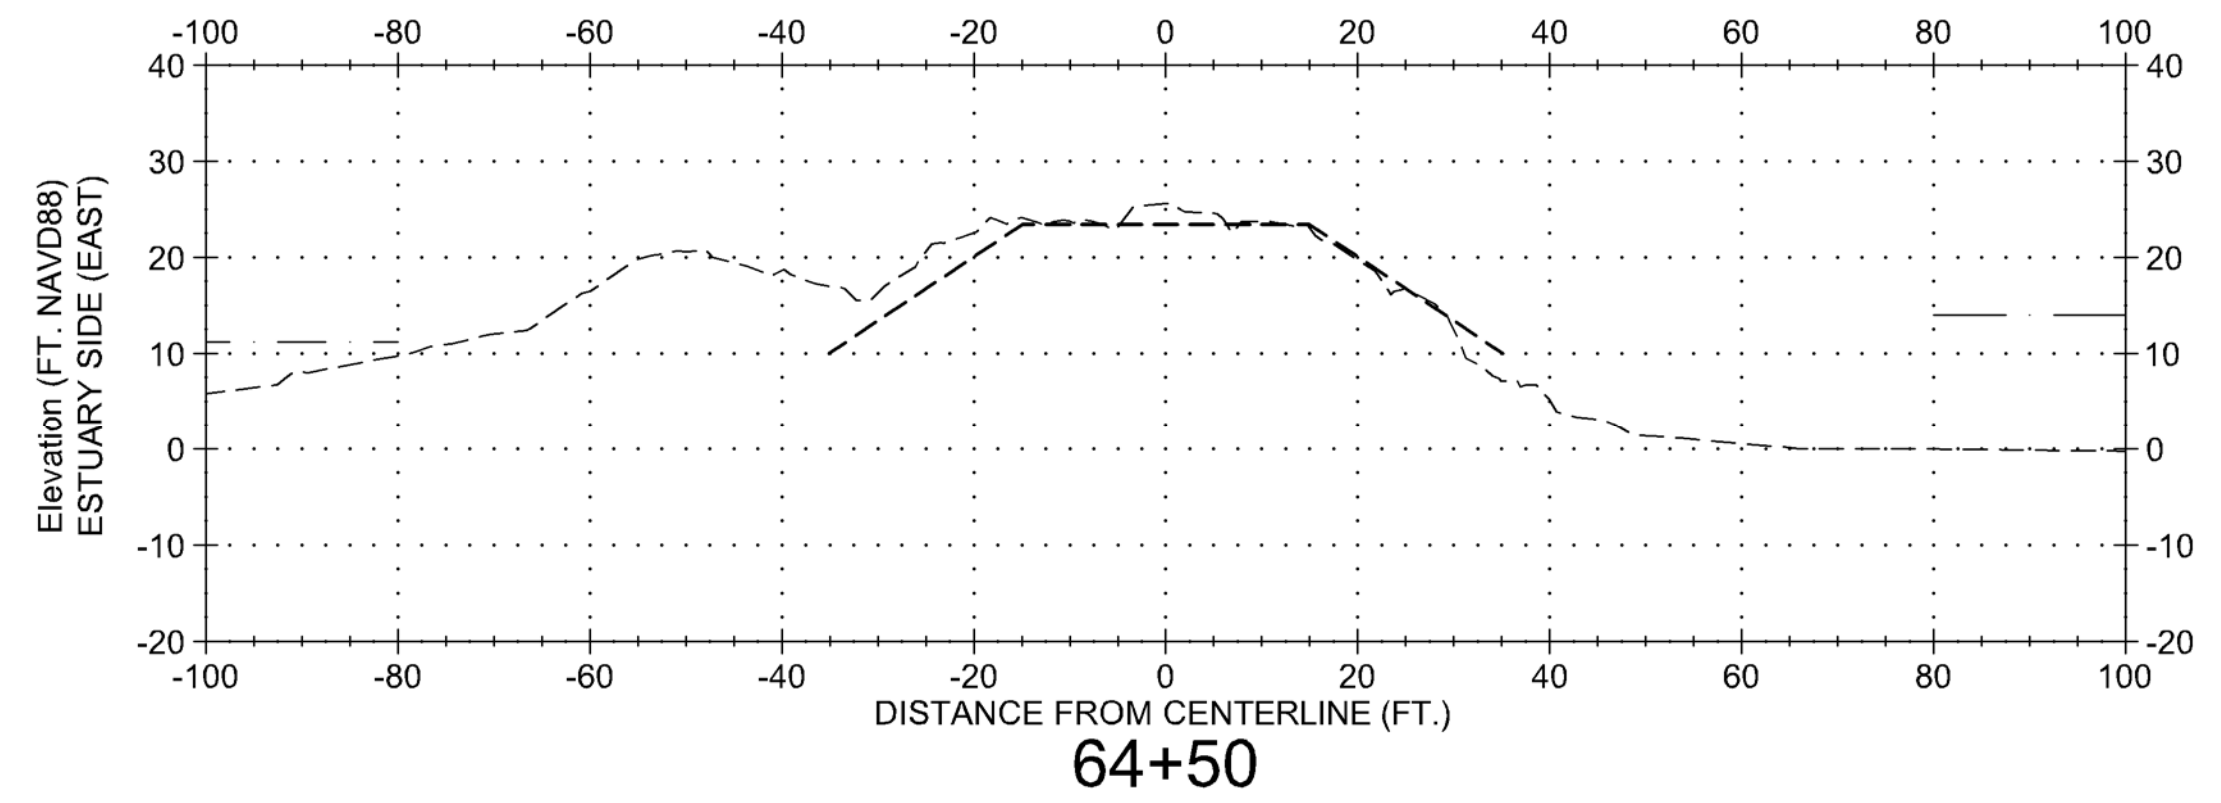
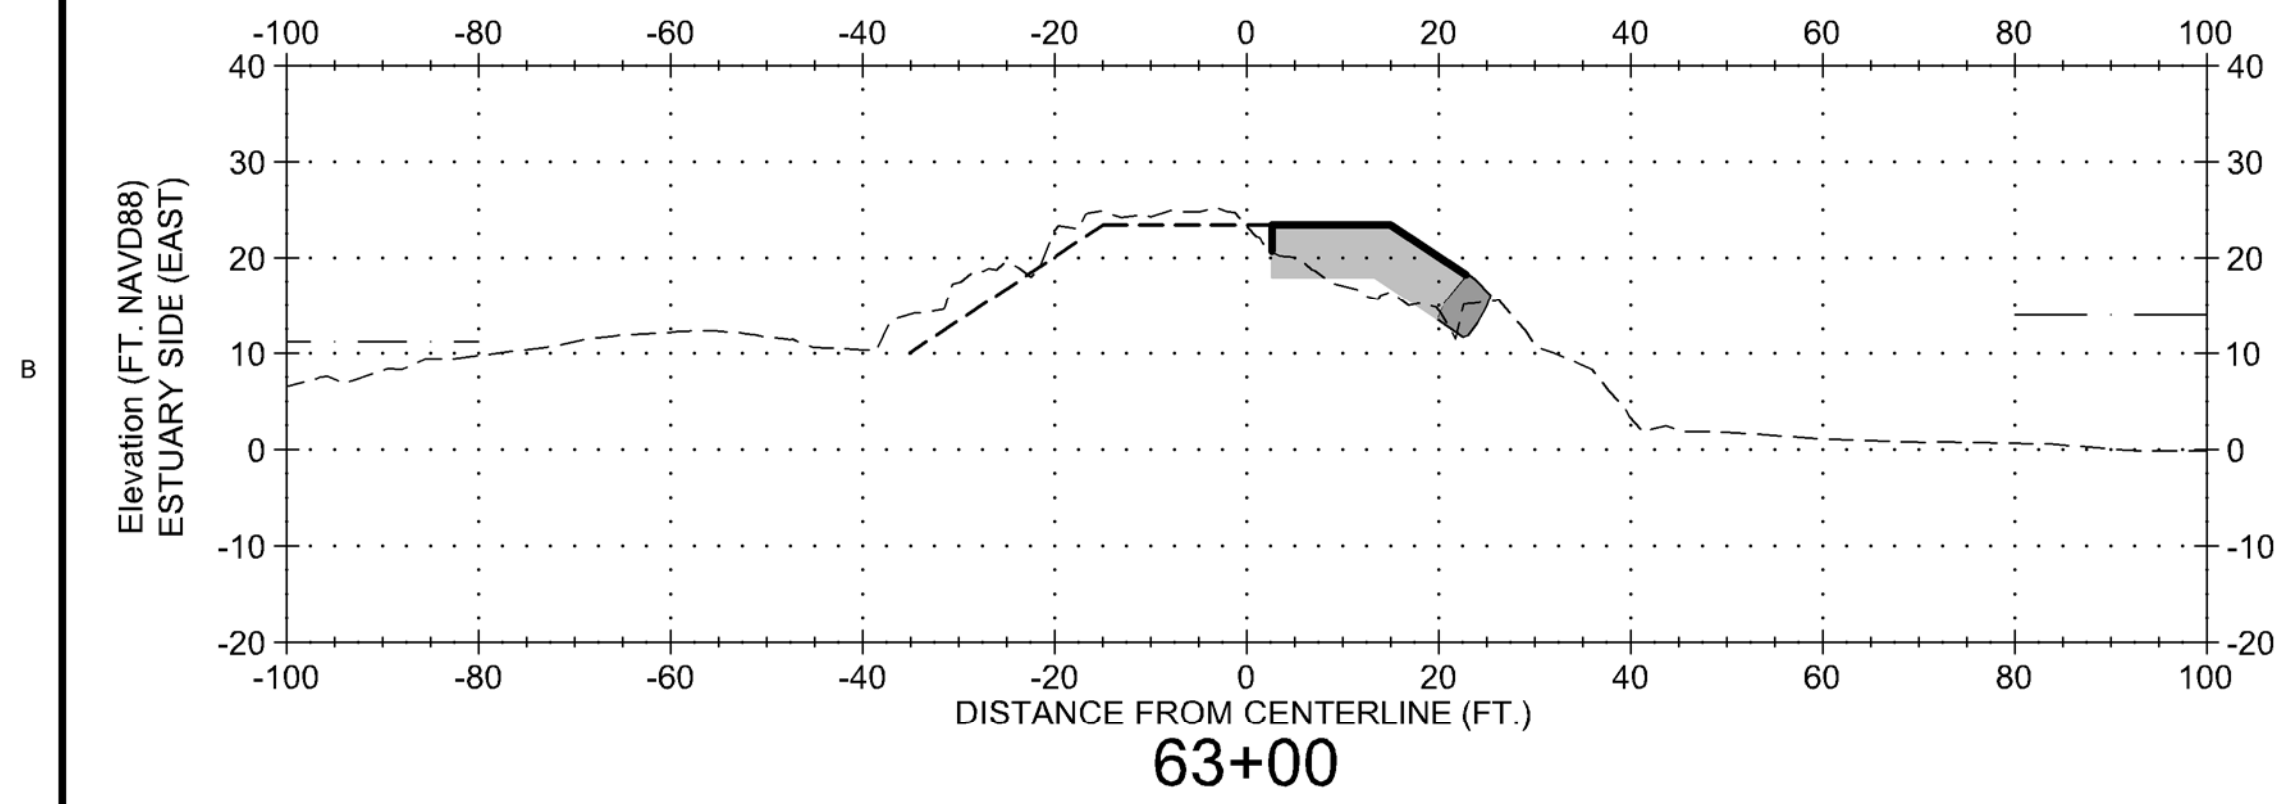
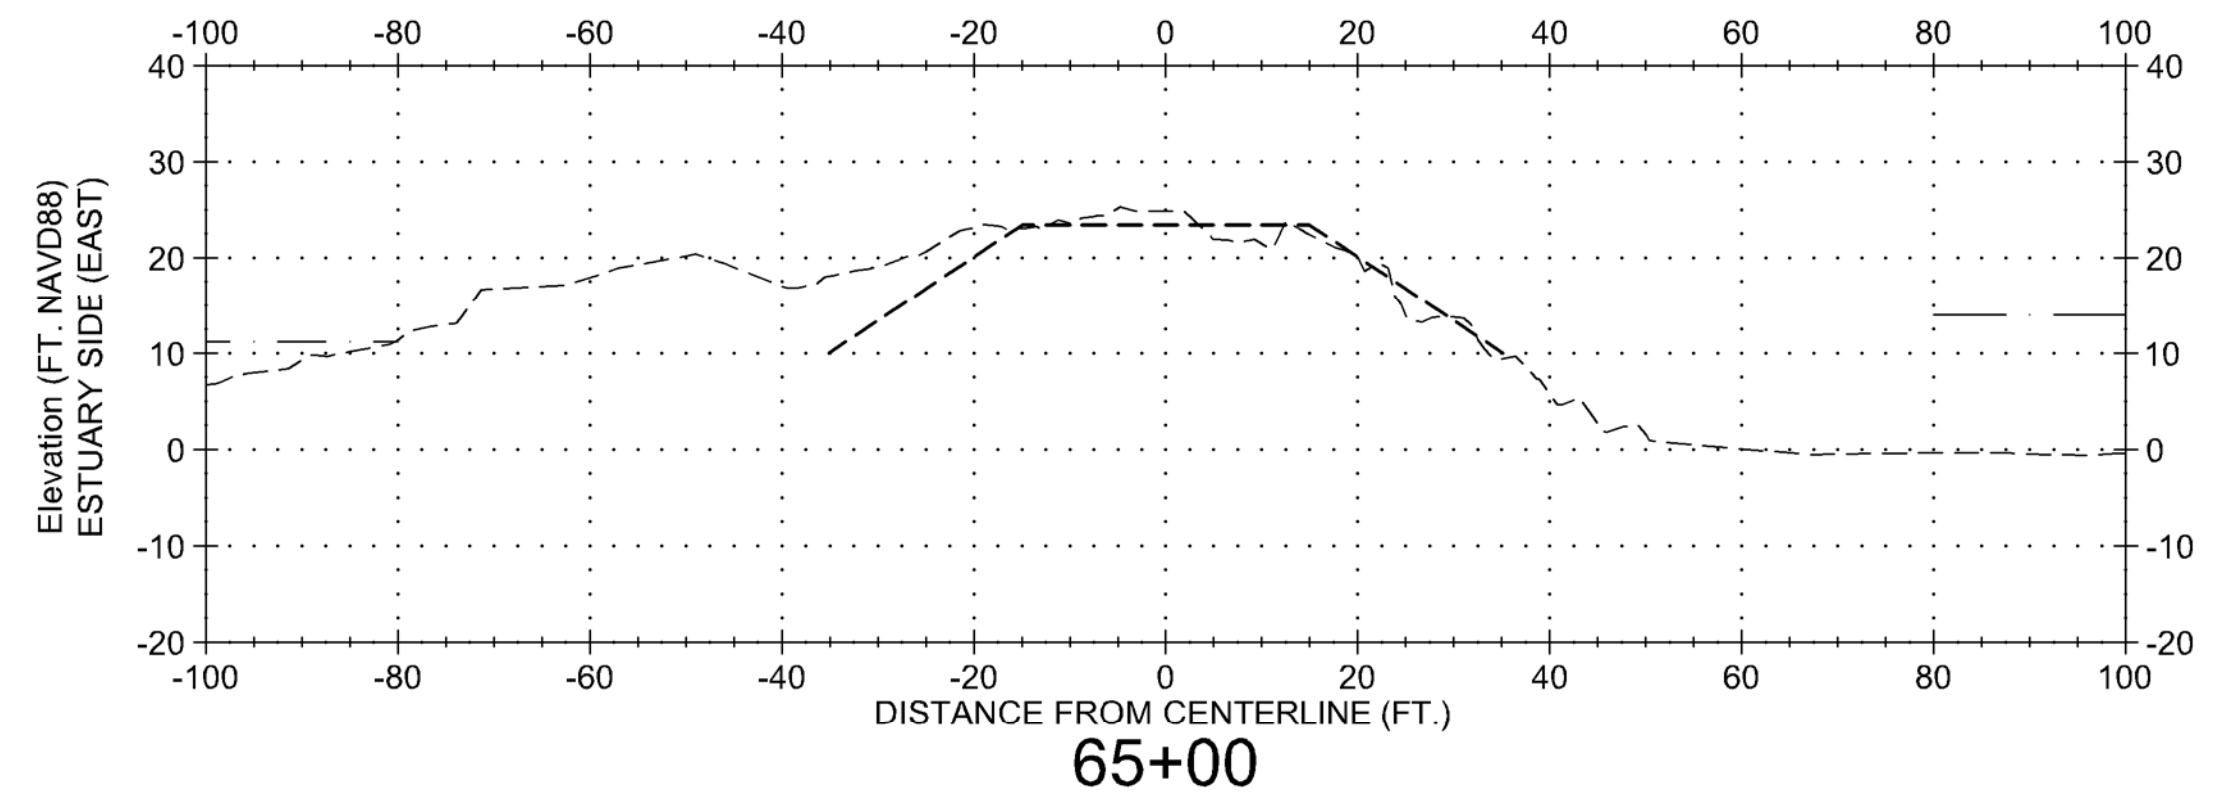
SHEET
IDENTIFICATION
CS008

COLUMBIA RIVER
MCR JETTY A REHABILITATION
CROSS SECTIONS
62+00 - 65+50

- NOTES:
1. SHOWN CONDITIONS APPLY TO THE SPECIFIC CROSS SECTION AT THE TIME OF SURVEY: AUGUST 2014, UNLESS WHERE NOTED OTHERWISE.
 2. TOE ELEVATION OF REPAIR TEMPLATE VARIES BASED ON POINT OF INTERSECTION BETWEEN:

1) RELICT ARMOR STONE MASS OF EXISTING CROSS SECTION, AND
2) FALL LINE (GRADE) OF REPAIR TEMPLATE
 3. THE AMOUNT AND LOCATION FOR WHERE EXISTING RELICT STONE WOULD NEED TO BE REPOSITIONED (TO ACCOMMODATE INTERLOCKING WITH NEW ARMOR STONE) IS VARIABLE. THERE MAY BE INSTANCES WHEN EXISTING RELICT STONE NEEDS TO BE MOVED, AND OTHER INSTANCES WHEN IT DOES NOT.

4. NO REPAIRS ARE REQUIRED FOR AREAS ABOVE THE DESIGN TEMPLATE LIMITS. THE JETTY IS TO BE REPAIRED IF A MINIMUM OF 1 LAYER OF NEW JETTY STONE CAN BE ACCOMMODATED WITHIN THE CROSS-SECTION TEMPLATE AND ITS TOLERANCES. SEE SPECIFICATION 35 31 26.40 25 3.3.1 e. DASHED LINE SHOWN REPRESENTS AREAS WHERE DESIGN TEMPLATE IS BELOW EXISTING GRADE.

6. NOMINAL THICKNESS OF 1 LAYER OF NEW A-STONE IS 5.5 FT, BASED ON 171 PCF. STONE DENSITY OF EXISTING ARMOR STONE.
 7. WOODY DEBRIS NOTE - AREA SHOWN IS KNOWN TO HAVE WOODY DEBRIS, WHICH WHEN REMOVED MAY EXPOSE DEFICIENT JETTY SECTIONS WHICH SHALL BE REPAIRED, AS NEEDED TO PROVIDE FULL CROSS-SECTION TEMPLATE ACCORDING TO CONTRACT PLAN NEAT LINE.

10. VERTICAL DATUM: NAVD88
 11. TOE STONE IS REQUIRED FOR REPAIR AREAS WHERE SIDE SLOPES EXTEND BELOW CREST 1 OR MORE STONE DIMENSIONS.
