US Army Corps
of Engineers
Portland District

COLUMBIA RIVER MOUTH OF THE COLUMBIA RIVER JETTY A REHABILITATION

**COLUMBIA RIVER
 MCR JETTY A REHABILITATION**

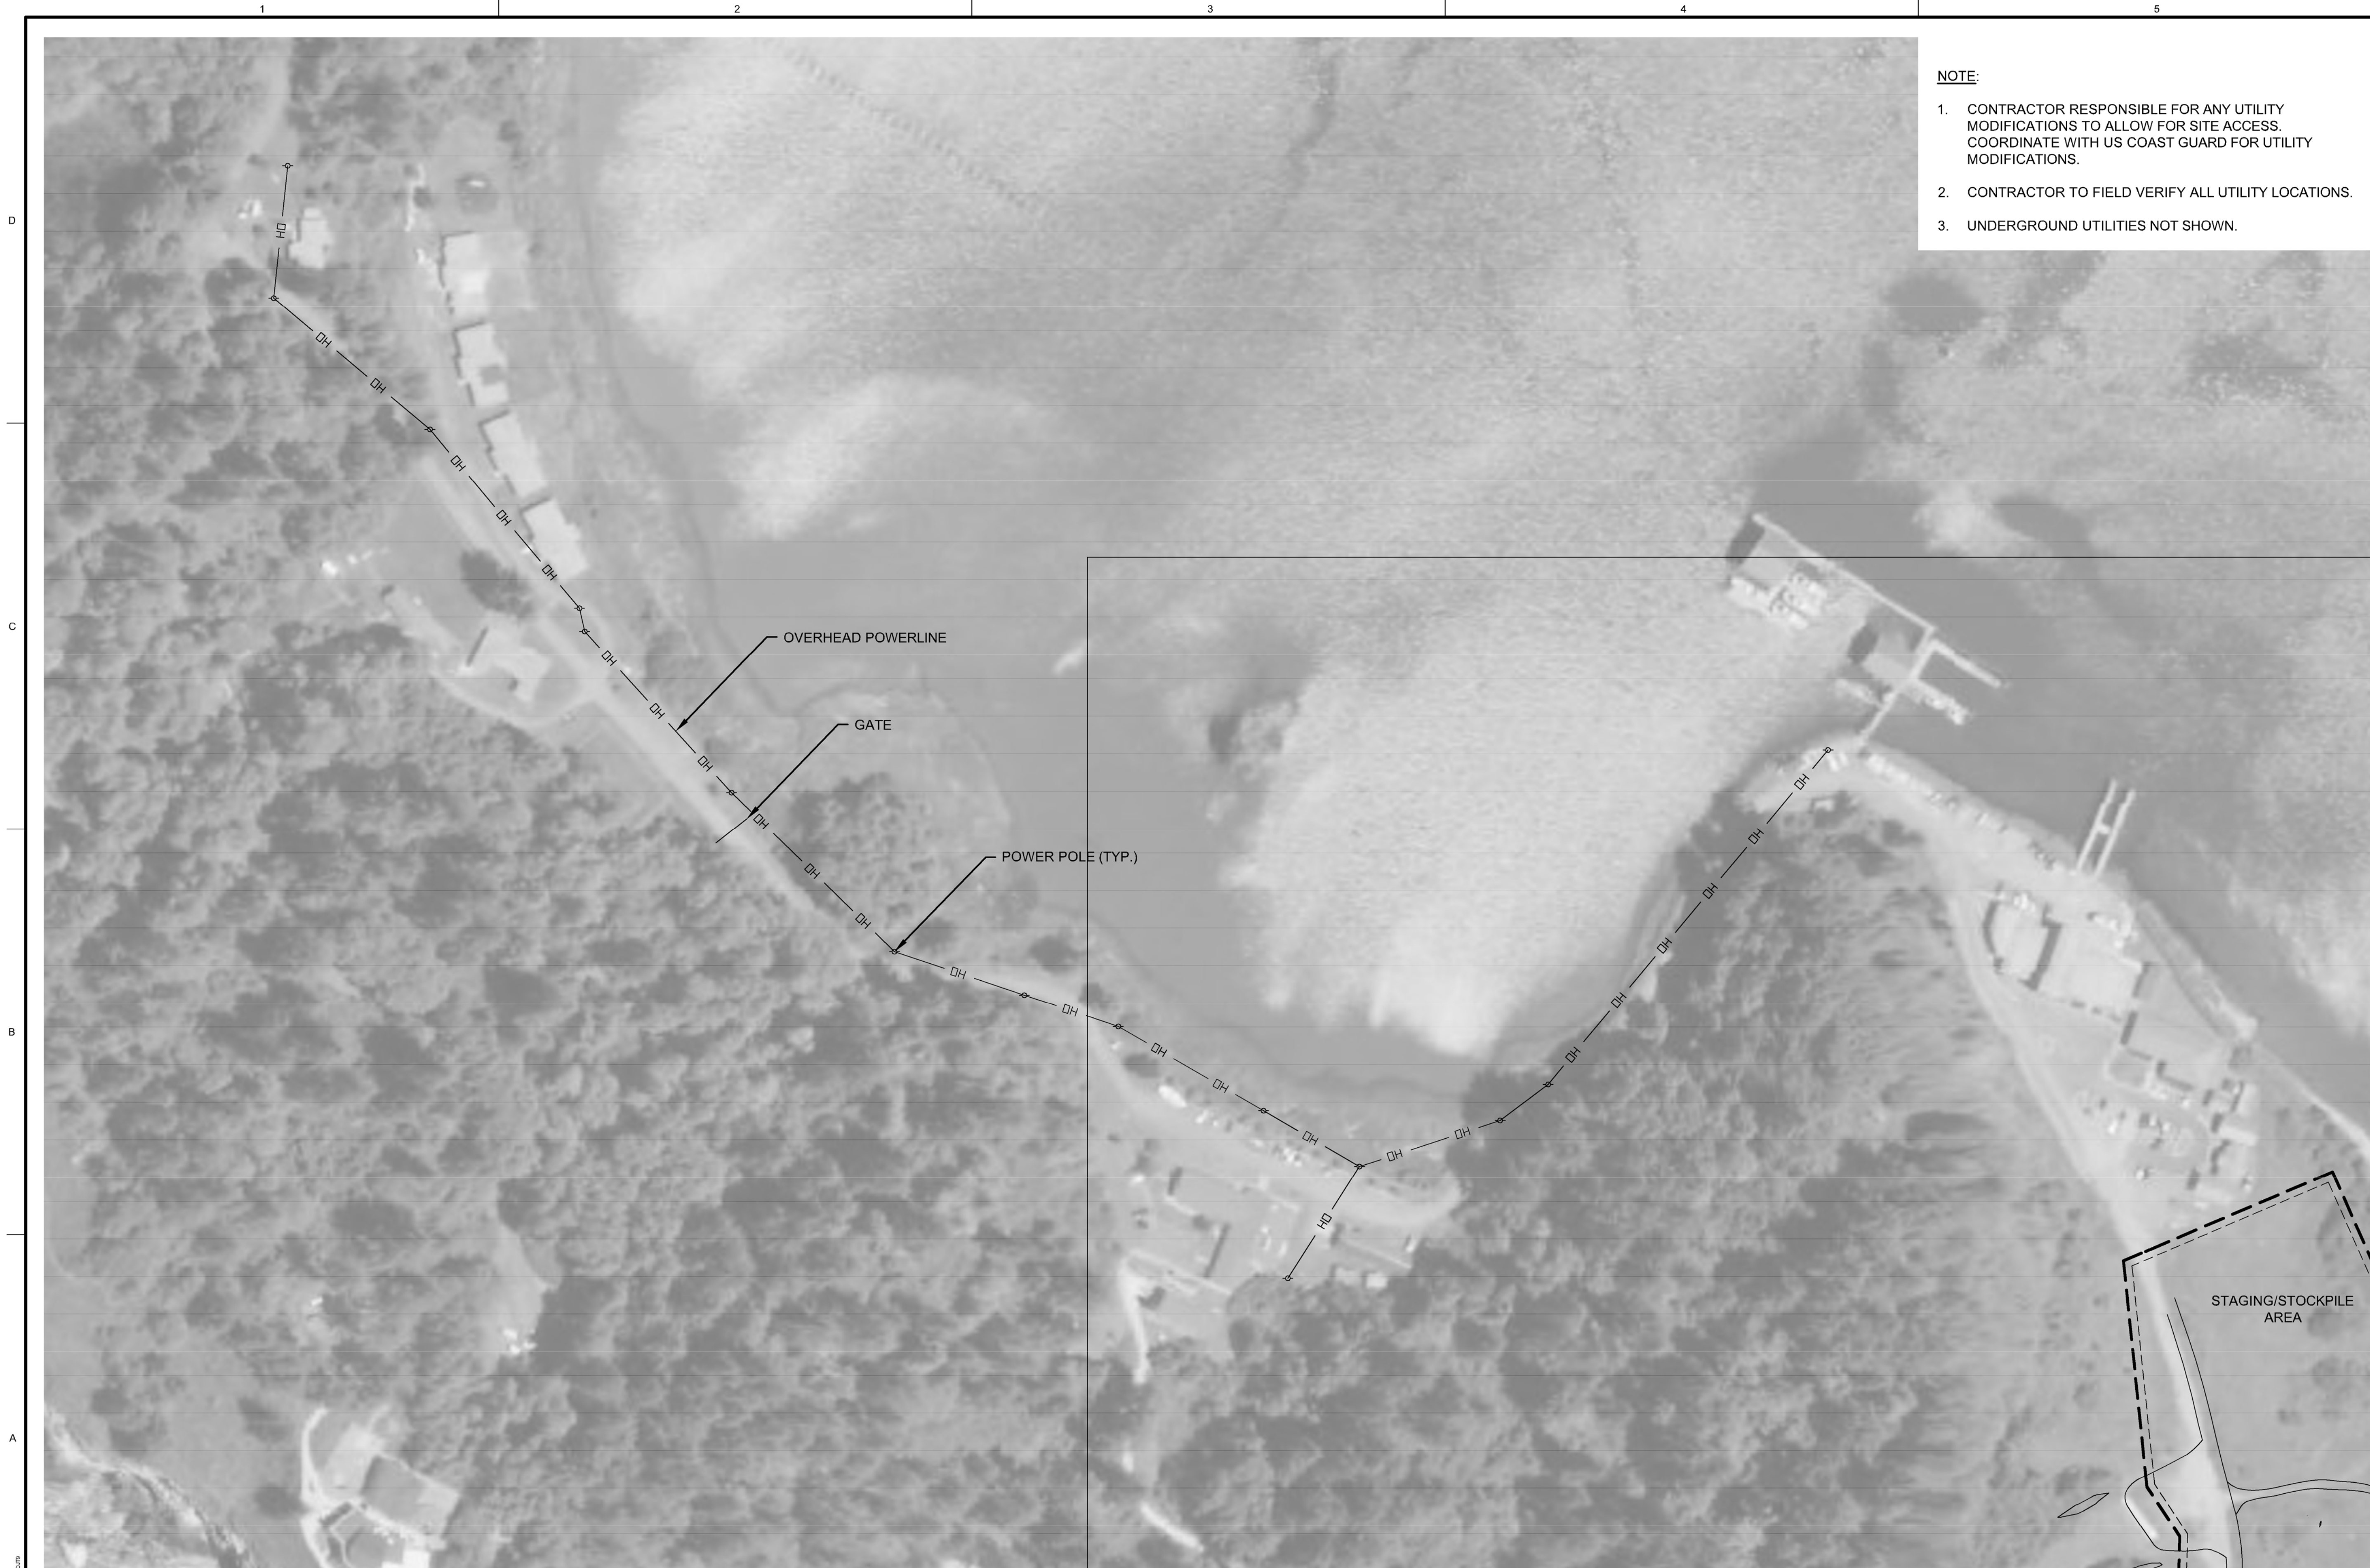
SHEET IDENTIFICATION
 CS014

CROSS SECTIONS
 86+00 - 89+00

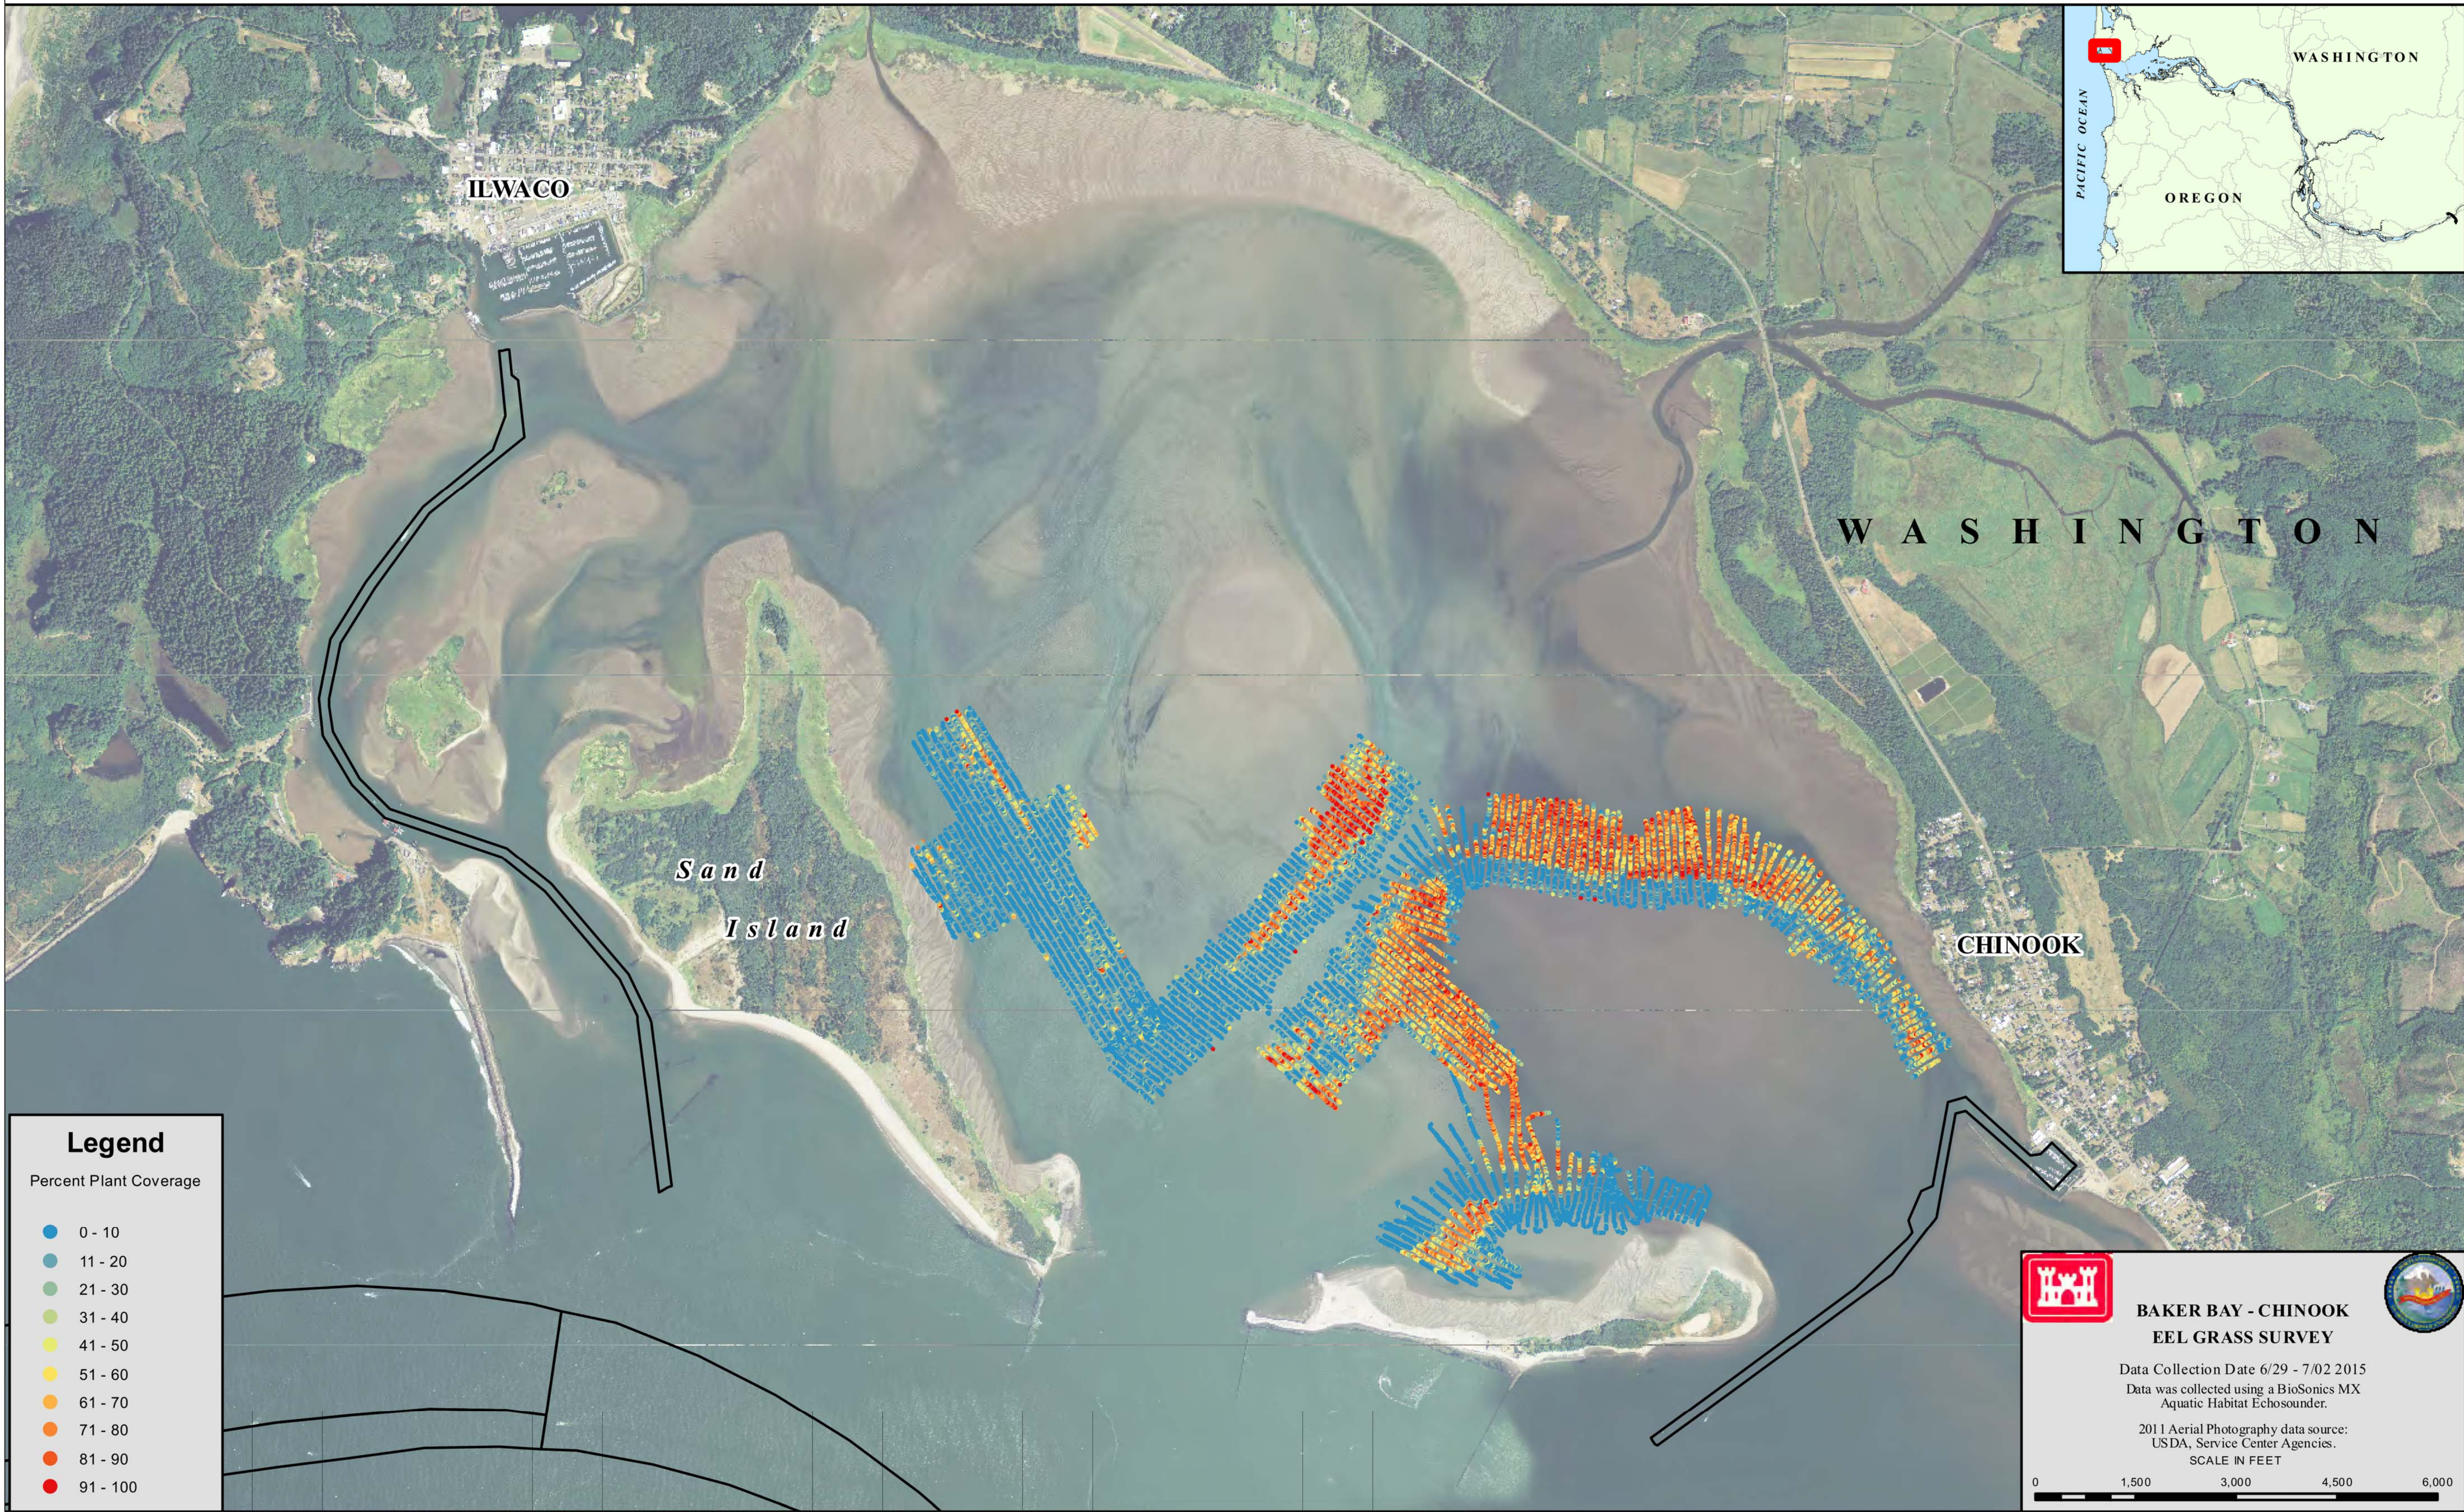
SHEET IDENTIFICATION
C-502

COLUMBIA RIVER
MCR JETTY A REHABILITATION
EELGRASS LOCATION MAP
FOR INFORMATION ONLY
