710 WILSHIRE BOULEVARD

MIXED-USE HOTEL PROJECT

WINDOW DETAILS

A-620

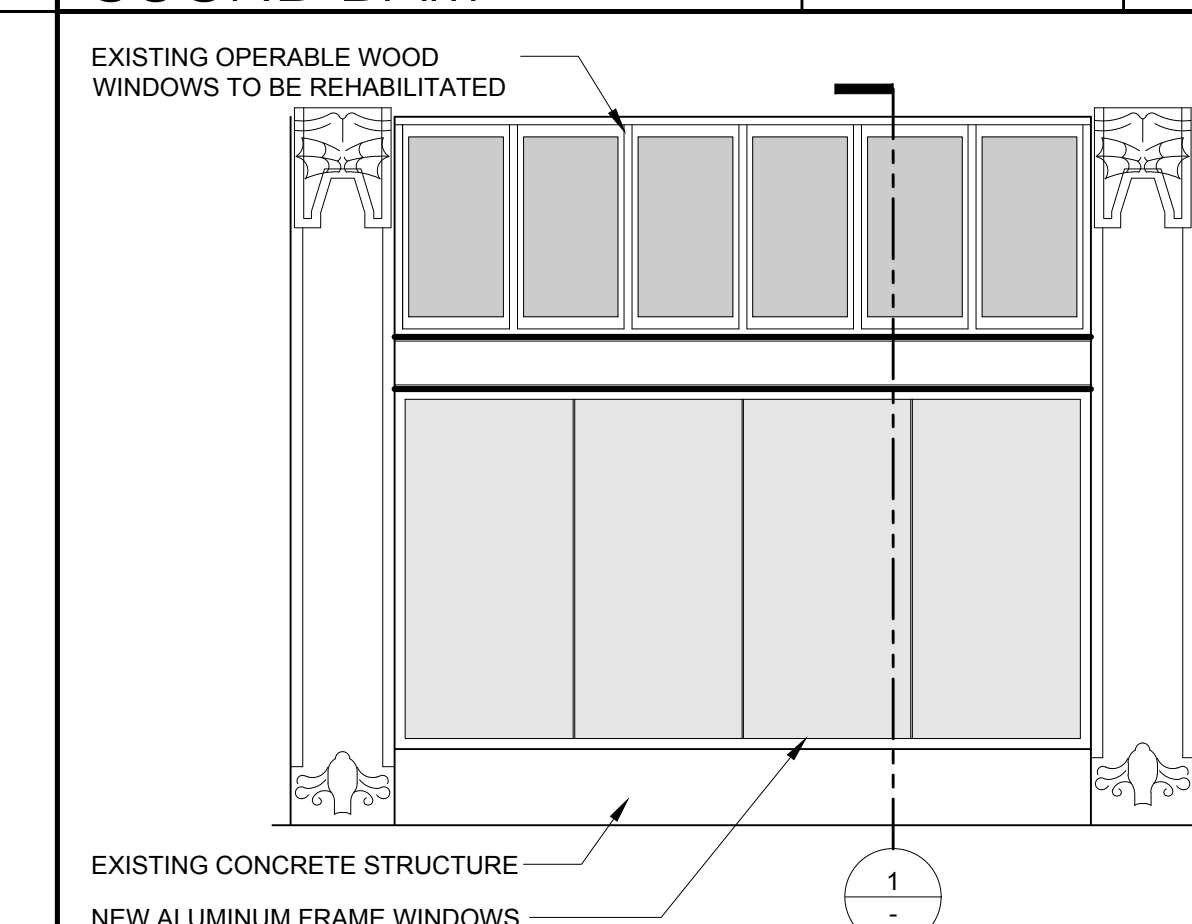
<p>EXISTING OPERABLE WOOD WINDOWS TO BE REHABILITATED</p> <p>EXISTING CONCRETE STRUCTURE</p> <p>NEW ALUMINUM FRAME WINDOWS</p>

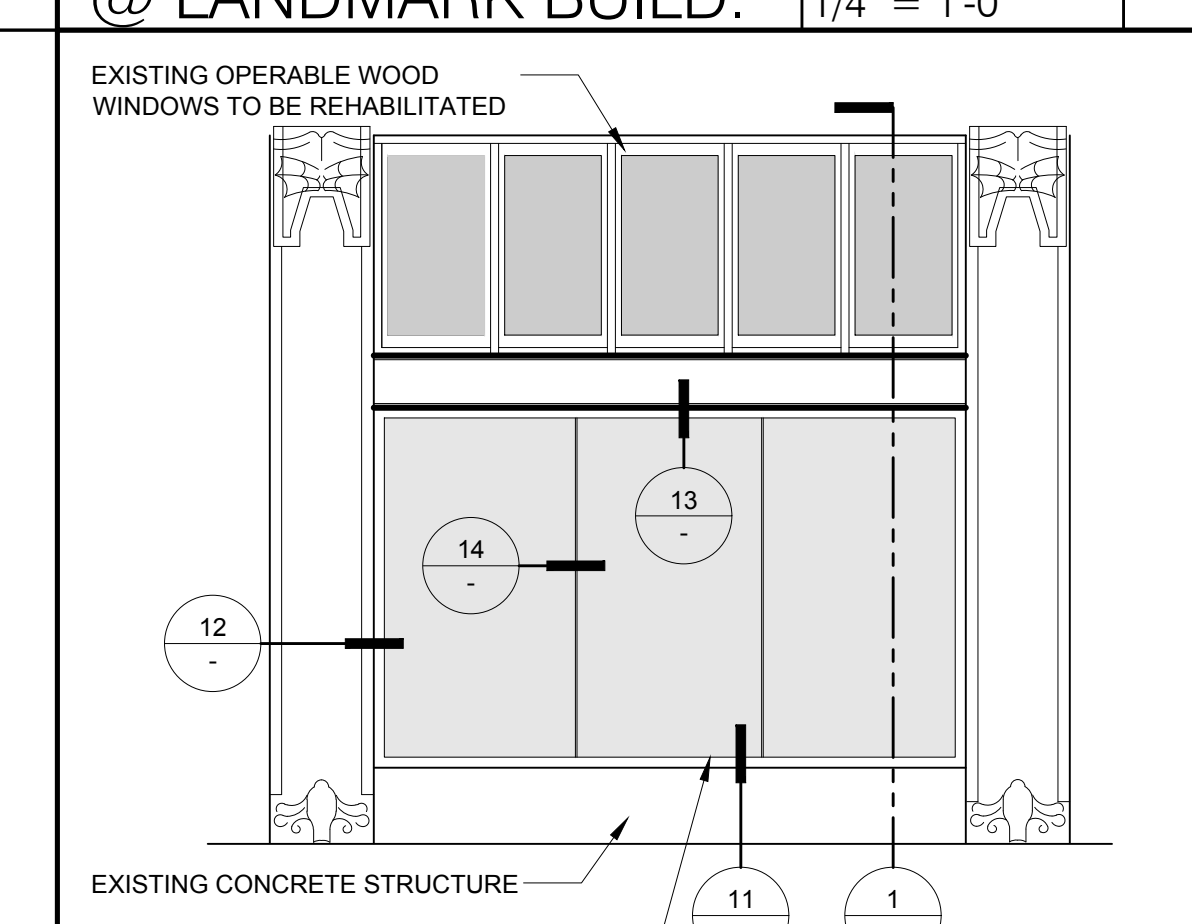
<p>EXISTING OPERABLE WOOD WINDOWS TO BE REHABILITATED</p> <p>EXISTING CONCRETE STRUCTURE</p> <p>NEW ALUMINUM FRAME WINDOWS</p>

<p>EXISTING CONCRETE STRUCTURE</p> <p>SEALANT JOINT</p> <p>NEW ALUMINUM STOREFRONT WINDOW SYSTEM</p>		
WINDOW SILL @ OPERABLE WINDOW			STOREFRONT SILL @ LANDMARK BUILD.			WINDOW REHAB 5 BAY @ LANDMARK BUILD.		
3" = 1'-0"			3" = 1'-0"			1/4" = 1'-0"		
16			6			1
