710 WILSHIRE BOULEVARD  
MIXED-USE HOTEL PROJECT  
SANTA MONICA - CALIFORNIA, 90401  
FOURTH AND FIFTH FLOOR PLANS

LM-S-203

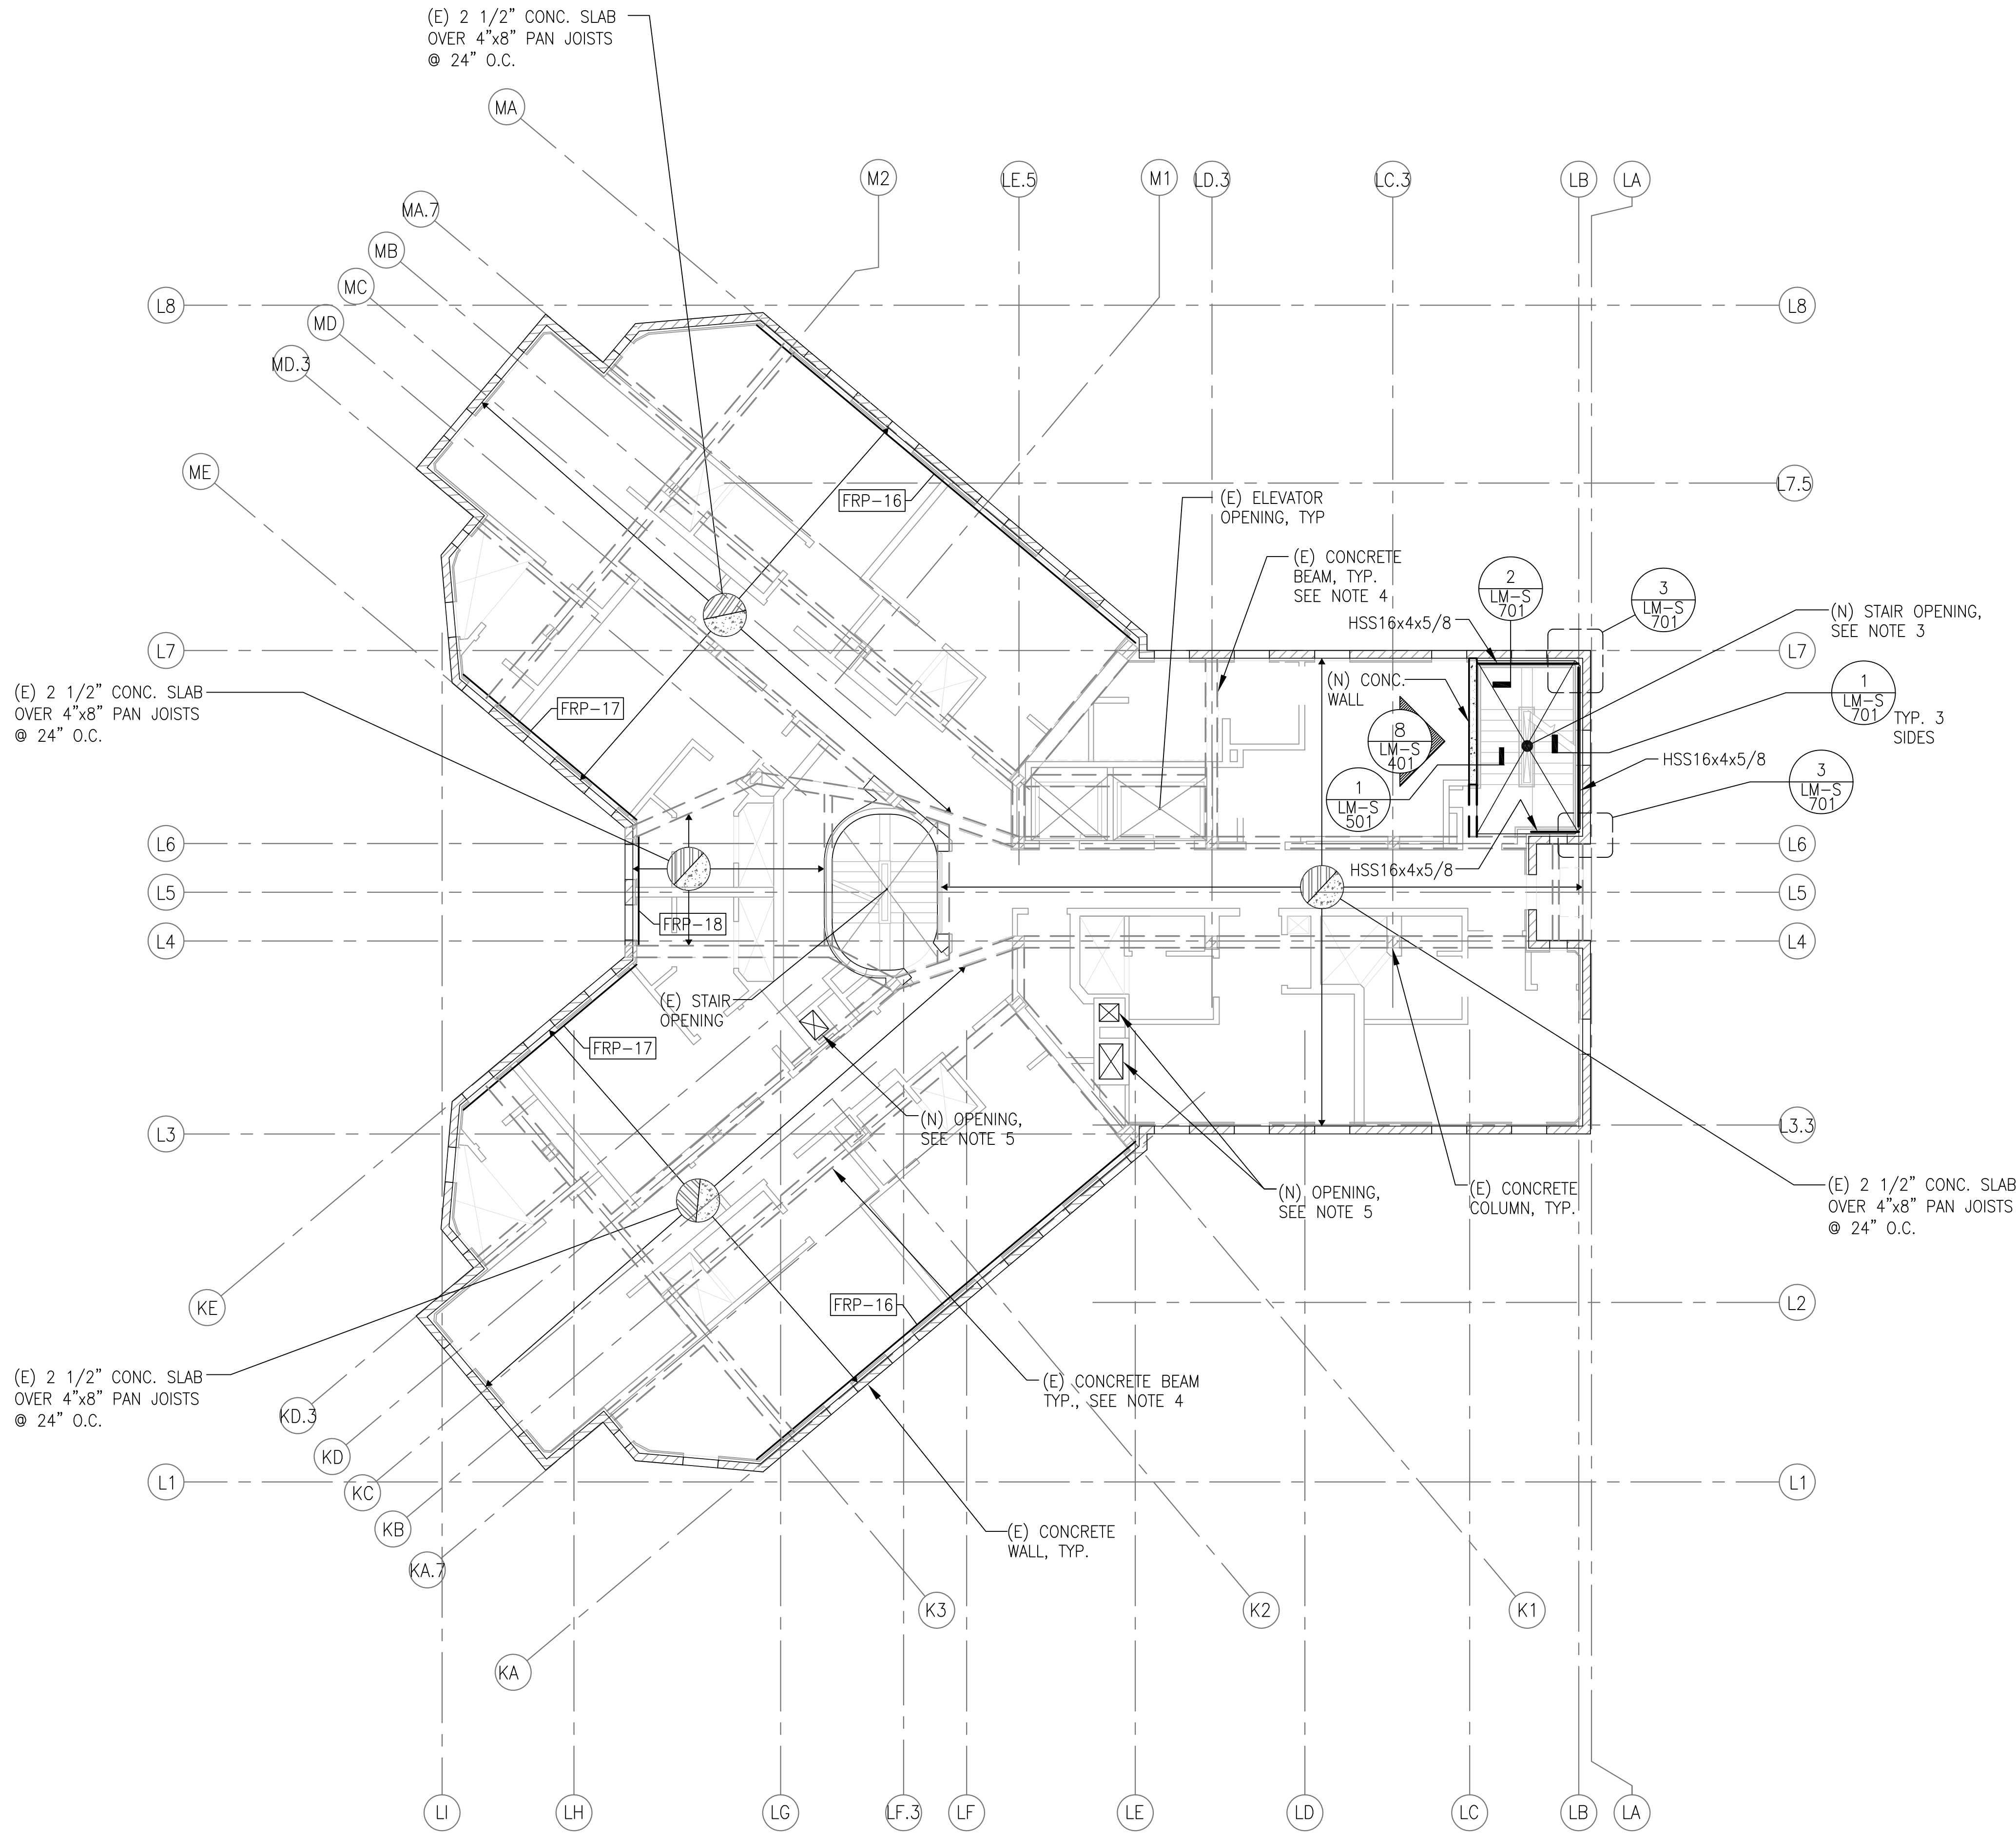
2 FIFTH FLOOR PLAN  
1/8"=1'-0"

- NOTES:
1. \_\_\_\_\_ INDICATES EXTEND OF FRP.
  2. [FRP-XX] INDICATES TYPE OF FRP, SEE 6/LM-S-801.
  3. CONTRACTOR IS SOLELY RESPONSIBLE FOR EXCAVATION AND SHORING PROCEDURES INCLUDING LAGGING, UNDERPINNING AND PROTECTION OF EXISTING STRUCTURE.

4. REFER TO THIRD LEVEL FLOOR PLAN, 2/LM-S-202 FOR EXISTING BEAM CALLOUTS AND DETAIL 16/LM-S-501 FOR BEAM SIZES.
  5. SEE DETAILS 22/LM-S-501 AND 8/LM-S-501 FOR STRENGTHENING REQUIRED AROUND NEW OPENINGS PENETRATING THRU (E) CONCRETE PAN JOISTS.

6. LOCATE SMALLER PENETRATIONS BETWEEN (E) CONCRETE PAN JOISTS & REFER TO DETAIL 7/LM-S-004 FOR STRENGTHENING REQUIREMENTS. REFER TO DETAILS 22/LM-S-501 AND 8/LM-S-501 AT LOCATIONS WHERE (E) CONCRETE PAN JOISTS ARE TO BE CUT.
